# Wittich Hall Renovation

Preservation Plan  
Appendix 2

University of Wisconsin – La Crosse  
November 1, 2016

DFD Project No. 14I20

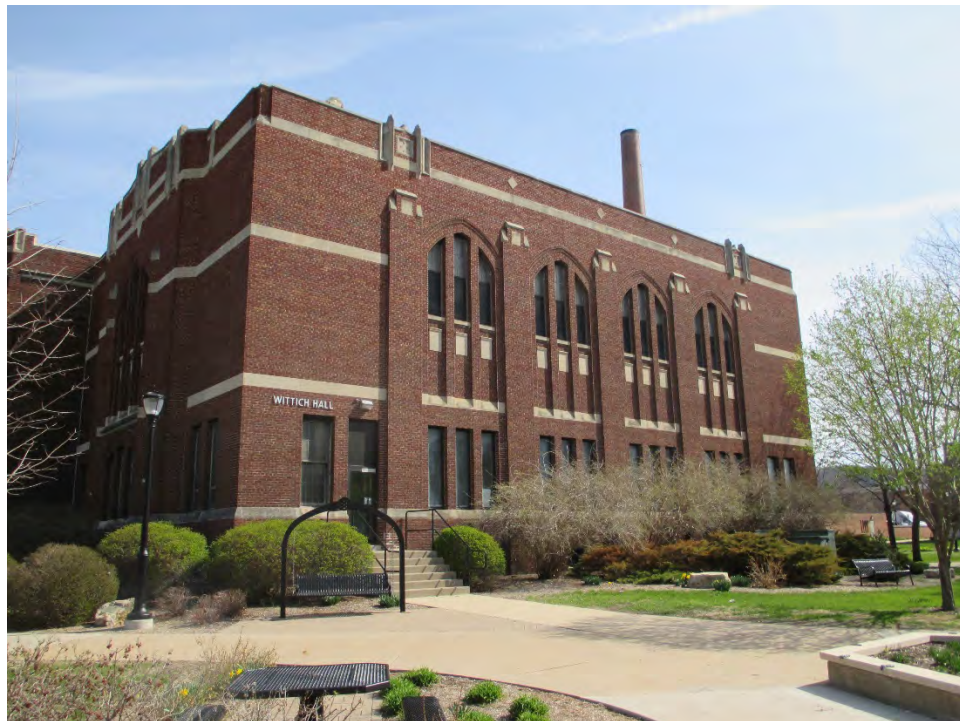
Figure 12: South Elevation, Wittich Hall; River Architects (2014)

Wittich Hall's unique character, rich history, and structural conditions are the primary reasons for saving this structure. The exterior is in relatively good condition considering the building's age. Window replacements have helped prolong some of the challenges the building has faced over time and these windows will now need to be addressed. A total of 52% of the total window area of Wittich Hall have been modified in some fashion. Windows that have not been replaced are reaching the end of their useful life and should be replaced. One interesting observation of Wittich Hall is that all of the existing windows include obscured glass of some kind. There are a number of sashes that have been replaced with clear glass. Including the lower level, there are original windows, replaced windows, and windows infilled with masonry. The recommendation by this design team is to replace all windows with a metal-clad wood window with thermal glazing and profiles to match the original design. The brick and limestone are in good condition and require a complete cleaning along with pointing of existing joints wherever necessary. Broken limestone located near the northwest entrance should be replaced.

The roof has been altered and repaired several times. The most recent roofing project, conducted in 1985, applied a Hypalon coating over the entire roof, including the original 1916 skylight infills. This coating is also placed over flashings. Parapet coping stones should be removed and a flashing should be installed in the setting bed of the stone coping in order to provide a more weather-resistant solution.

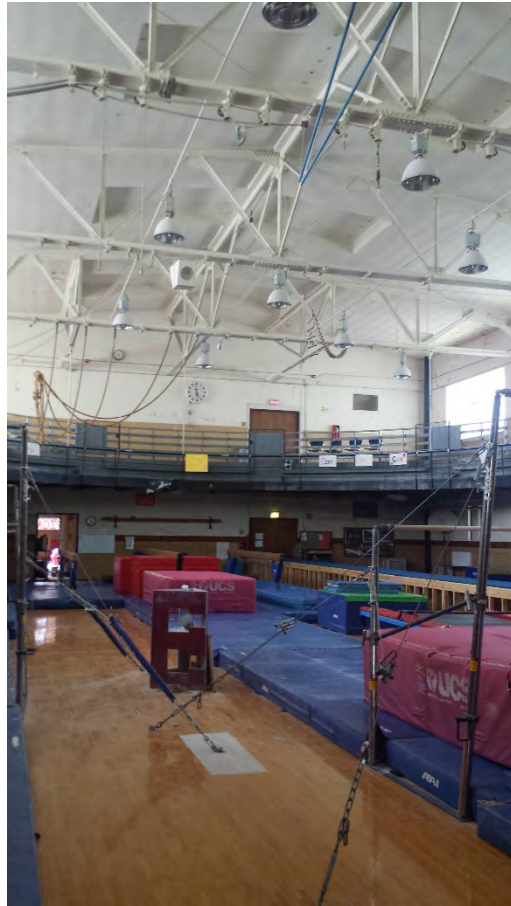
Figure 22: 1916 Gymnasium, Wittich Hall; River Architects (2016)

Plaster walls in the gymnasium are in fair to poor condition depending on location. A full plaster restoration should be explored with possibly expressing of the light-colored brick wainscot and wood cap.

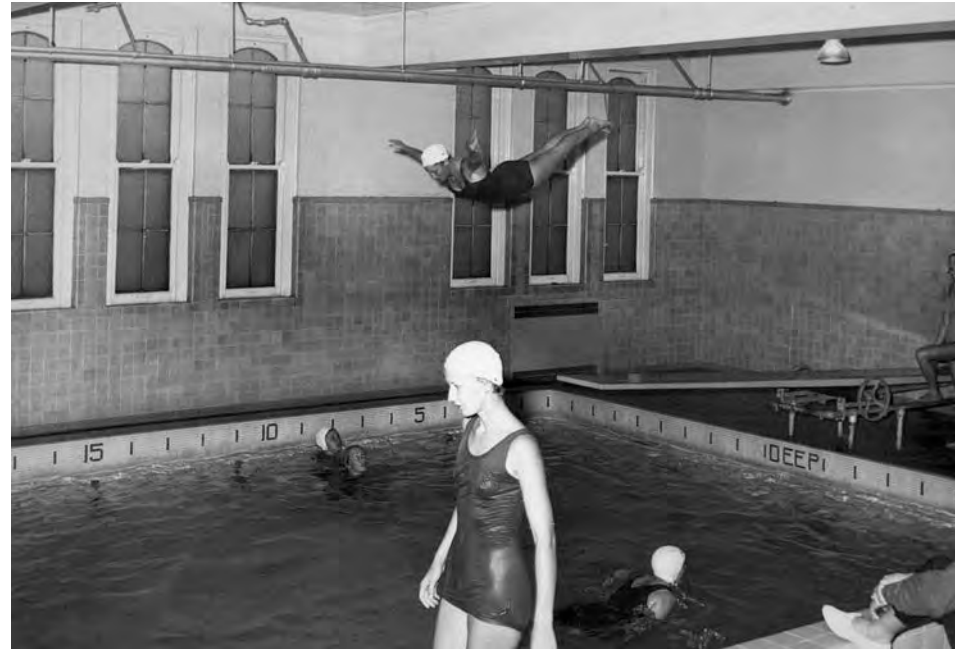
Figure 32: 1930 Pool, Wittich Hall; UW-La Crosse Area Research Center (c.1931)

Windows in the 1930 pool area have been replaced with aluminum units and will be removed and replaced with units to match the historic double-hung configuration. It is recommended that these units be painted as originally specified.

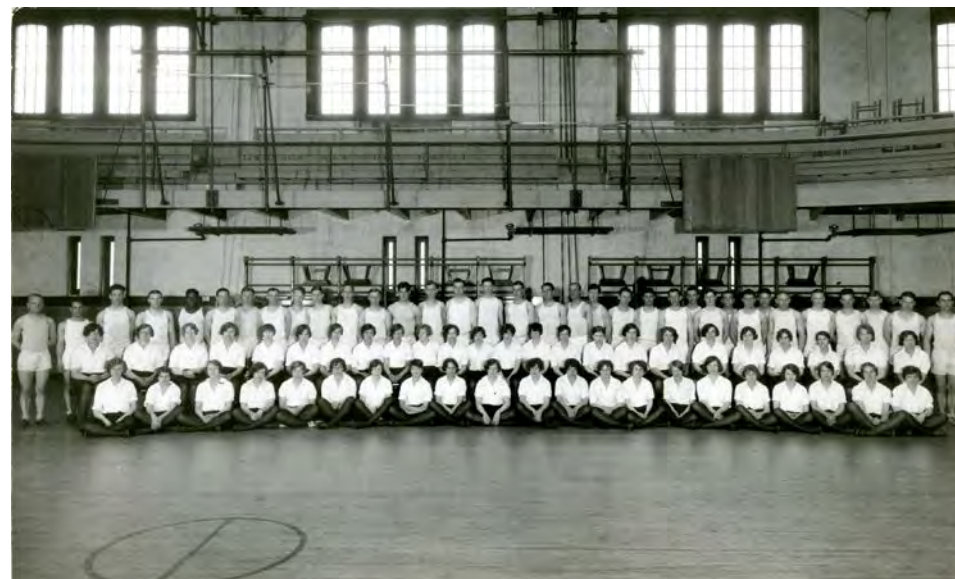
Figure 33: 1916 Gymnasium, Wittich Hall; UW-La Crosse Area Research Center (c.1930)

Upper level windows in the 1916 gymnasium that have been replaced with glass block were originally trimmed in wood and stained. It is recommended that the new units match the historic color as closely as possible.

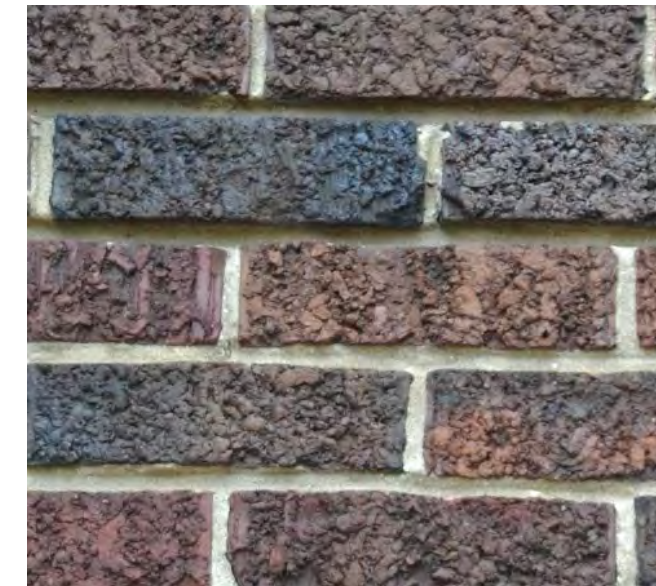
Figure 34: 1916 Brick, Wittich Hall; River Architects (2016)

Although the brick, limestone, and mortar appear to be in relatively good condition, further examination of the mortar should be conducted prior to any masonry restoration work in the future. Because there is a noticeable difference in the mortar between the 1916 and 1930 portions of the building, this analysis of the mortar makeup will provide a consistent match to the original mortar of both areas of the building.
