WITTICH HALL RENOVATION

WITTICH HALL RENOVATION
FACILITY CONDITION ASSESSMENT
APPENDIX 3

DFD Project No. 14120

November 1, 2016

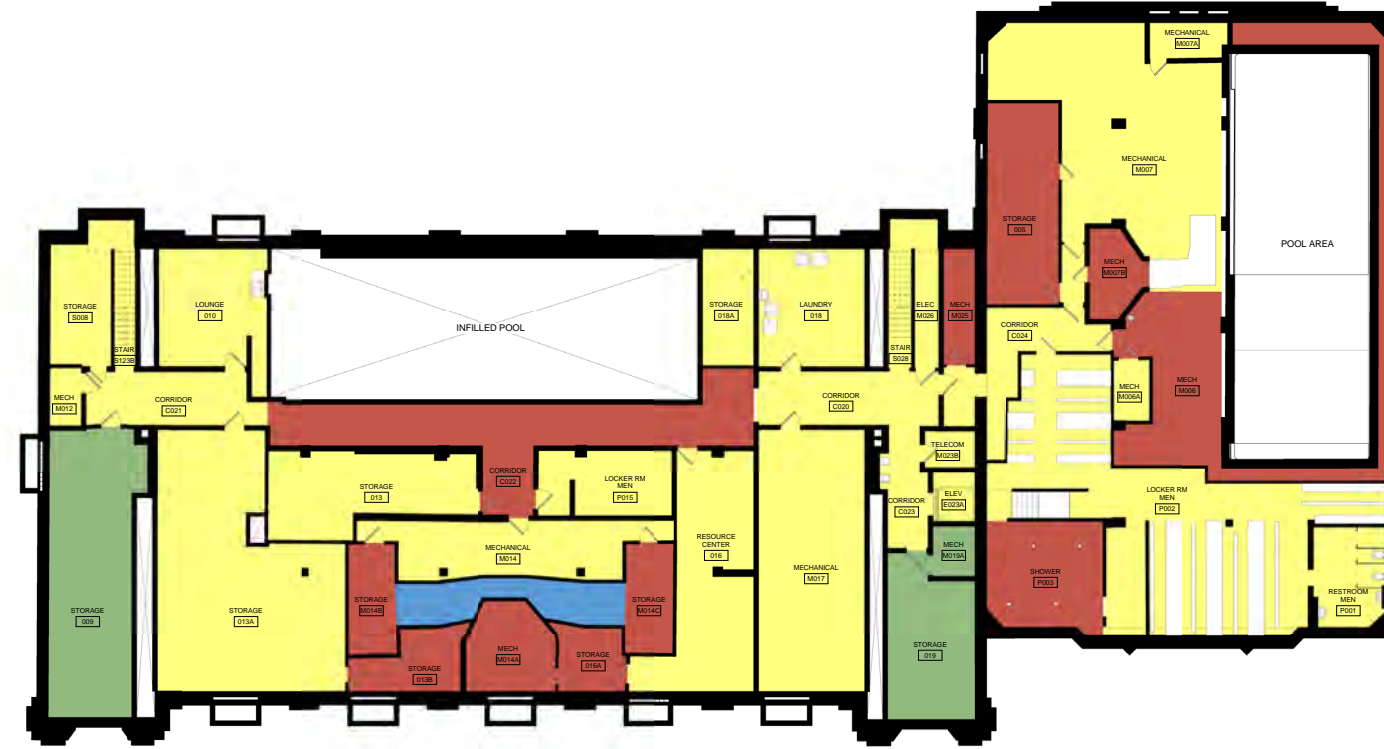
1 LOWER LEVEL - CONDITION PLAN
1" = 1'-0"

The lower level space consists mainly of general building maintenance rooms, locker rooms, and storage rooms for the building. The general condition of the floor ranges from “satisfactory” (2) where spaces have been remodeled, to “unsatisfactory” (5) in many of the mechanical and storage rooms.

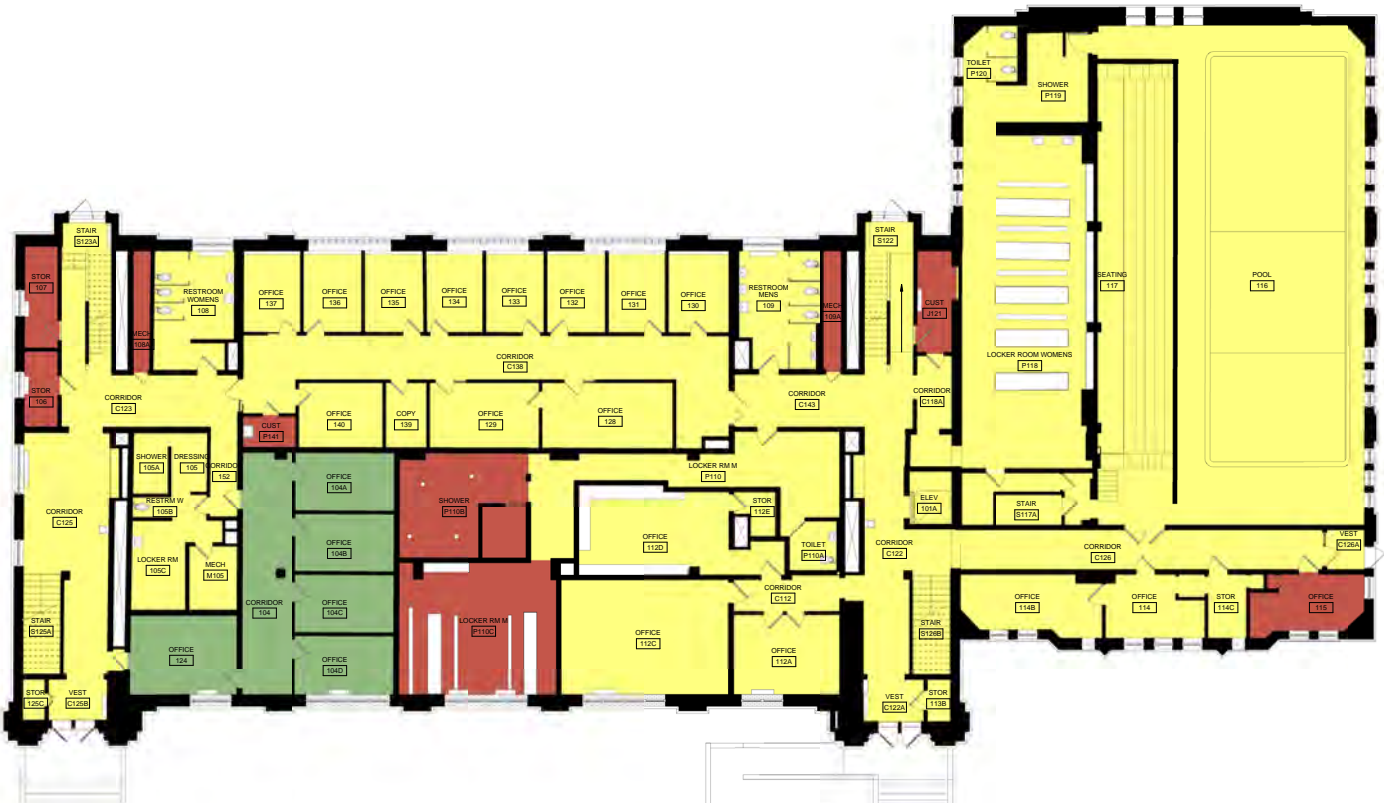
1 FIRST FLOOR - CONDITION PLAN
1" = 1'-0"

The First Floor of the building consists mainly of office spaces, locker rooms and the remaining pool.

The general condition of the spaces on the first floor are in “fair” condition, however there are some areas that are in “poor” (4) to “unsatisfactory” (5) condition. There is one area of “satisfactory” (2) offices in the building that have been recently remodeled.

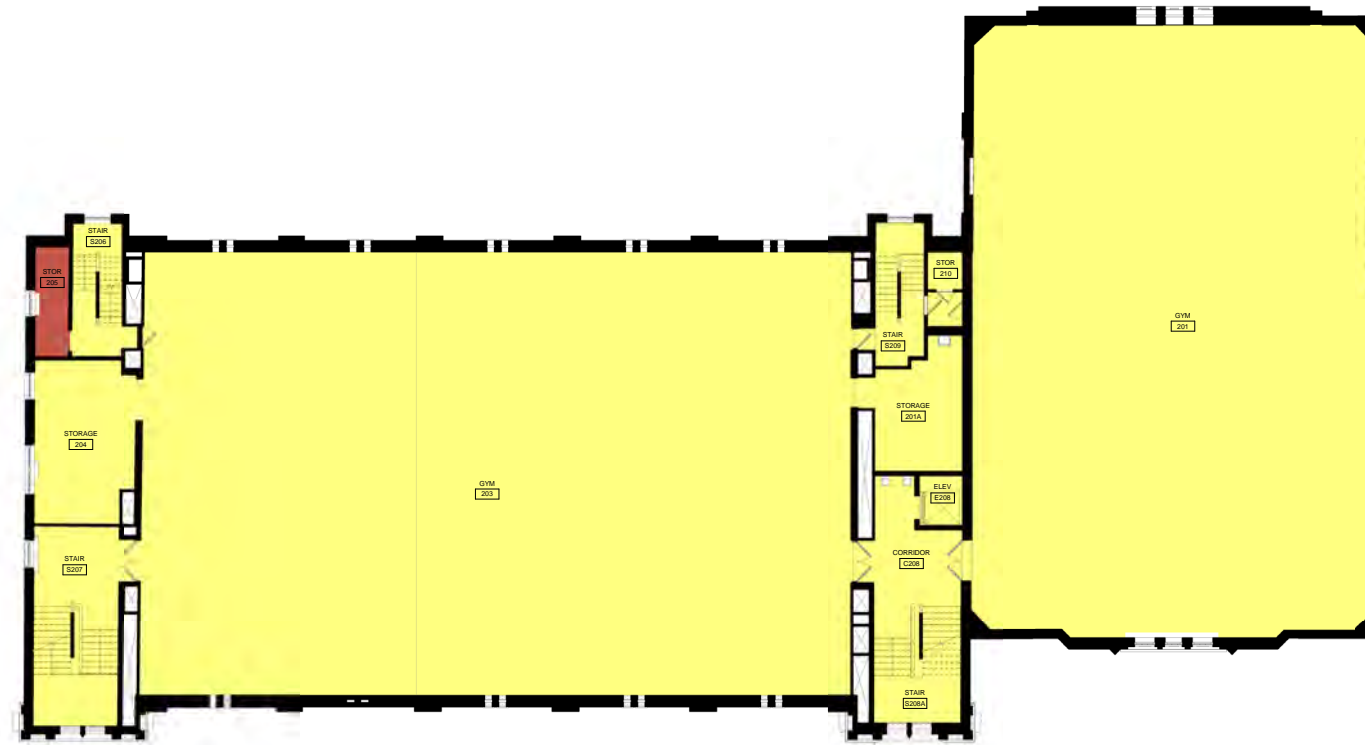
1 SECOND FLOOR - CONDITION PLAN
1/8" = 1'-0"

The second floor of the building is where the gymnasiums are located along with spaces that are auxiliary to the gyms. The entire floor is mostly in “poor” condition. One of the storage rooms on this level is considered to be in “unsatisfactory” condition.

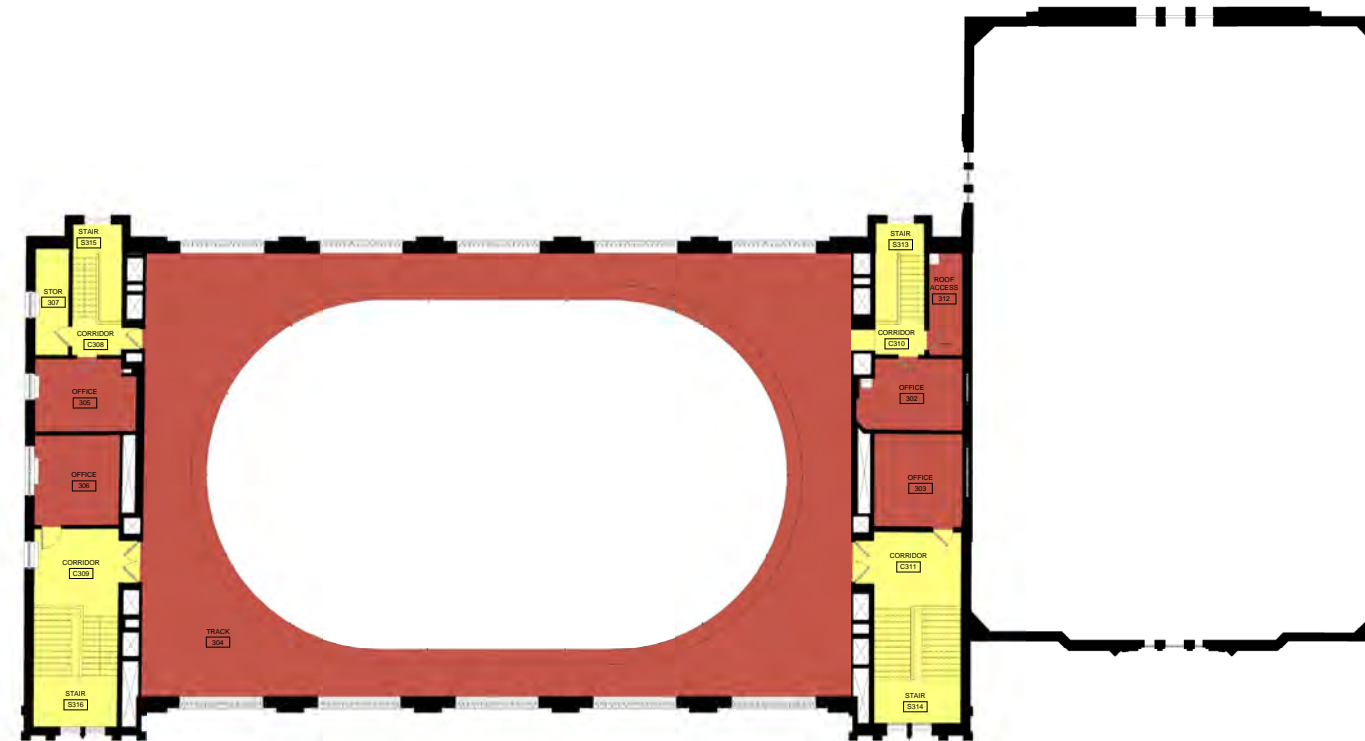
1 THIRD FLOOR - CONDITION PLAN
1/8" = 1'-0"

The third floor of the building is where the suspended track is located, along with a couple of office and storage spaces. The entire floor is mostly in “unsatisfactory” condition.

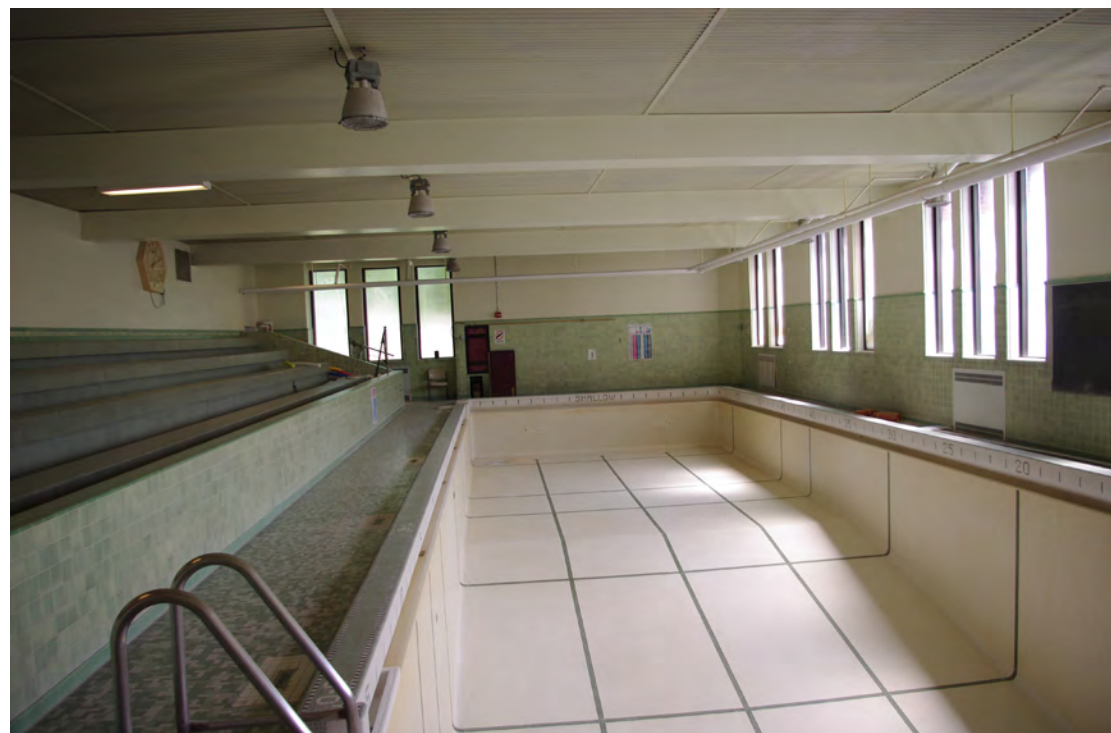
POOL-116-01

The pool is original to the building. All of the tile is in “fair” condition however, being original to the building, the mastic is assumed ACM and will need to be removed. The pool is no longer being used and is empty and walled off at the time of observation.

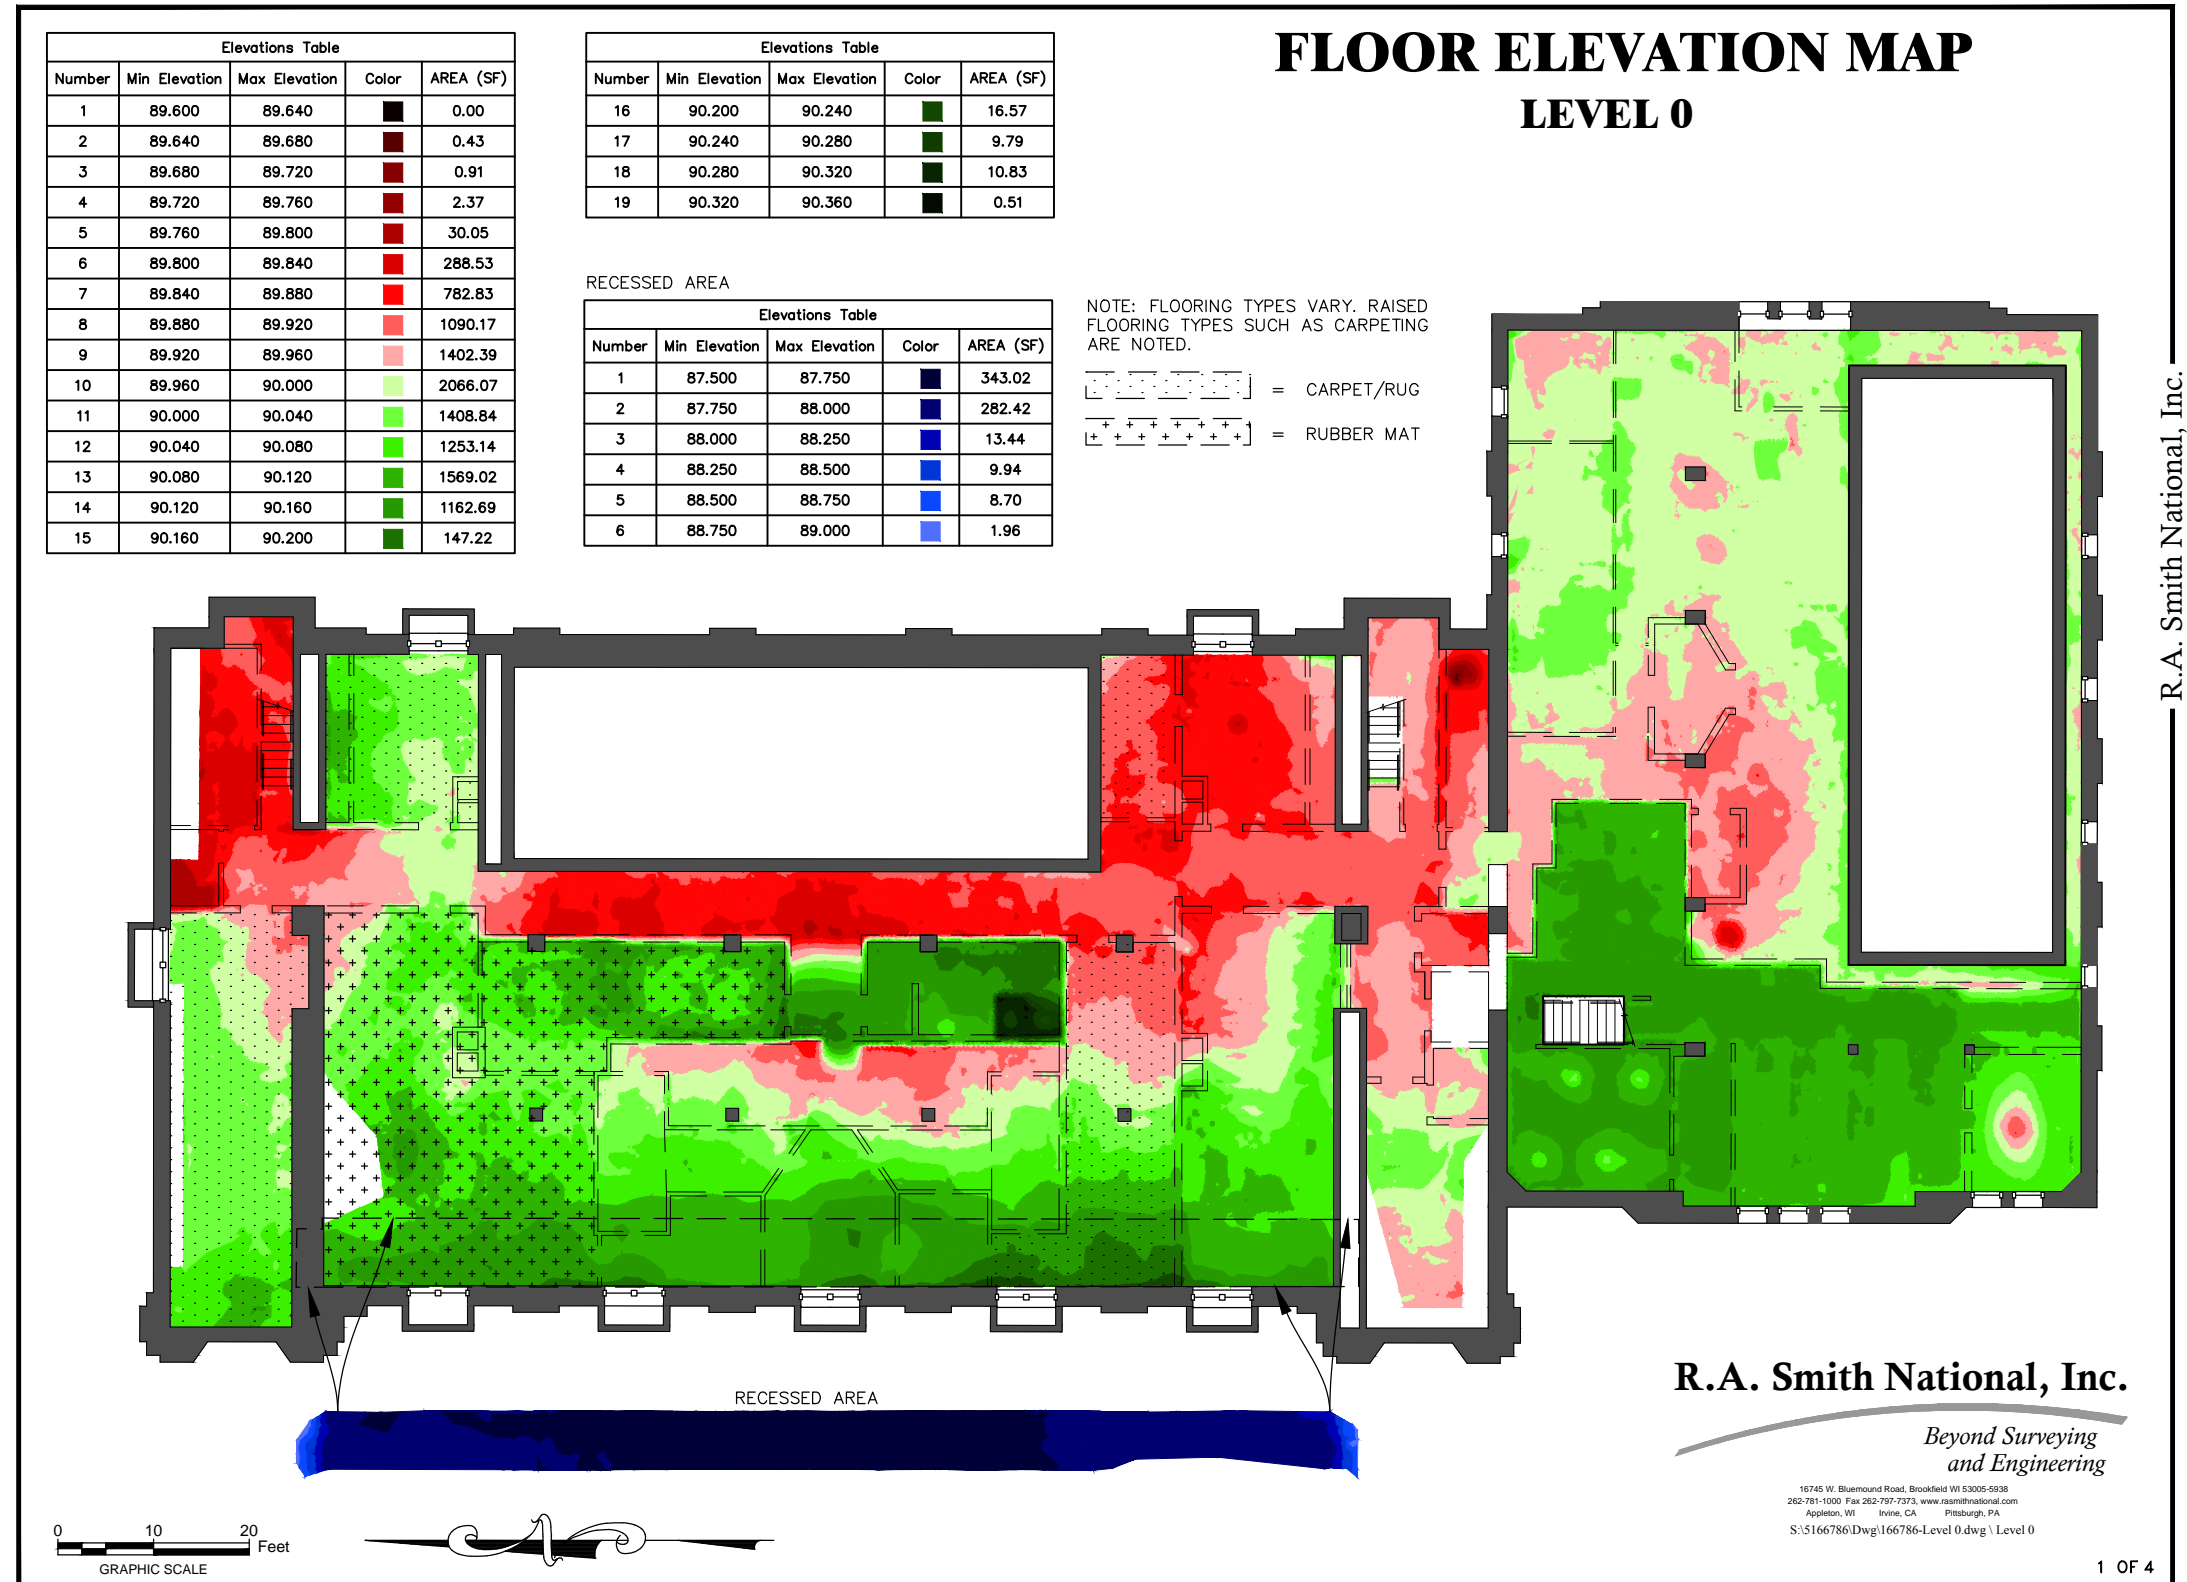
LOWER LEVEL

Laser scanning revealed level changes of 4" in a span of 40 feet in some locations. Some of this floor variation is due to existing floor finishes, there is rubber flooring in many of the current storage rooms. There is also an area that ramps up into one of the mechanical rooms which is where most of this level change happens. Many portions of this slab will need to be removed for under slab piping replacement, so much of the floor may be replaced. Depending on the final floor finishes selected, leveling will need to be done to bring the building up to current construction standards.

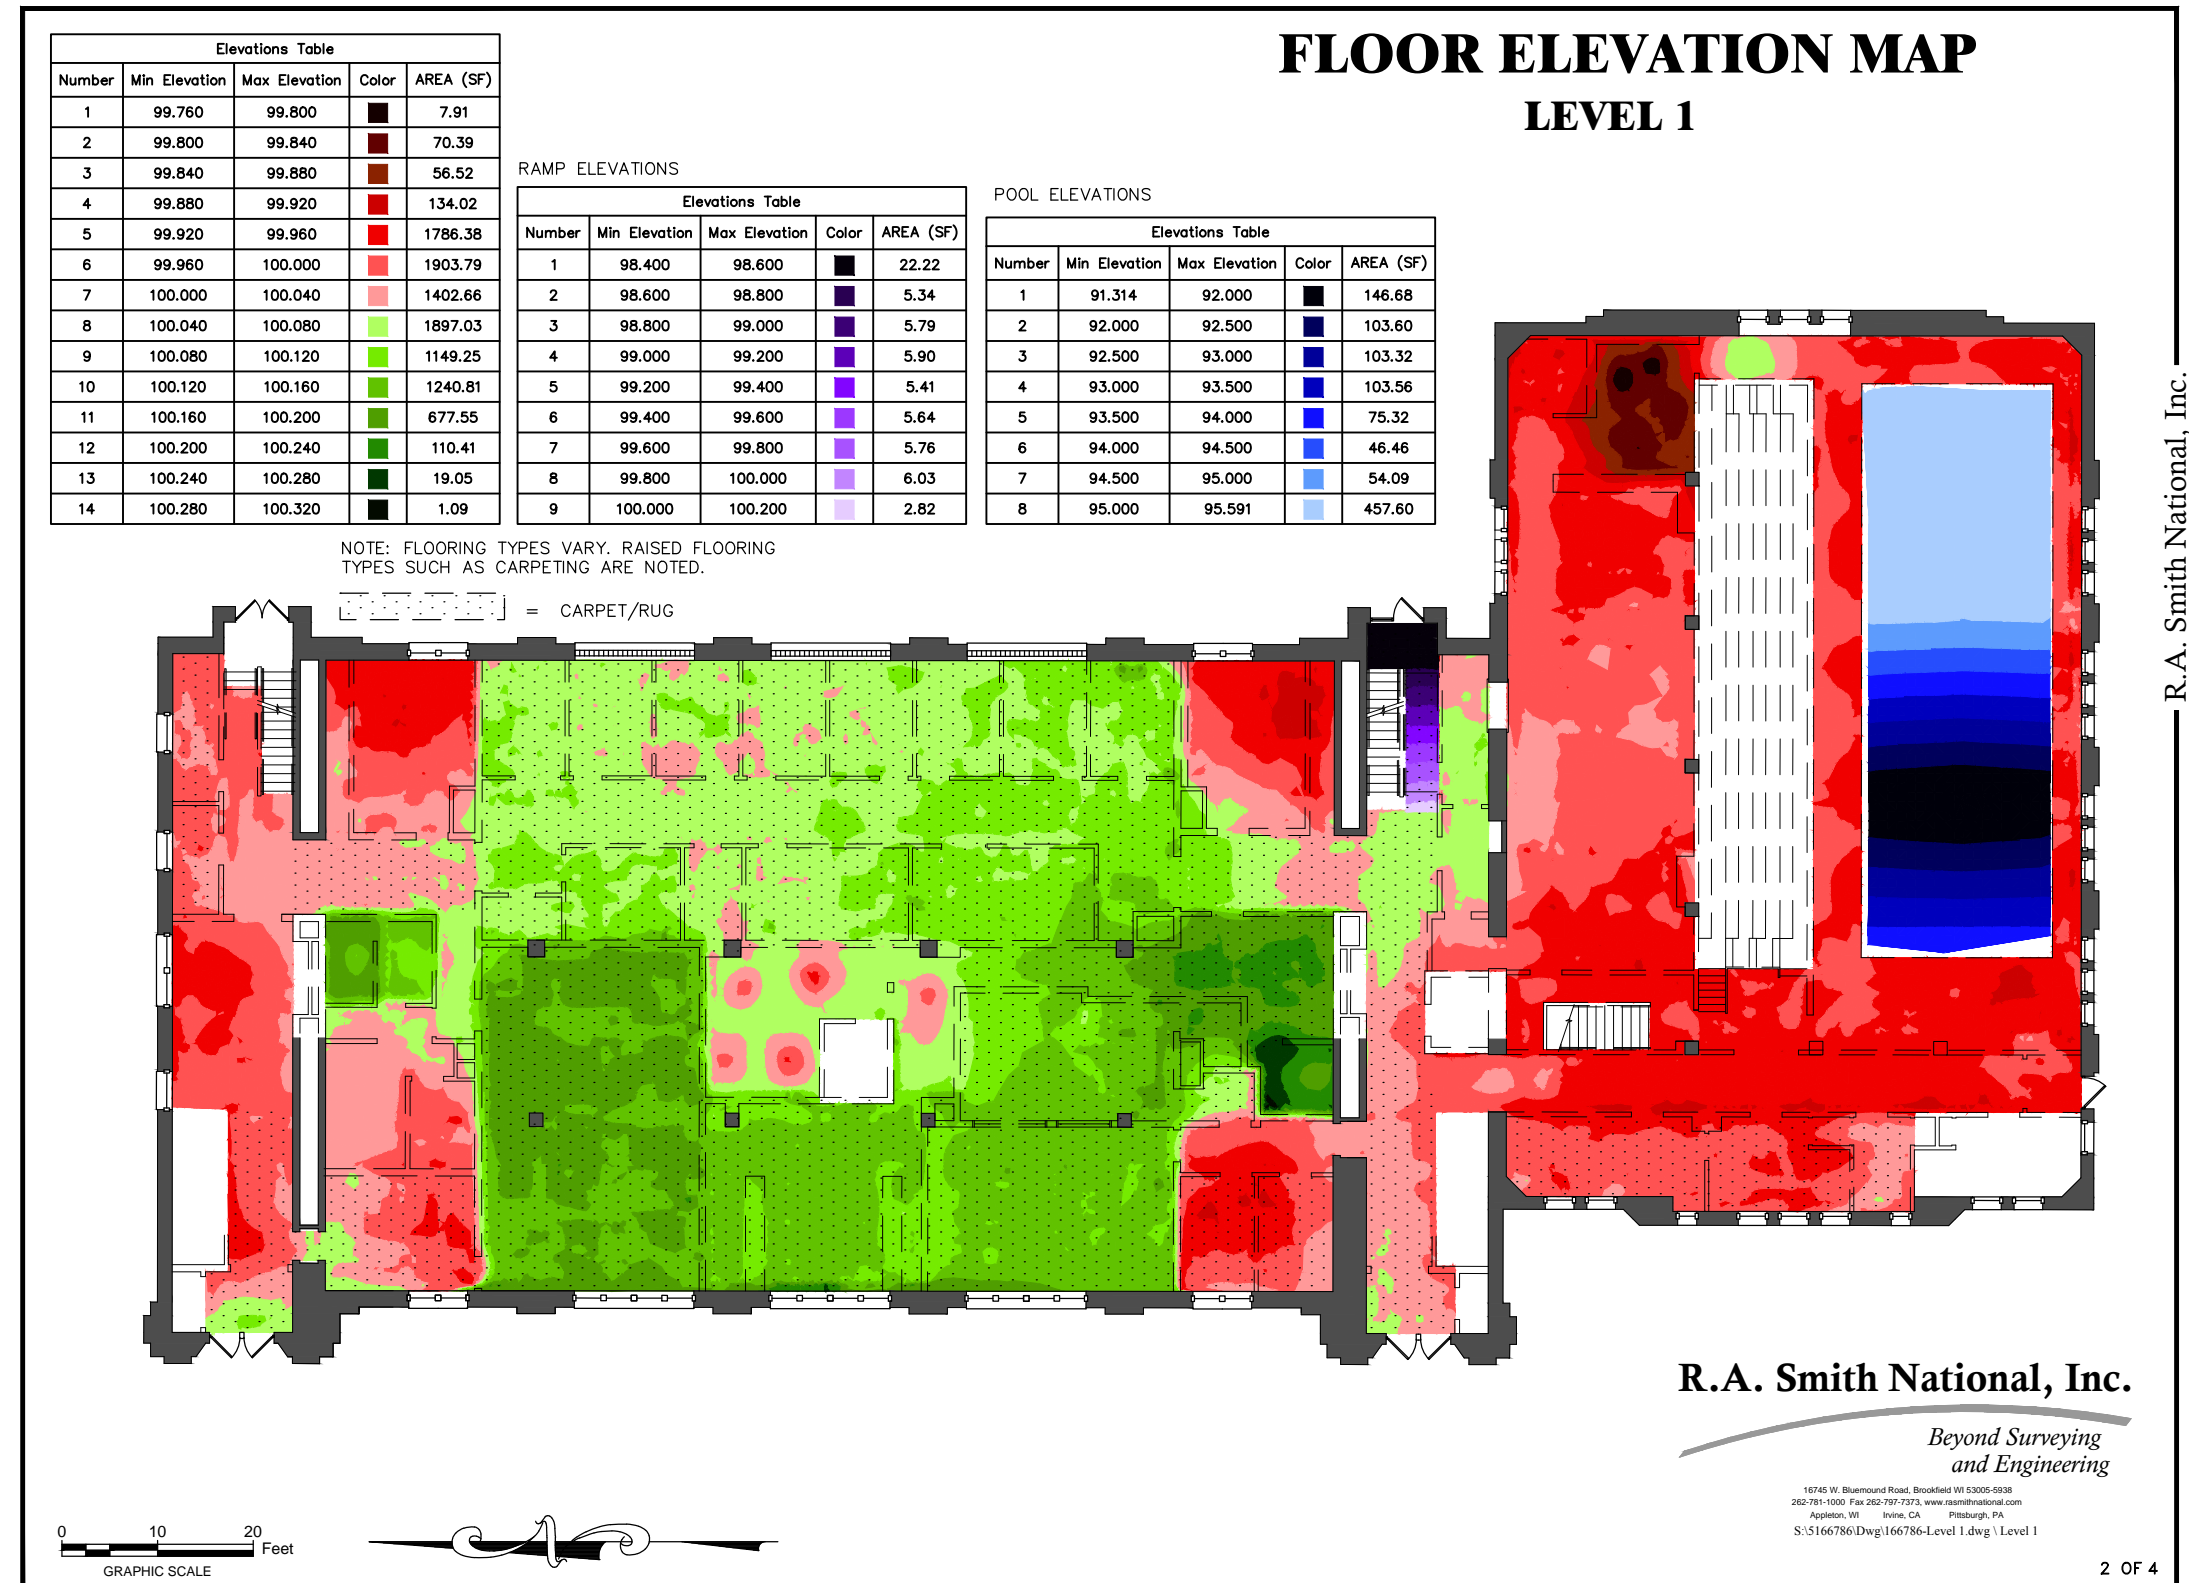
FIRST FLOOR

First floor level changes are less severe than the lower level. 1 1/2" changes in floor level are indicated in the bathrooms and shower areas due to floors sloping to the drains. These will need to be leveled as part of the new construction. There is an existing ramp at one of the main entrance doors that is depicted with purple coloring on this plan. Also the pool area is depicted in shades of blue and will be removed as part of the new construction. Other areas of unlevelled flooring could be due to existing floor tile and carpeting. This floor will need to be leveled as part of the new construction.

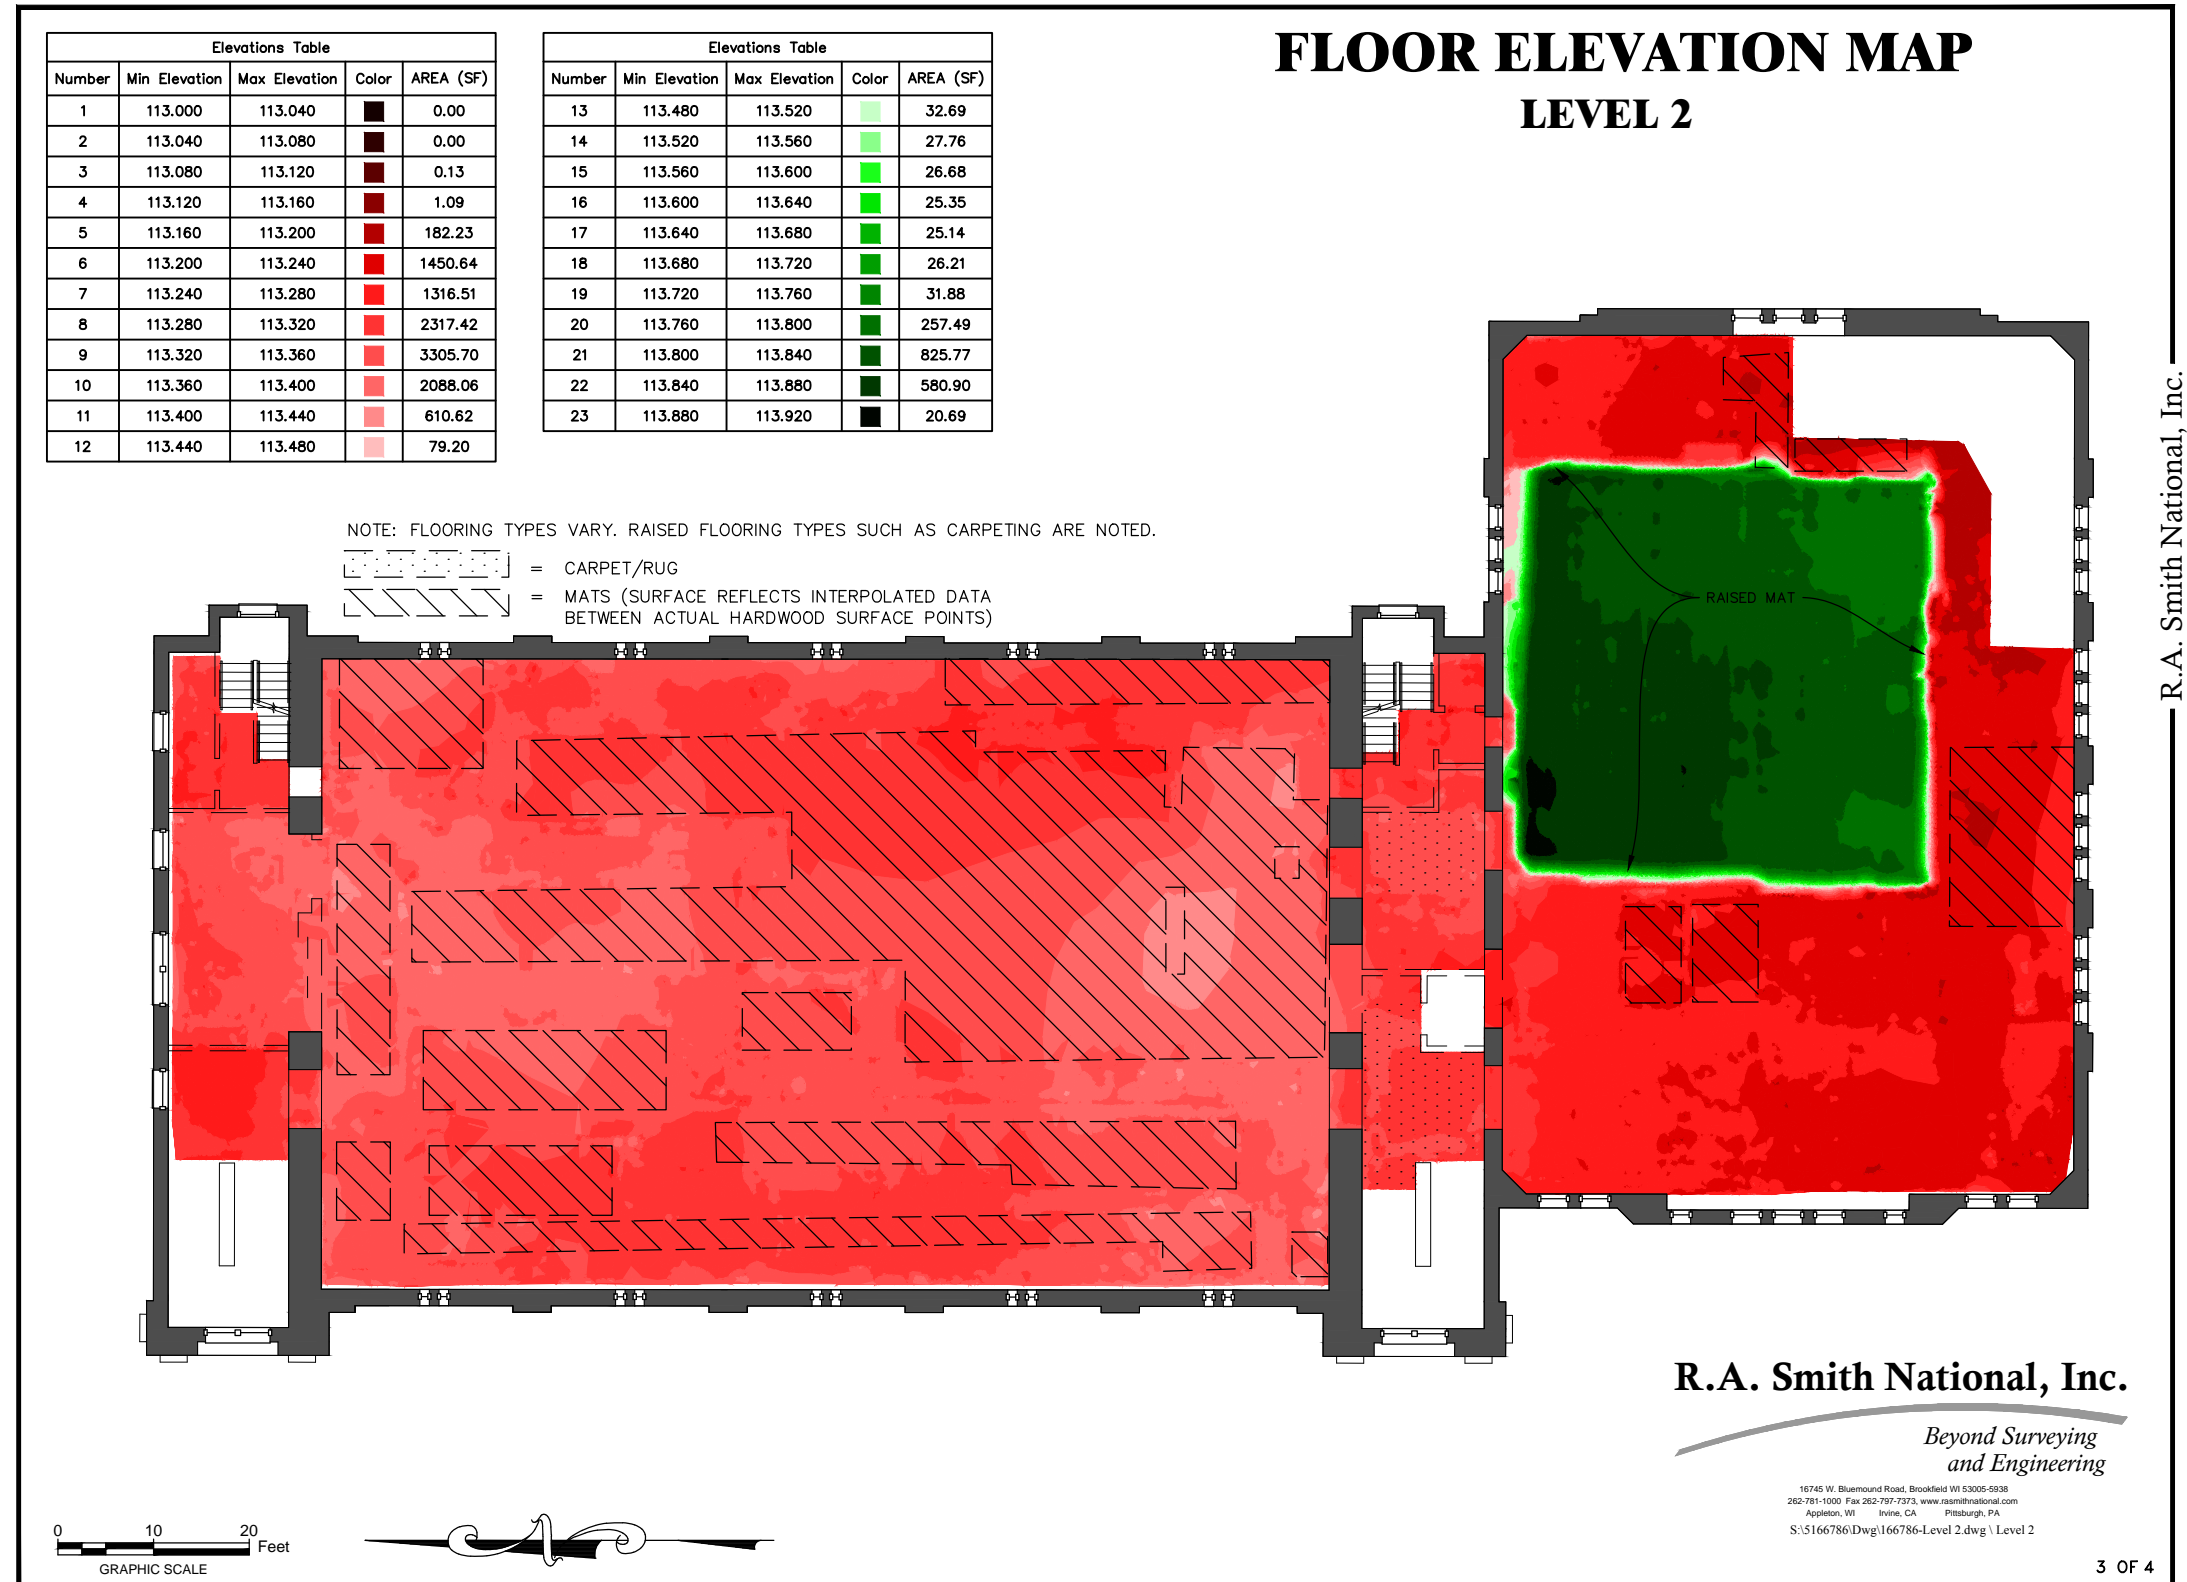
SECOND FLOOR

Second floor contains the gyms for the building and has level changes of up to 1 1/2" across the length of the gym. This is not a large concern for the new construction as the level changes indicated are very gradual. The dark green area in the south addition is due to the existing gymnastics mat. Much of this plan has been interpolated based on the exposed wood flooring due to the fact that there were existing gymnastics mats present on the floors during scanning.

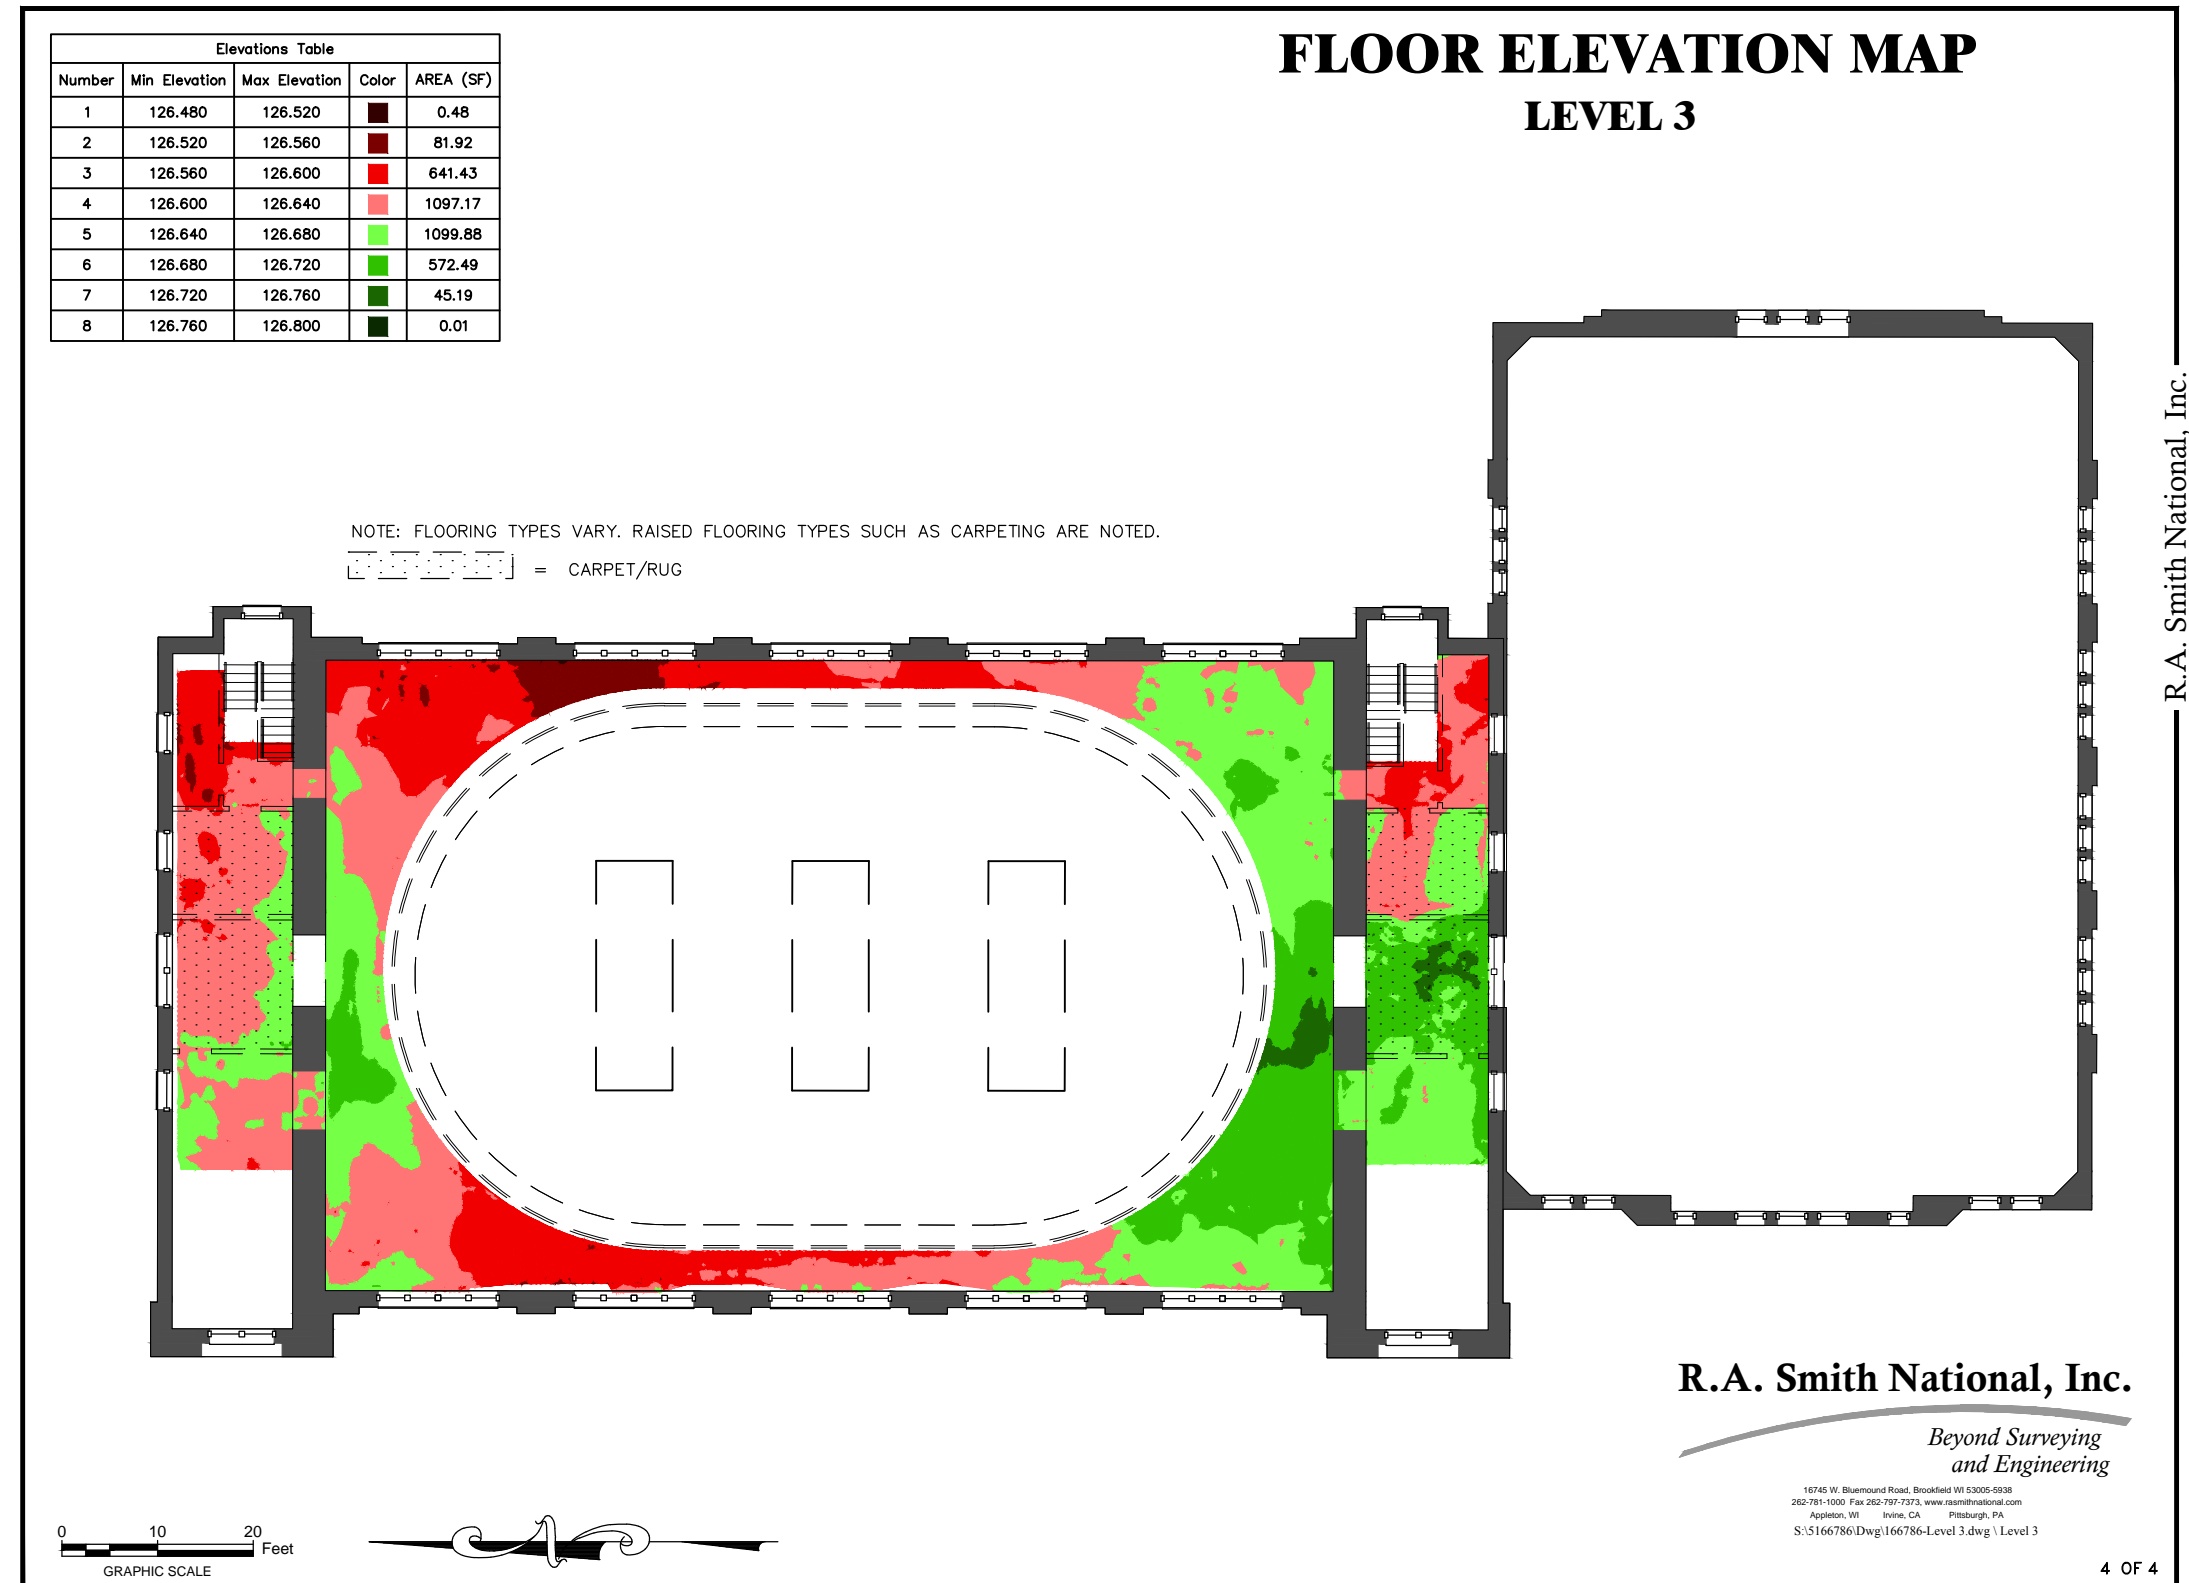
THIRD FLOOR

Third Floor contains the running track and some ancillary storage spaces. The floor on this level changes almost 3" across the length of the building. The condition of the plywood flooring in the track is peeling up at the corners, in some areas, and the level changes could be due to that condition. In the storage areas, the existing carpet is shredded in many cases and laying on top of the floor. This could also be revealing more unlevelled flooring than actually exists. This floor is not a large concern as the running track will be removed as part of the new construction and replaced with a new flooring system.
