WITTICH HALL  
FACILITY STUDY

*river* ARCHITECTS

DRAFT SUBMITTAL  
November 10, 2014

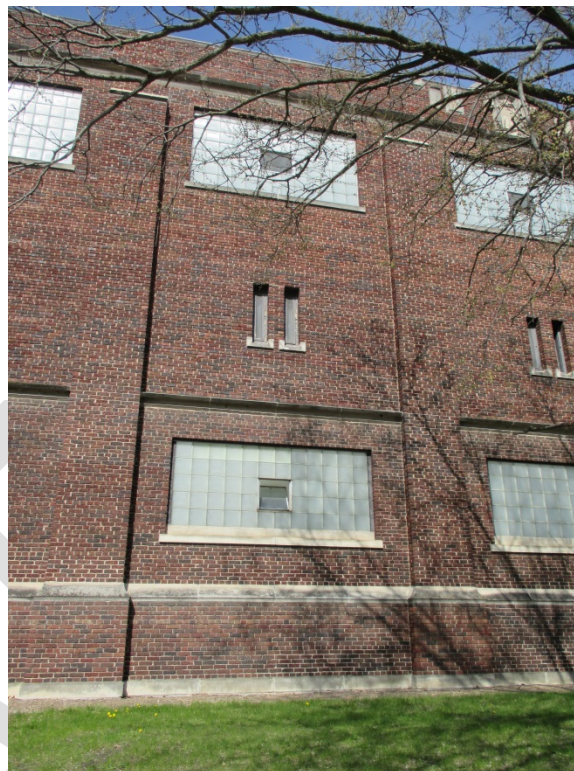
There are no visual signs of cracking in the masonry. There are currently no control or soft joints in the masonry walls other than at the joint between the 1916 and 1930 wings. The mortar joints of the limestone trim appear to have been replaced with joint sealant. The masonry walls are finished on the interior with plaster.

In general, considering the age of the building, the exterior walls are in very good condition. Upon visual inspection, no structural damage or instability can be found.

East Elevation – 1916 Wing (2014)

It is recommended to thoroughly clean the brick and limestone along with pointing and repair of the mortar joints where needed. It is also recommended to remove and replace all caulked joints.

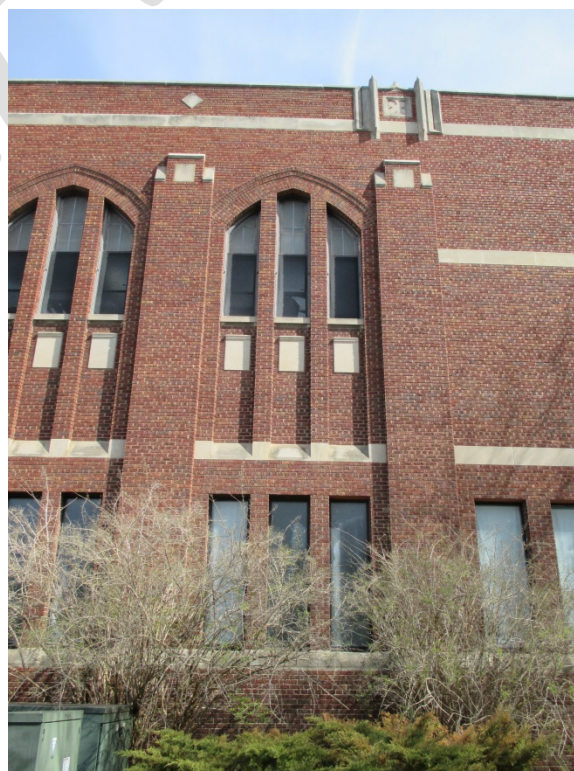
South Elevation – 1930 Wing (2014)

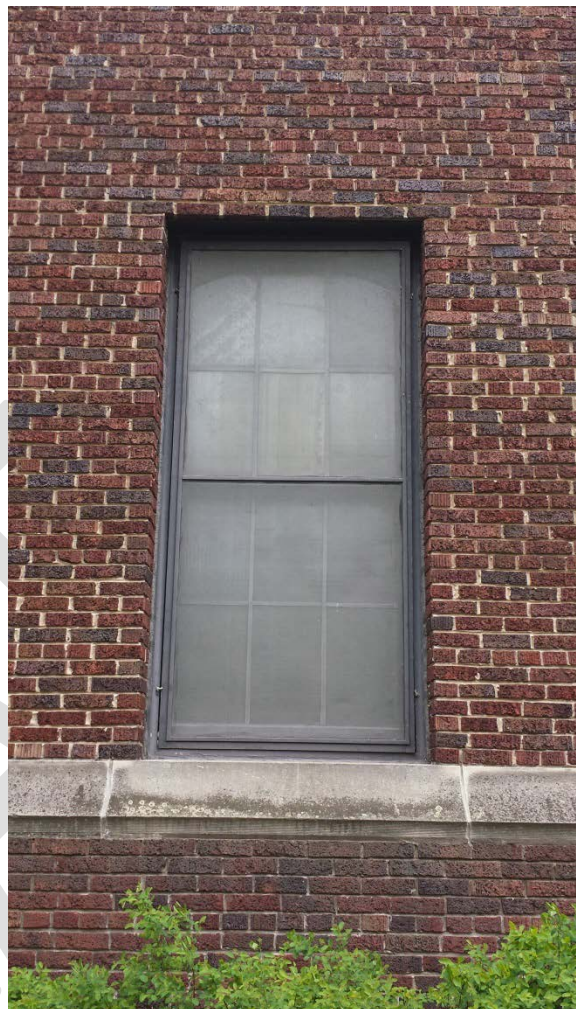
Based on field observations, it would appear that the majority of the windows in Wittich Hall are original. The exception being the glass block units in the upper floor of the 1916 gymnasium. The exterior finishes are deteriorating and as such the window frames and sashes are in need of repair or replacement.

Typical Window (2014)

Window replacement could be handled in two ways. First, a sash only replacement would provide modern-day, energy efficient glazing and could be done in a clad exterior – wood interior in order to provide a maintenance free exterior and historic interior. The existing wood brick molding would need to be covered or removed and replaced with metal of a similar profile. A second option would be to replace the entire window assembly. Since the interior woodwork is in good shape, this approach may not be the preferred option.

Regardless of the approach, the windows should be restored to their original light color at the exterior.

Masonry openings should be cleaned thoroughly and new sealant be provided as required for a proper window installation.

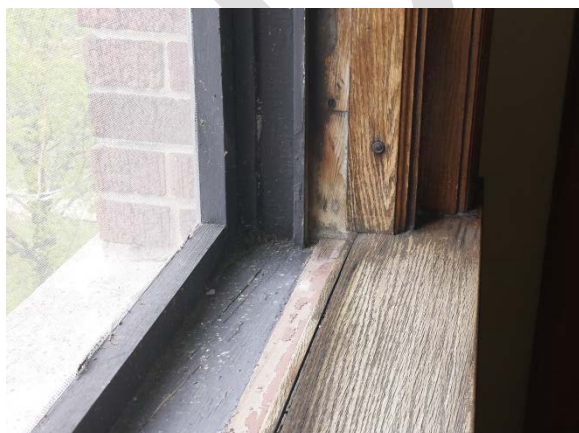
Window Sill (2014)

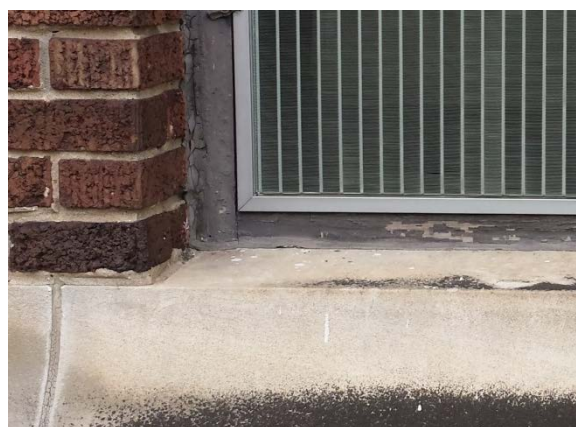
Window Sill (2014)

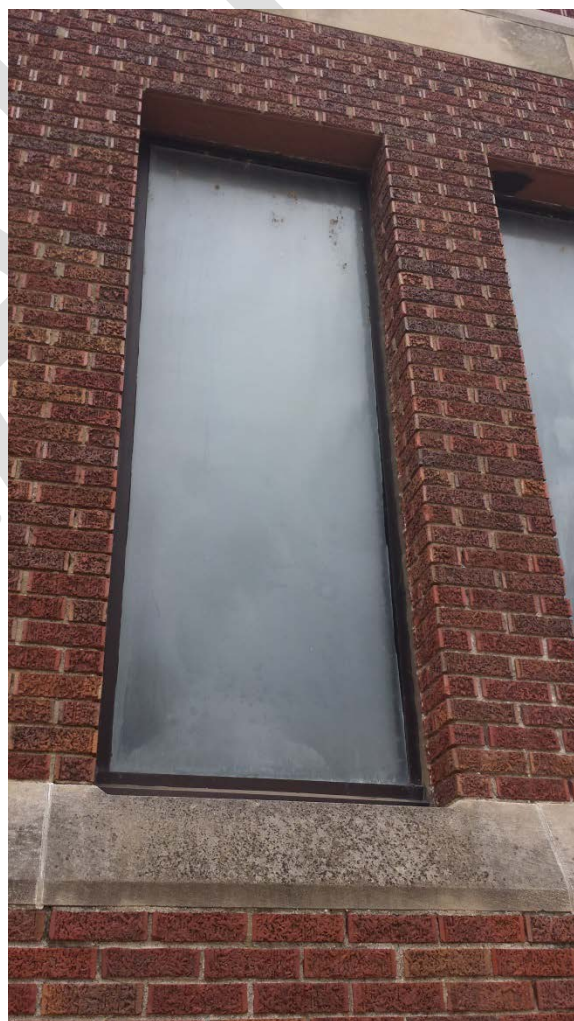
Level 1 Pool Window – 1930 Wing (2014)

The aluminum windows currently located in the 1930 pool addition should be removed and replaced with units that match the historical character of the building.

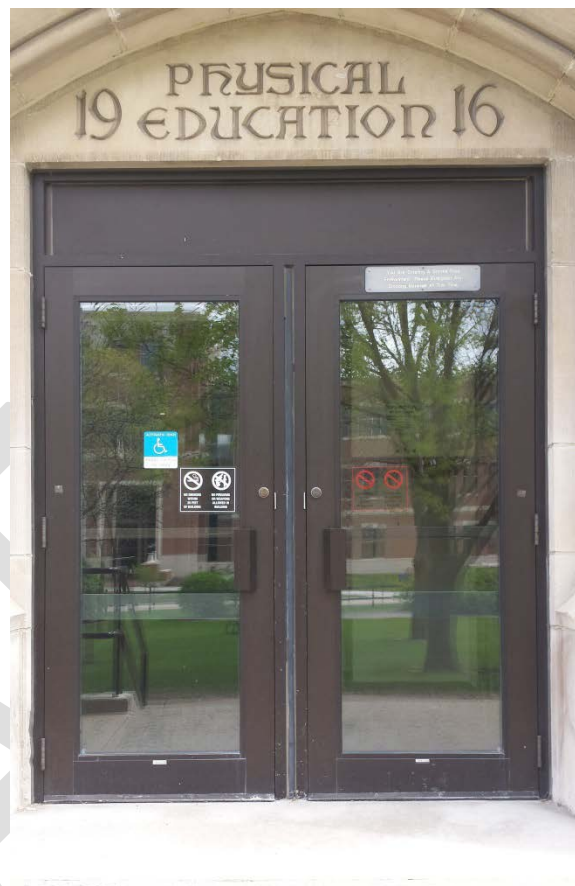
The primary entrance doors and transoms are of aluminum construction in an aluminum frame. The doors and transoms have been replaced with units containing insulated glass and are not historically accurate. Historic photos of these entrances depict wood doors with half-lite, arched glass panels.

The doors and frames are in good condition.

Entrance Doors (2014)

If historic restoration is desired, then these aluminum doors should be removed and replaced with a period appropriate door. Although it is unlikely that the university would want wood doors with a painted or stained exterior finish, aluminum-clad wood doors may be an appropriate option.

If historic restoration is not being sought, then these doors should remain in place. Inspection of all sealants and hardware functions is necessary.

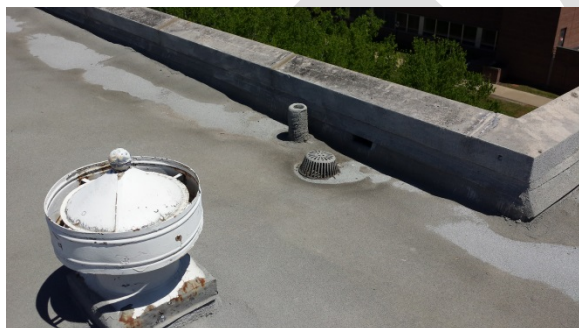
According to the 1985 roof replacement drawings, the existing roof consists of two layers of insulation for a total insulation thickness of 2 ¾" plus a ½" recovery board. The adhered sheet membrane roofing with hypalon coating was placed up the inside face of the parapet walls and terminated by a metal flashing. The roofing system also extends over the skylights of the 1916 wing.

Roof D (2014)

Our recommendation is to remove all roofing materials down to the original wood decking, install an appropriate vapor barrier, roof deck insulation, and a fully adhered ethylene-propylene-diene-monomer (EPDM) membrane.

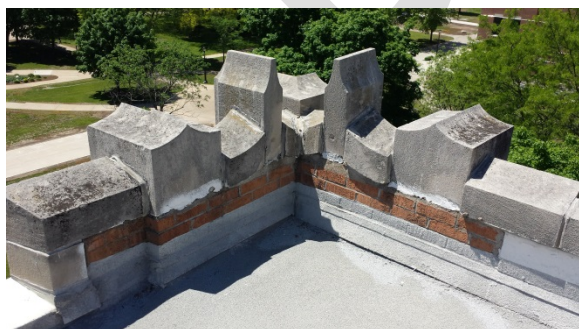
Parapets are solid brick with a stone coping. The roofing membrane extends up the parapet wall a minimum of 8" and in some instances, extends to the underside of the stone coping.

Roof Parapet (2014)

It is recommended to replace all metal flashing with stainless steel. Recommended flashing installation at the parapet would be to provide a through-wall flashing under the parapet coping rather than relying on sealant in a reglet joint. The original stone coping should be salvaged and reinstalled once the new flashing is in place.

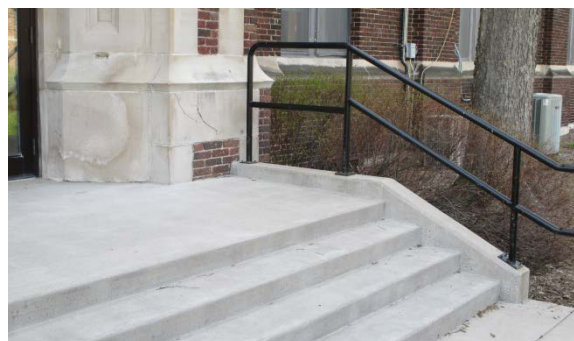
Currently, there is no slip resistant treatment present at the four entrance stairs. The university has indicated that the concrete stairs can be hazardous in the winter season.

Northwest Entrance Stairs (2014)

Slip resistive nosings are recommended at all four entrance stairs. An abrasive nosing should be applied to the leading edge of each tread to provide slip resistance and visual distinction.

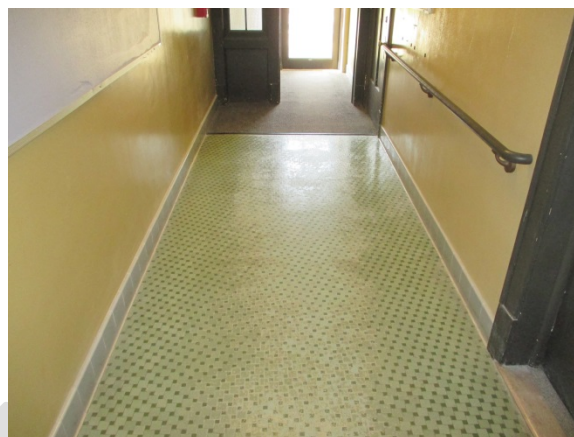
There are numerous flooring types within Wittich Hall. First, terrazzo flooring can be found in the entrances and main corridors. The terrazzo is in fair condition but appears to have been painted. Floor tile can be found in a number of locations. Per the hazardous materials assessment provided by UW-La Crosse, the tile and adhesive is likely to be asbestos containing material and will require special treatment for removal.

Interior Corridor – 1930 Wing (2014)

Terrazzo flooring in the entrances and corridors should be cleaned and repaired as needed.

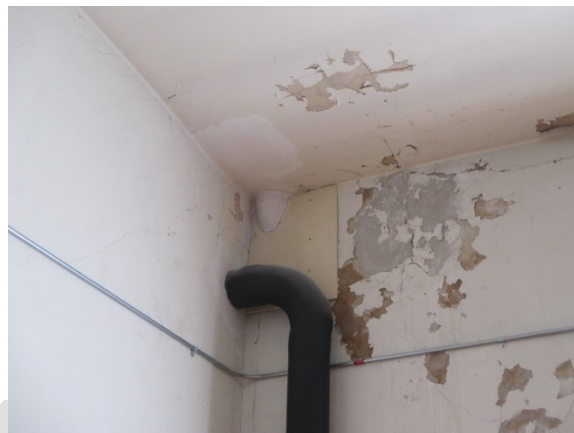
Moisture damage can be seen in each corner of the 1916 gymnasium near the ceiling where water infiltrated the roof and walls through failed roof drain systems.

Water Damage at Gymnasium Ceiling – 1916 Wing (2014)

Plaster damage located in the gymnasium should be repaired.

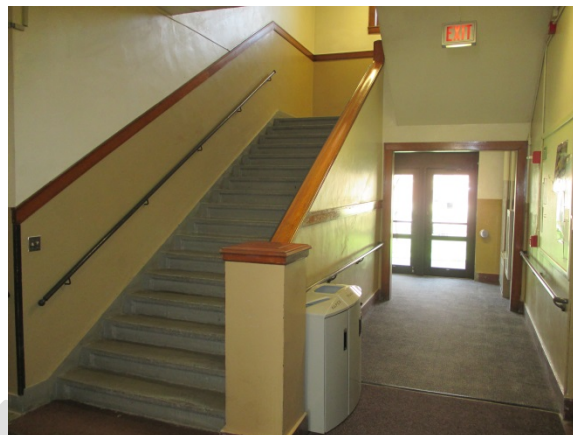
The two stairs located along the west side of the 1916 wing are 58" wide and appear to be originally constructed with terrazzo treads and risers that have been painted. The paint has worn off on each tread. There is currently no slip resistance or visual strip at the stair treads. Metal railings are provided on each side of the stair and currently do not extend beyond the top or bottom riser.

Northwest Interior Stair (2014)

It is recommended that the life-safety issues related to each stair be addressed. An abrasive nosing should be applied to the west stairs. It is also recommended that each of these stairs receive new handrails that meet current codes and standards. The two stairs along the east side of the building are too narrow to meet code and therefore cannot contribute to exiting requirements.

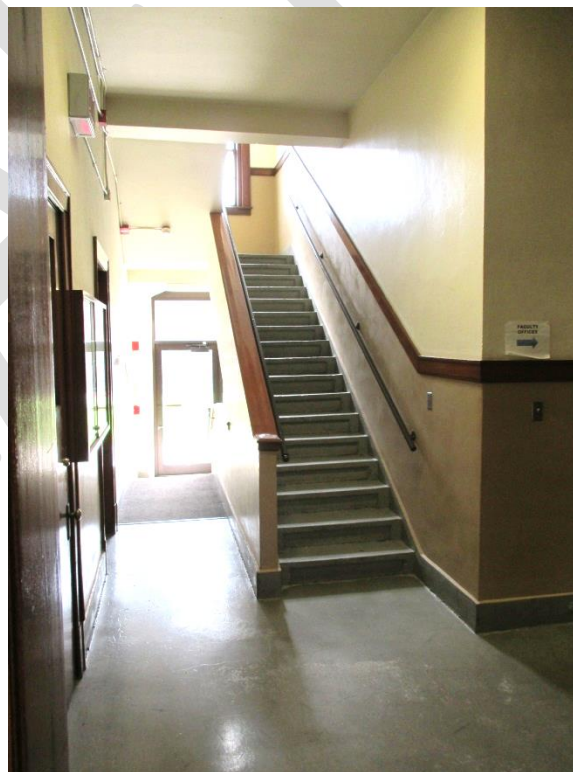
The two stairs located along the east side of the 1916 wing are 33 ½" wide and appear to be originally constructed with terrazzo treads and risers that have been painted. The paint has worn off on each tread. There is currently no slip resistance or visual strip at the stair treads. Metal railings are provided on each side of the stair and currently do not extend beyond the top or bottom riser.

Northeast Interior Stair (2014)

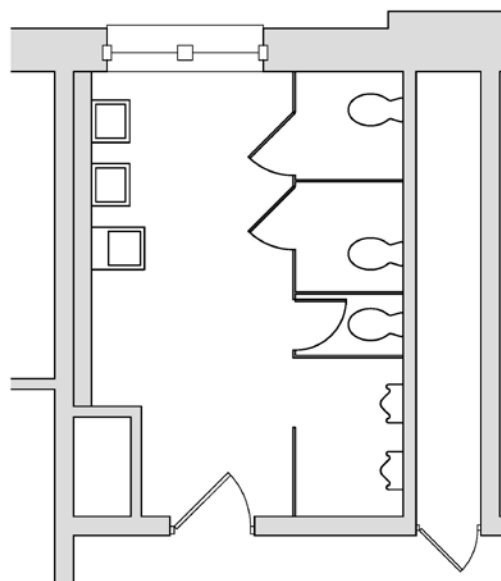
Public restrooms are located on Level 1 only. Restrooms associated with locker rooms are located on Levels 0 and 1. The restrooms on Level 1 were renovated in 1978 by adding grab bars. While the grab bar addition may have been sufficient in 1978, the size of the toilet stalls is still inadequate to today's codes and standards.

Men's Restroom Plan (2014)

The restrooms should be increased in size to accommodate the number of building users and they should also meet current ADA regulations and standards.

Because ADA compliance goes beyond providing adequate area within the toilet stalls and takes into account everything from lavatory height to door hardware, it is recommended that the existing restrooms in Wittich Hall be completely renovated to accommodate these requirements.

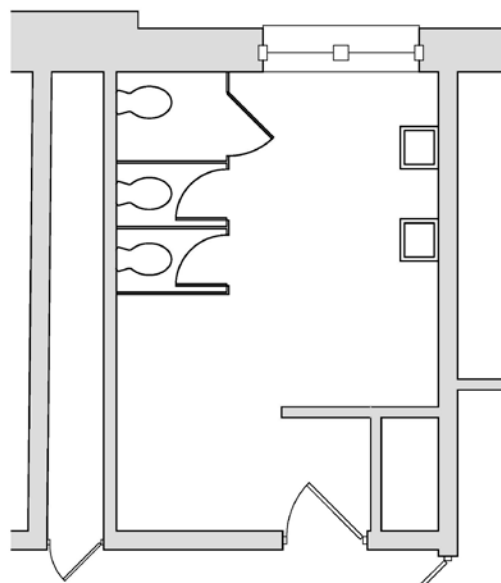
Women's Restroom Plan (2014)
