MEETING NOTES

Meeting Date: Friday, July 28th, 2017 – 10:30–11:30am
DFD Project Number: 14I2O
Project: Wittich Hall Renovation
Location: Wisconsin Historical Society – 816 State Street, Madison, WI 53706
Purpose: Wittich Hall – Historical Review Meeting
Prepared by: Michael Eberle, AIA

WITTICH HALL

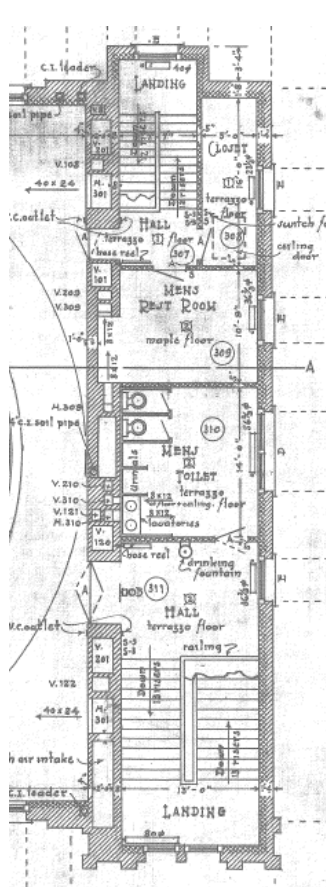
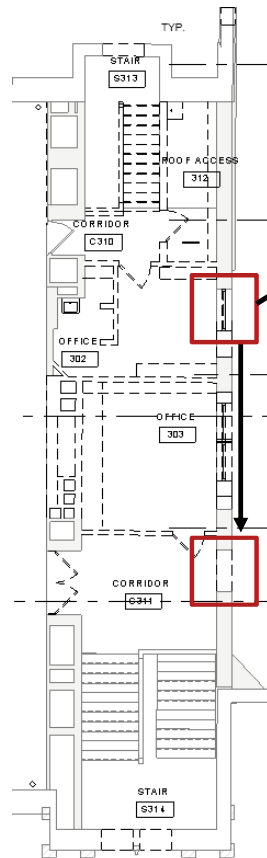
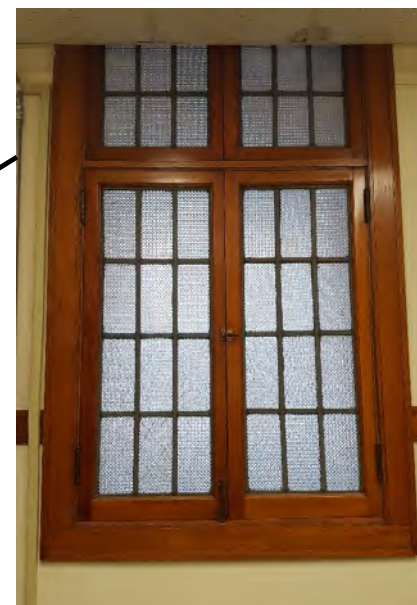
THIRD FLOOR WINDOWS

- a. The group discussed moving the single existing window from its current location in room 302 to a previous location where a similar size window existed in the stair.
- b. Moving the office wall approximately 1 foot (creating a 4 foot wide double height opening) was deemed ok in the 1930 wing north location.
- c. The groups discussed removing the existing wall grilles from the radiator niches in the exterior walls of the 1930 and 1916 wings.
 - i. Removing the 1916 wing grilles and filling with a blank-off or other material was noted as being acceptable.
 - ii. The grilles in the 1930 wing are in brick and located in the history display zones on the west and south walls. Jen thought we could have more flexibility with what goes back into these opening or if they are left as recesses and something else incorporated.

Relocate window to previously blocked up location

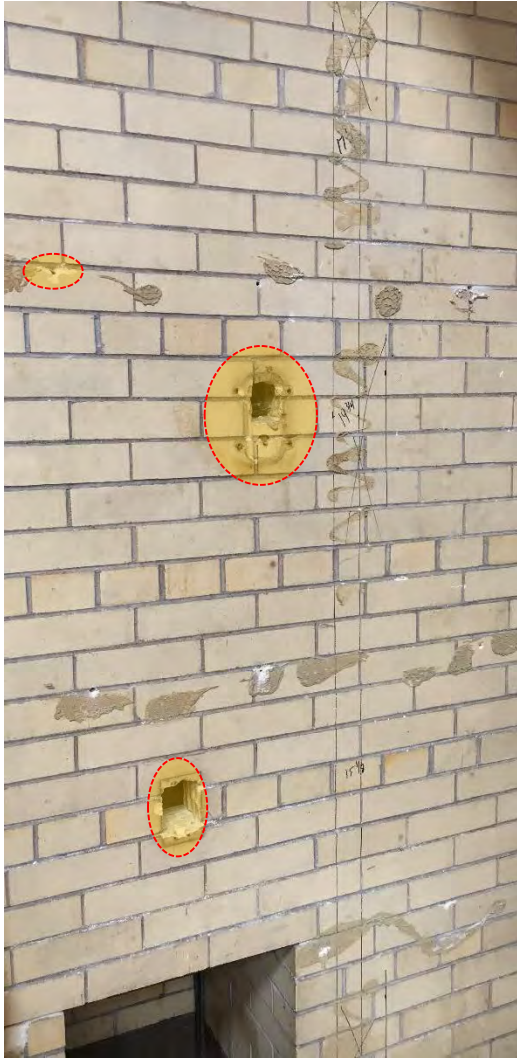
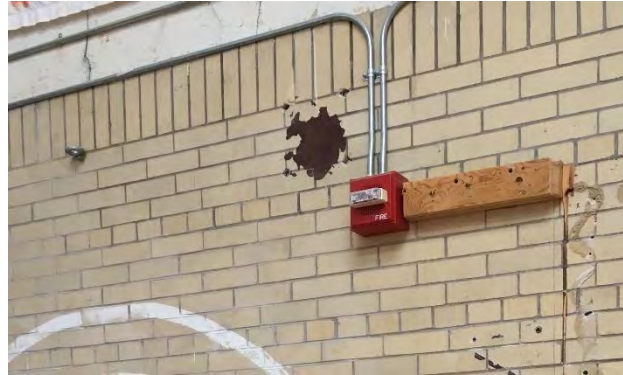
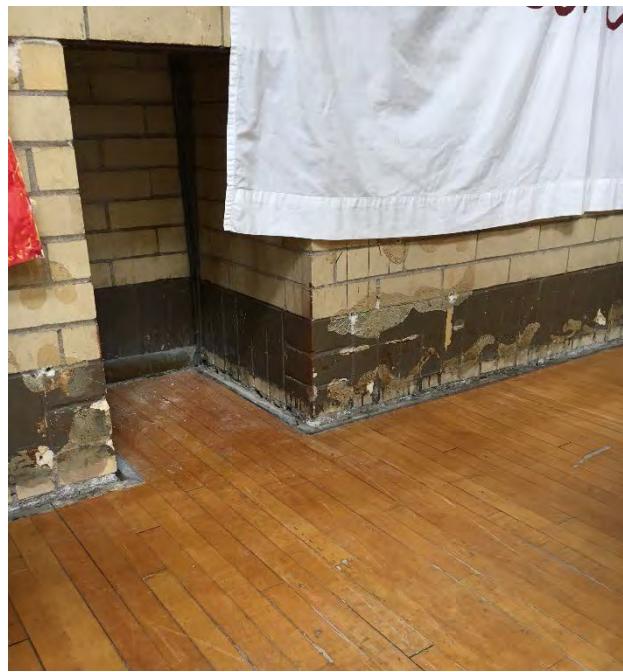
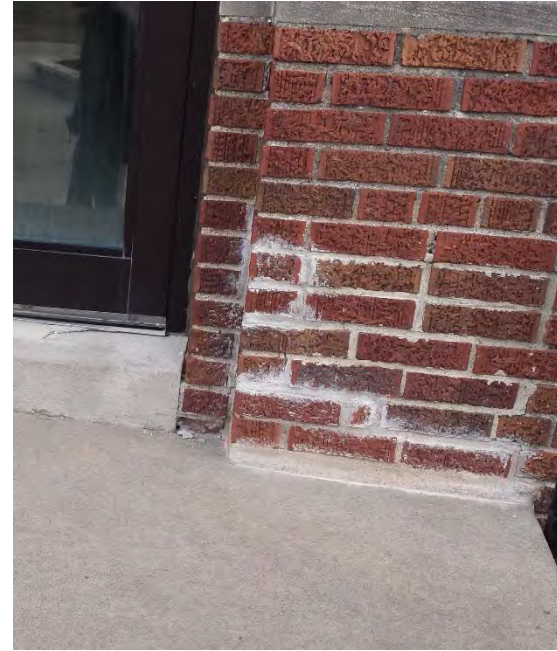
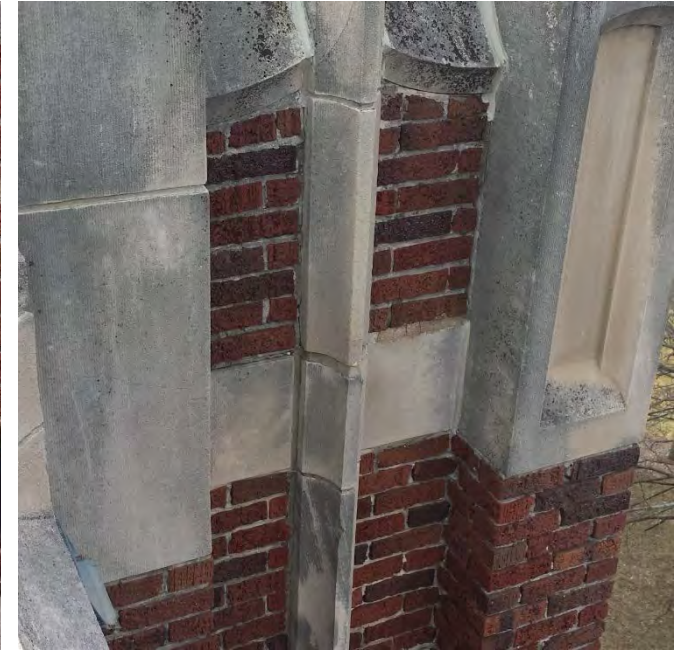
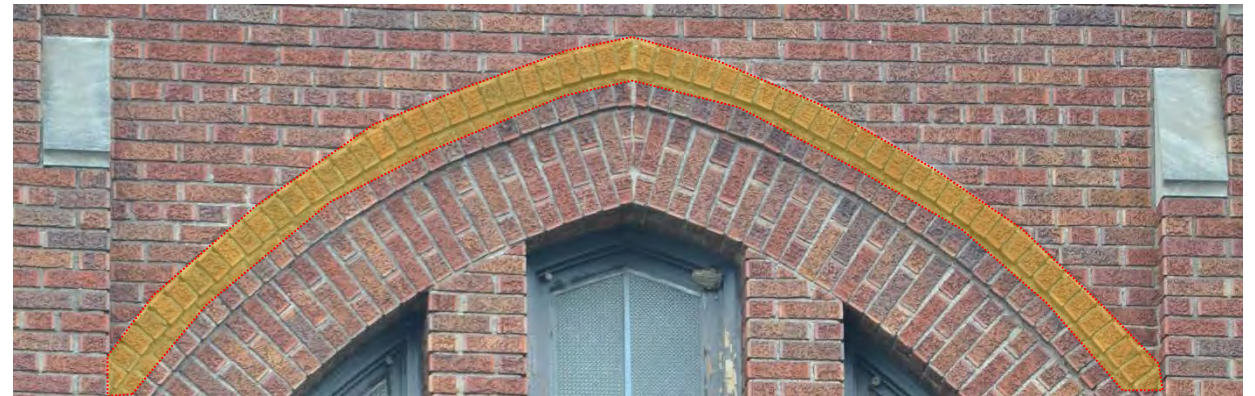
EXTERIOR RESTORATION/REHABILITATION - BRICK

- a. Cleaning / Pointing
 - i. All brick (interior and exterior) is planned to be cleaned.
 - ii. 40% of the brick is currently planned to be pointed.
- b. New Brick
 - i. The group discussed the need to define allowances for new brick and additional pointing. **Action: Aro Eberle / River Architects**
 - ii. It was noted that Mike will have several brick suppliers visit the site and try to match color and texture. **Action: River Architects**
 - 1. It was noted that an exact match may not be possible, but will get close.
 - 2. Brick match will need to be approved by DFD and UWL.
 - iii. New brick on the trash enclosure will match the other enclosures being installed on campus and not match the building.
- c. Brick Repairs
 - i. Stepped cracks are being documented on the elevations.

- ii. Skyward facing brick joints were discussed with the group agreeing that these could be caulked or a piece of flashing installed.
- iii. Bricks with holes in the face were discussed as being removed and possibly flipped over if the back finish of the brick matches the face. Otherwise bricks would be removed and replaced with new.

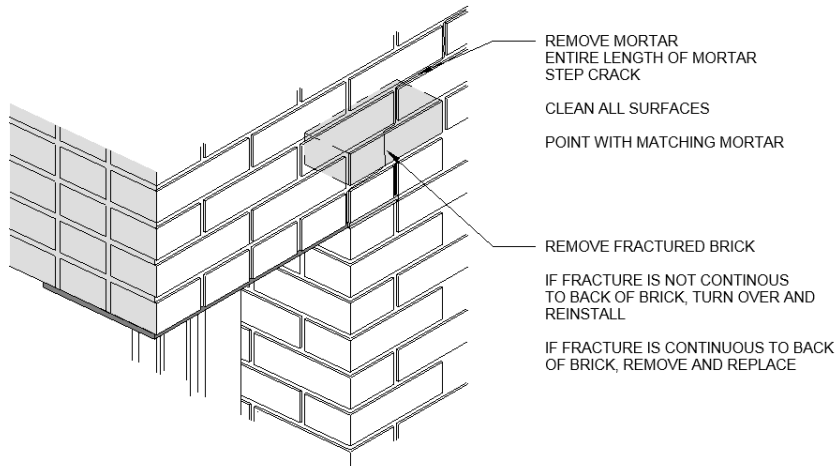
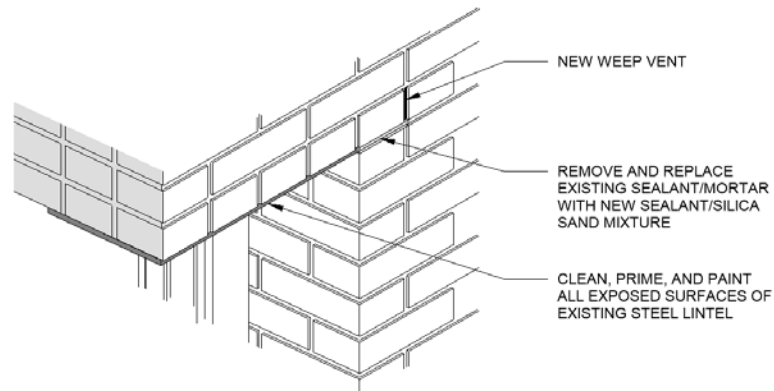
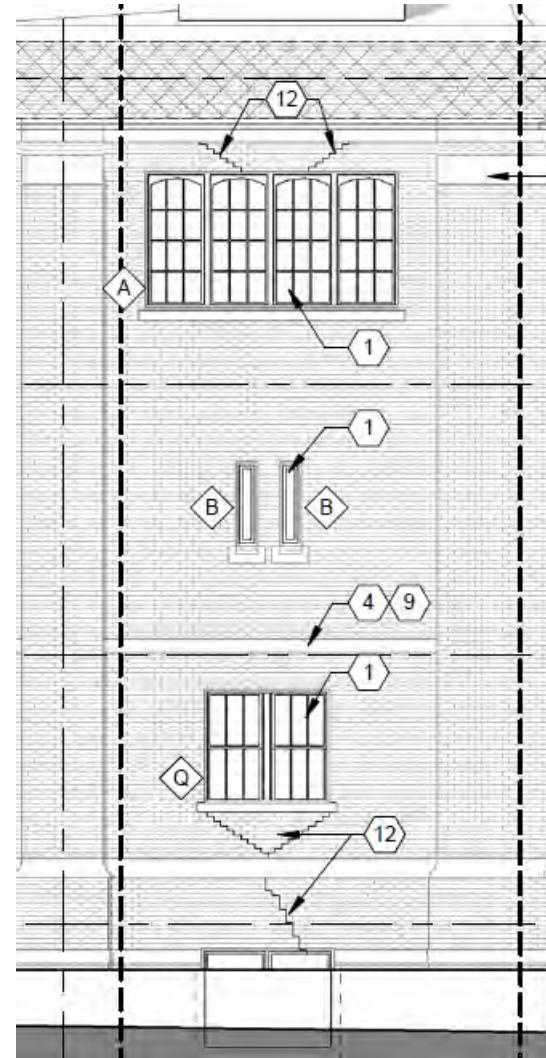
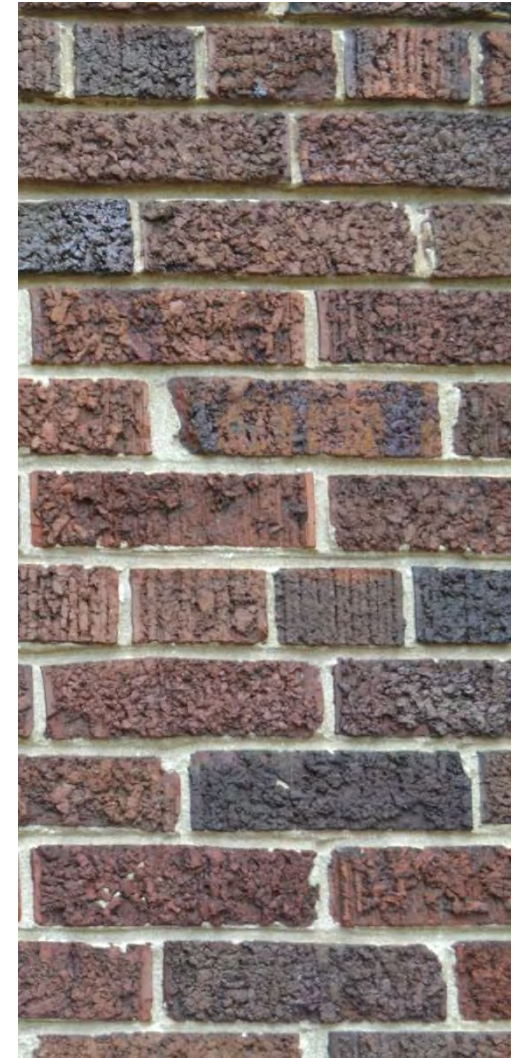
EXTERIOR RESTORATION/REHABILITATION - BRICK

Contractor bid to include allowance for 500(?) replacement brick for fractured units that are deemed unsalvageable. Replacement brick to be used where MEP items are removed.

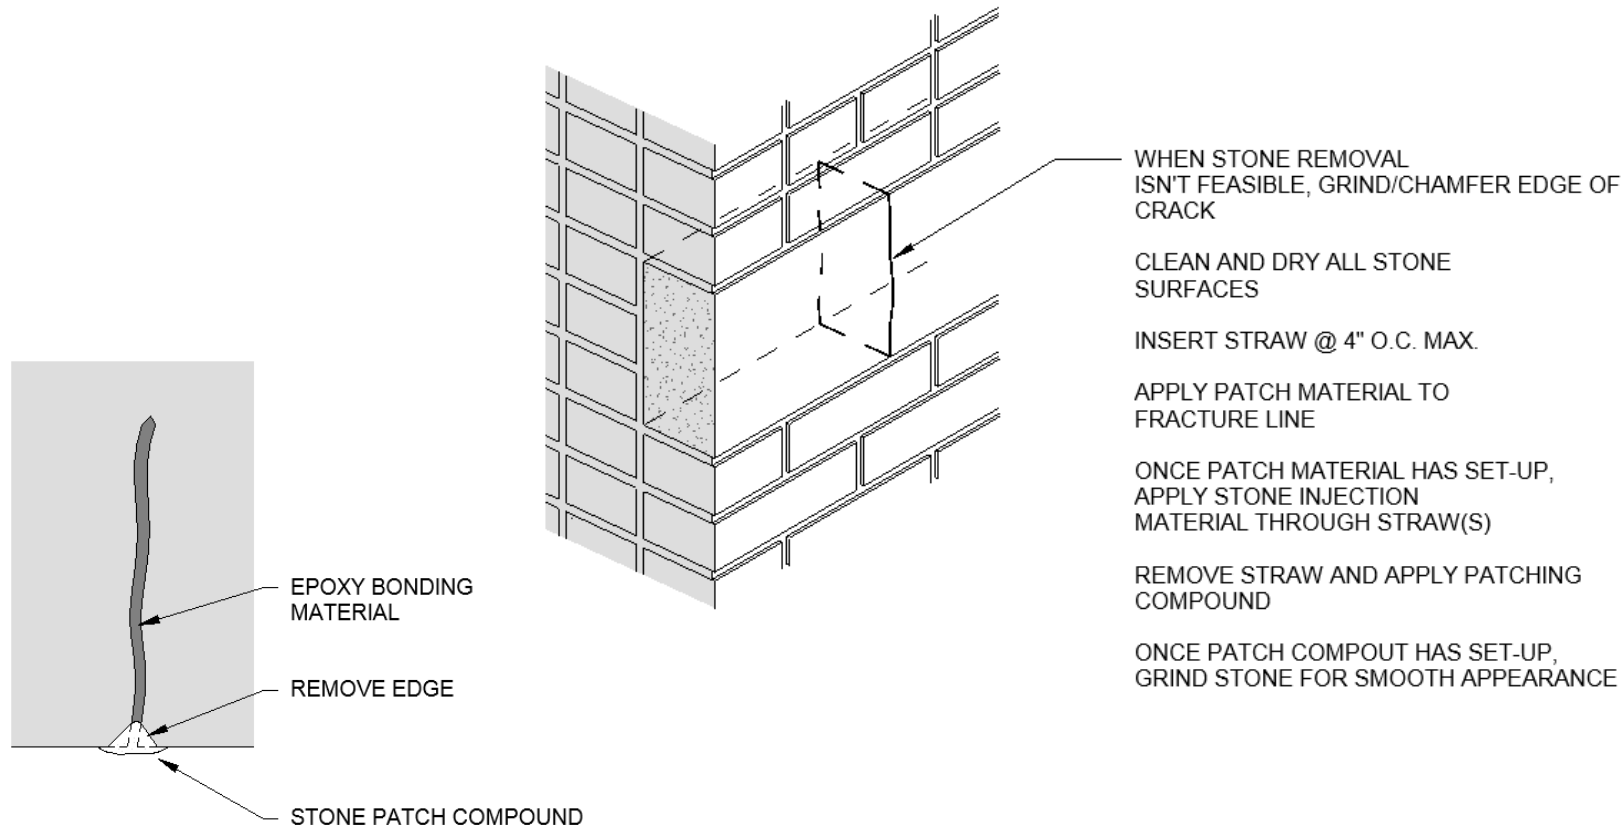
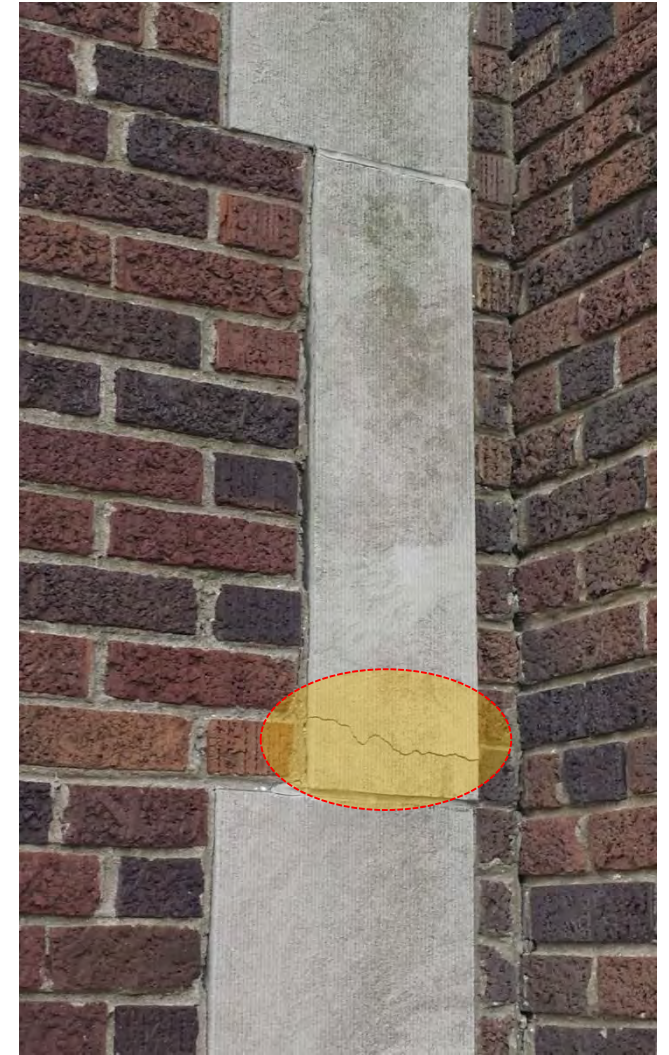
EXTERIOR RESTORATION/REHABILITATION - LIMESTONE

- a. Mike reviewed areas and details for replacing the 2" facing of several damaged stones at the northwest entry.
- b. Mike described a Jahn mortar patching product that they have used successfully for repairing areas where stone has spalled.
 - i. Mike noted successful experience Bonstone out of Mukwonago.
 - ii. Epoxy bond is very strong and color match is nearly exact.

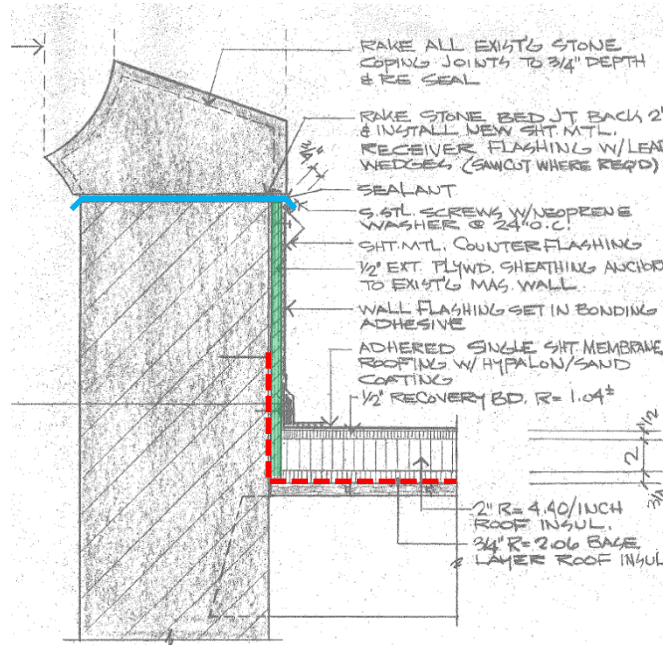
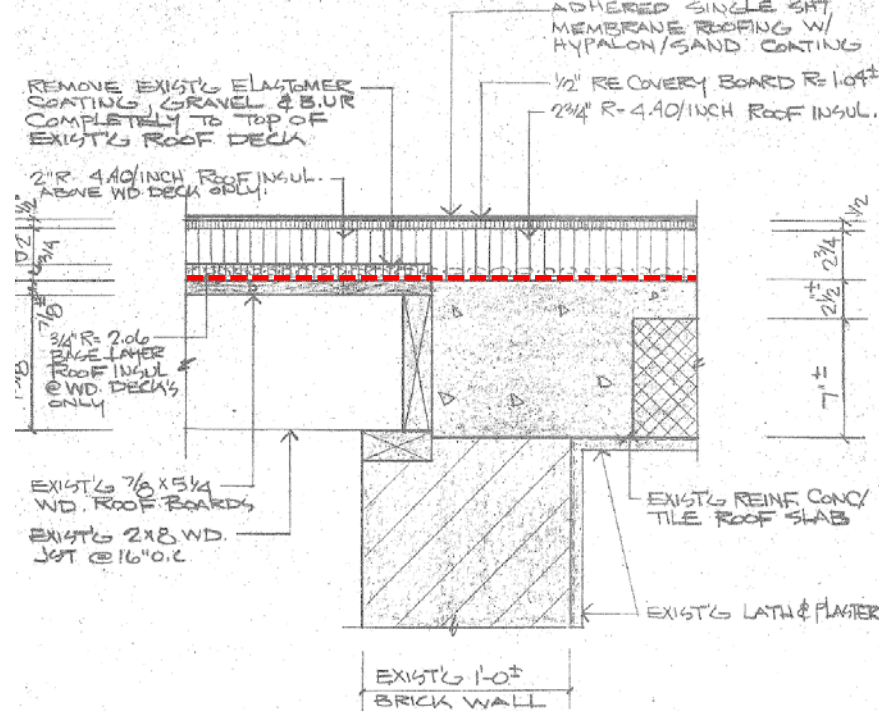
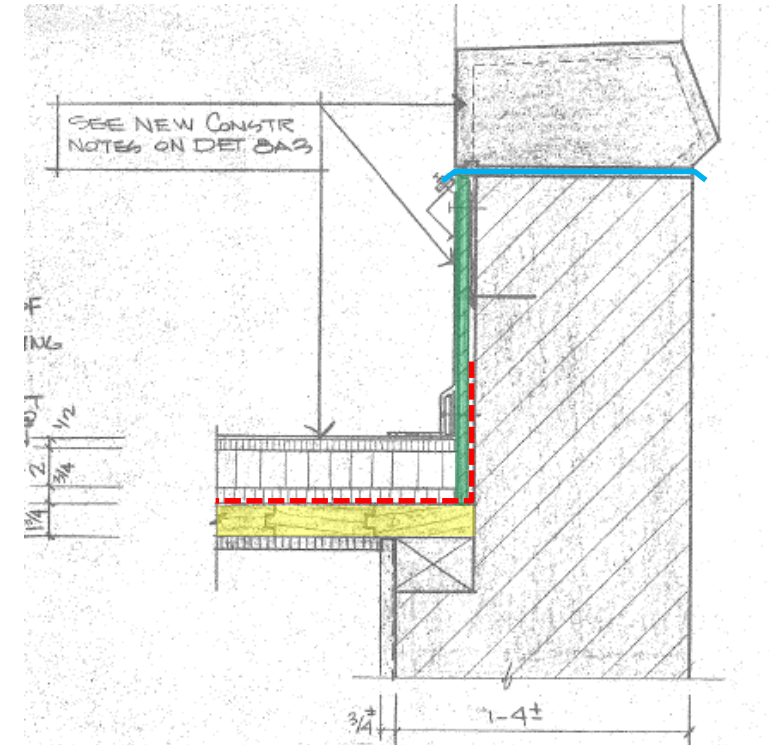
- Insulation thickness ranges from 2" to 2 3/4" (4" min. recommended). Challenges with vertical height at various parapets.
- 1930 Gymnasium has 1 3/4" structural wood decking that was originally exposed and has since been covered (highlighted in yellow).
- Verification needed if plywood sheathing was installed at back of parapets as detailed (highlighted in green).
- Installation of vapor barrier membrane will be included in roofing work (shown in red) along with flashing beneath stone coping

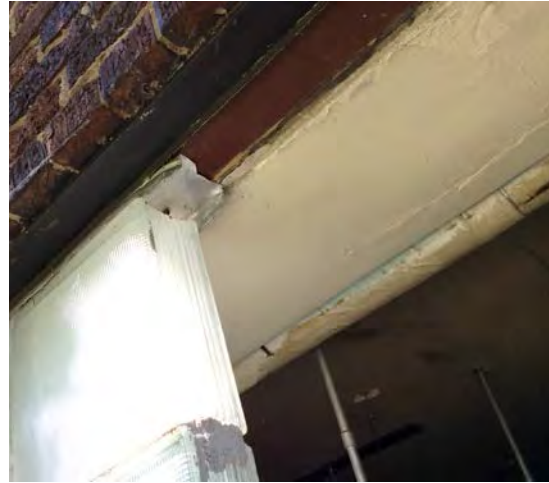
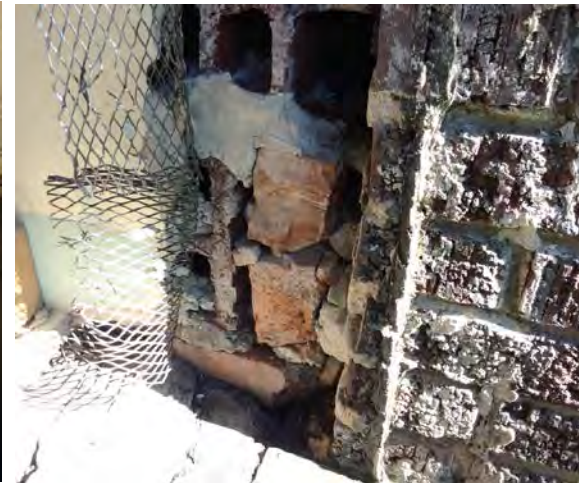
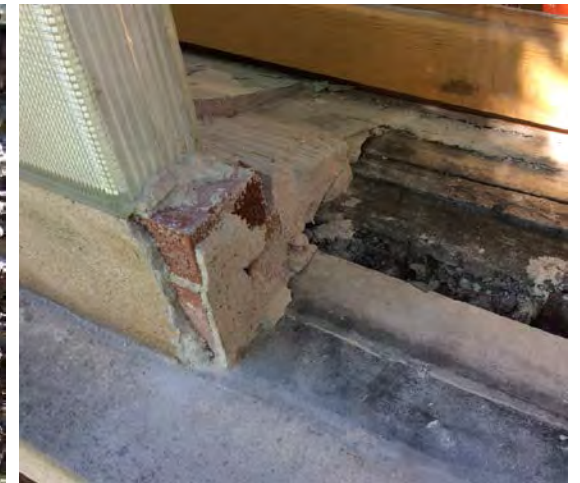
EXTERIOR RESTORATION/REHABILITATION - WINDOWS

- a. New aluminum clad windows with wood interiors are proposed.
- b. Investigative demolition of 6–8 existing windows has occurred with several of the existing conditions presented.
 - i. It was noted that the existing drawings are pretty accurate.
 - ii. Glass block was installed over the existing wood sill.
 - iii. Jamb condition will need to be filled with mortar & epoxy.
- c. Paint analysis of 24 interior and exterior locations is underway.
