CAMPUS PHYSICAL DEVELOPMENT PLAN

2011 – 13 Capital Budget

University of Wisconsin – La Crosse July, 2010

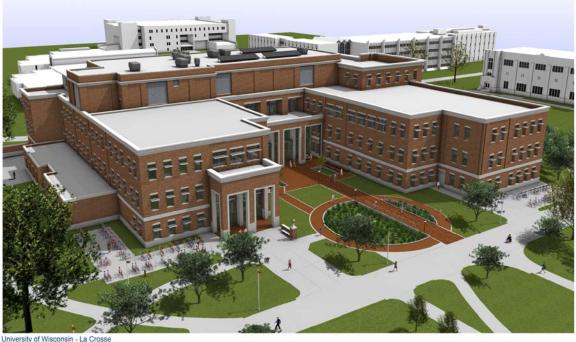
Centennial Hall

The new building will contain new general assignment classrooms to replace a portion of the existing deficient classrooms that are located throughout campus. Various academic and student advising departments that do not currently have enough space to meet their program needs will also relocate into the new building. As these departments and activities move to the new building, the areas in the existing buildings (Graff Main Hall, Wimberly Hall, and The Center for the Arts) that they vacate will be acquired by the remaining occupants in those facilities in an attempt to mitigate some of the space constraints under which they are currently operating.

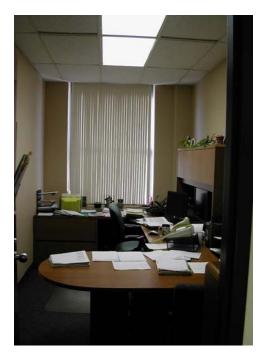
(At Left - Former storage closet converted to office)

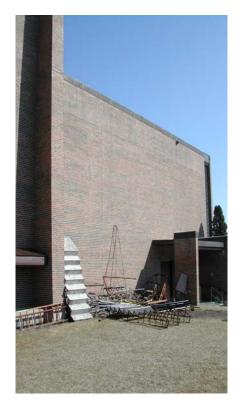
(At Right – Lack of storage for Theatre Arts results in items used for productions overflowing outside of the bldg)

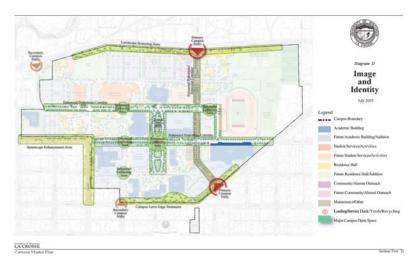
As indicated previously in this document, most of the main campus is located on the site of what was once a residential neighborhood. The conversion of the property from a residential setting to a university campus diminished the need for the matrix-like grid of city streets that once existed throughout the campus. While some of those streets are still accommodating vehicular traffic into and through campus, most have been vacated or closed to public vehicular traffic.

These corridors have become pedestrian and bicycle malls that also accommodate access to the various campus buildings by service, delivery, mass transit and emergency vehicles. These areas also serve as appropriate setback and green space between the buildings. This is especially important on a compact and densely developed site such as the one occupied by UW-La Crosse.

However, due to capital budget limitations and emphasis on higher priority facility construction required to meet the academic program needs, the physical transformation of vacated streets into pedestrian malls/walkways/fire lanes has not been accomplished. Consequently, highly visible, unattractive, and somewhat nonfunctional corridors still exist on campus.

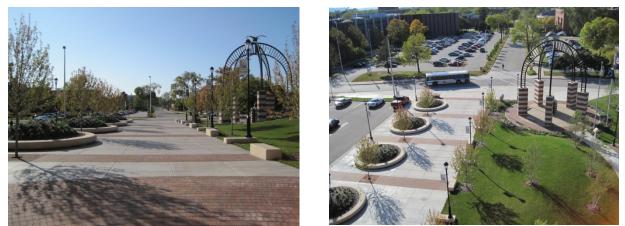
New pedestrian mall and gathering area outside the new Veterans Memorial Sports Fields Complex

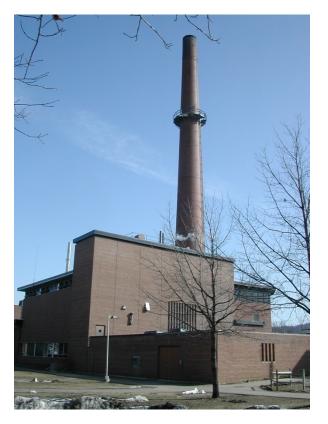
Campus steam is supplied by a central heating plant which produces and distributes high pressure steam through underground pipes which are located in concrete ducts (Permaduct or Z-Crete). Approximately, 19,100 linear feet of steam and condensate lines serve twenty-six buildings on the main campus. Within the buildings, the steam pressure is reduced from 100 to 15 PSIG. Steam is used for area heating, food processing, humidification, sterilization/autoclaves, domestic hot water, and, in limited applications, cooling.

In recent years, leaks have developed in the direct buried steam supply and condensate lines at various locations around campus. Visual inspection during repair of these portions of the lines has indicated that significant deterioration of the conduit system has occurred in some locations. It is suspected that the deterioration is attributable to the fact that these particular segments of direct buried lines are under vacated city streets and have been subjected corrosion caused by de-icers that were applied at the surface of the ground and which then leached down to the steam pipes. There are several segments of direct buried steam and condensate lines that are located such that they have probably been exposed to the same type of de-icers. Some of the more significant lengths of these lines are a segment between Morris and Baird Halls; and a segment between Trowbridge and Wilder Halls. A project was requested in the 2003-05 biennium to replace these segments of buried piping. However. these all lie in areas that will be disturbed by construction of the new academic building. Until the academic building project is complete, the known steam line maintenance will be deferred to avoid potential site routing conflicts and funding the same work more than once.

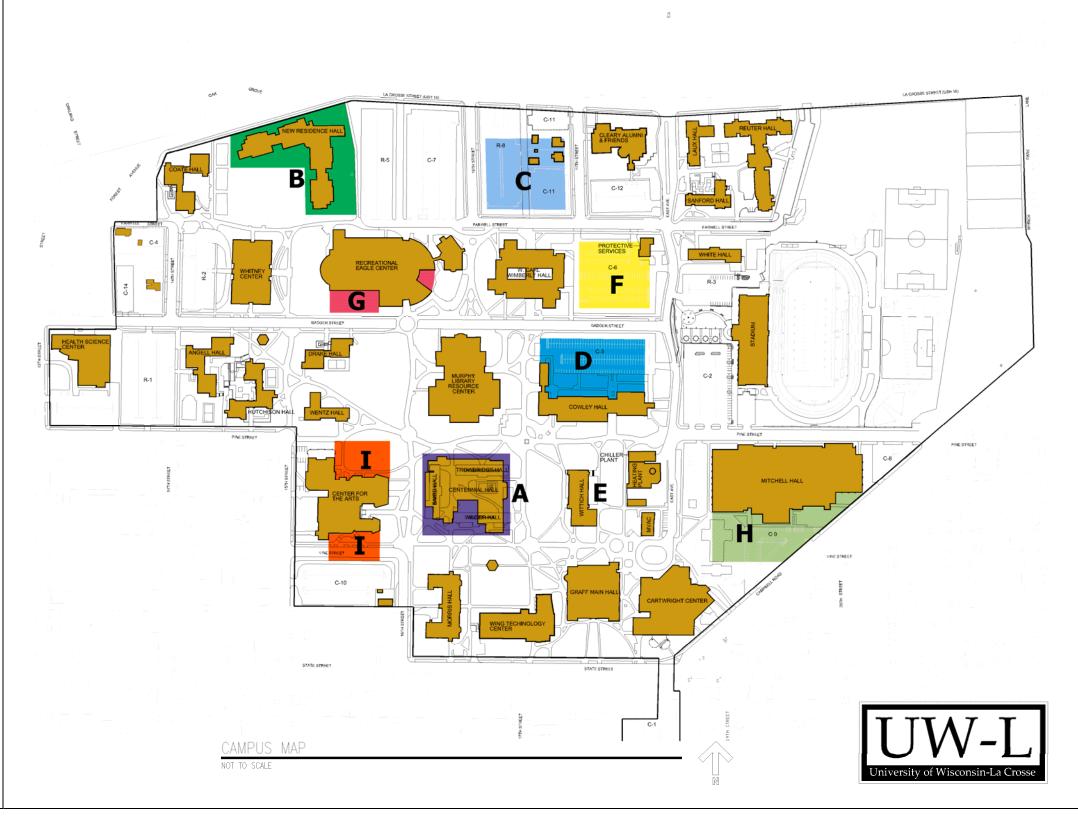
The university is proposing a Facilities Stewardship Project to completely renovate Wittich Hall to accommodate occupancy by the College of Business Administration.

The university will be submitting a request to us PR funds to begin a pre-planning project for replacement of its aged student union, Cartwright Center. The UW-L Campus Master Plan advocates locating the new facility in the location shown on the plan, which is currently a surface parking lot. Enumeration of this project is anticipated in the 13-15 biennium.

The university will be submitting a request to us PR funds to begin a pre-planning project for replacement of its aged student union, Cartwright Center. The UW-L Campus Master Plan advocates locating the new facility in the location shown on the plan, which is currently a surface parking lot. Enumeration of this project is anticipated in the 13-15 biennium.
