# CAMPUS PHYSICAL DEVELOPMENT PLAN

2015 – 17 Capital Budget

UNIVERSITY *of* WISCONSIN  
**LA CROSSE**

University of Wisconsin – La Crosse  
June, 2014

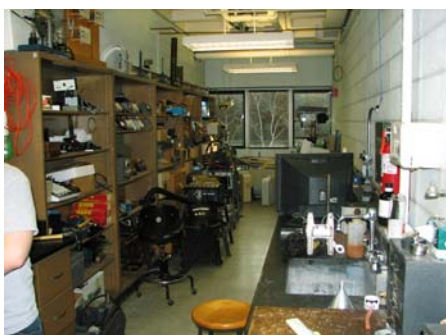
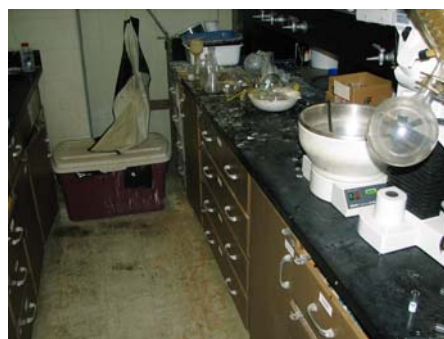
Existing conditions in Cowley Hall

Currently, the highest priority for the university is to construct a new facility that is adequate to accommodate instruction in the Physical and Life Sciences. The existing instructional science facility, Cowley Hall, was constructed in 1965 and the building has not changed significantly since then. The functional layout, size, and infrastructure of the building make it problematic for it to accommodate science instruction. And, this problem continues to be made worse by the increased demand for the science programs. With the assistance of UWSA and DFD, the university is has completed a Pre-Design Study for a new science facility that can be viewed in its entirety at <http://www.uwlax.edu/sciencefacility/>.

The entire infrastructure of the existing Cowley Hall is obsolete and beyond expected useful and service life. Essentially, the mechanical, electrical, and plumbing systems are the same as originally constructed over forty-five years ago. The existing building is not ADA compliant or able to meet today's NFPA standards. Existing Cowley Hall does not contain a fire suppression system. The floor, wall and ceiling finishes are mostly original construction and need to be replaced. The exterior windows and curtain wall systems of existing Cowley Hall are original and in an advanced state of disrepair. Also, there are locations of significant movement of the masonry wall sections, especially at the corners of the building.

Cowley Hall was constructed in 1965 when there were far fewer science programs, and those programs demanded much less from the facility. The building has never had a major renovation, and it can no longer accommodate the quantity and intensity of the instruction and research that must occur in the building. All of the programs in the physical and life sciences are experiencing severe space shortages. In addition, the quantity and condition of the instructional labs are inadequate to serve the number of students that are demanding access to the programs. Along with the space deficiencies and the poor condition of individual labs, the overall infrastructure of the building itself is completely beyond its useful and expected life.

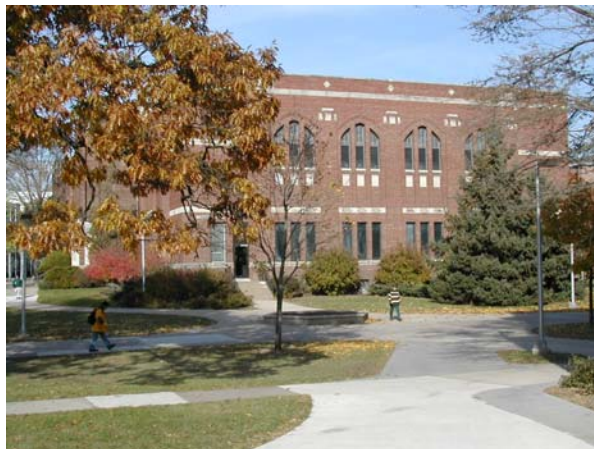
Wittich Hall

Wittich Hall, the original physical education building on campus (constructed in 1916), requires extensive renovation/remodeling to bring the building envelope, interior space and infrastructure up to current standards and code requirements. The facility currently provides a small amount of temporary office space for various programs and practice gymnasium space for the UW-L Women's Gymnastics team. Extensive capital investment in the near future will be required to allow continued occupancy of the facility. This has become even more evident by the occurrence of an electrical fire in June 2012 that required the activities in the building to be relocated for approximately two months so repairs and cleaning could occur.

The building, which is listed on the Federal Register of Historic Places, is in a state of advanced deterioration. The mechanical ventilation systems are served by essentially the same infrastructure as originally constructed in the building. All components of the building infrastructure are well beyond their expected life, the building contains hazardous building materials, and the facility is not ADA compliant. Finally, all of the finishes in the building are well beyond their useful life and are in need of replacement.

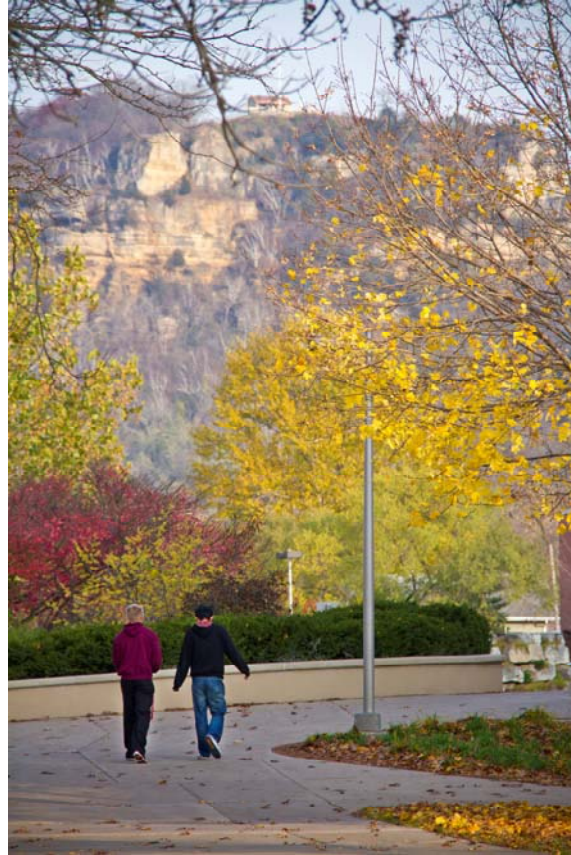
The university continues to place a high priority on the creation of the Central Campus Mall, as described in the UW-L Exterior Master Plan. The intent was to develop the southern half of the mall in conjunction with the new academic building project (Centennial Hall), and to develop the northern half of the mall as part of the Cowley Hall addition project. Although the southern half of the mall was not developed as part of the Centennial Hall project, it remains a high priority for the campus and development of the northern portion of the mall is still anticipated to occur as part of the new science facility site work. Completion of the central mall will be followed by the development of the Badger Street Mall which runs perpendicular to, and intersects, the central campus mall at the center of campus. The university will also continue to move forward with vacation of city-owned streets within the campus boundaries, as well as acquisition of the privately and city owned properties within the campus boundaries, as those properties become available.

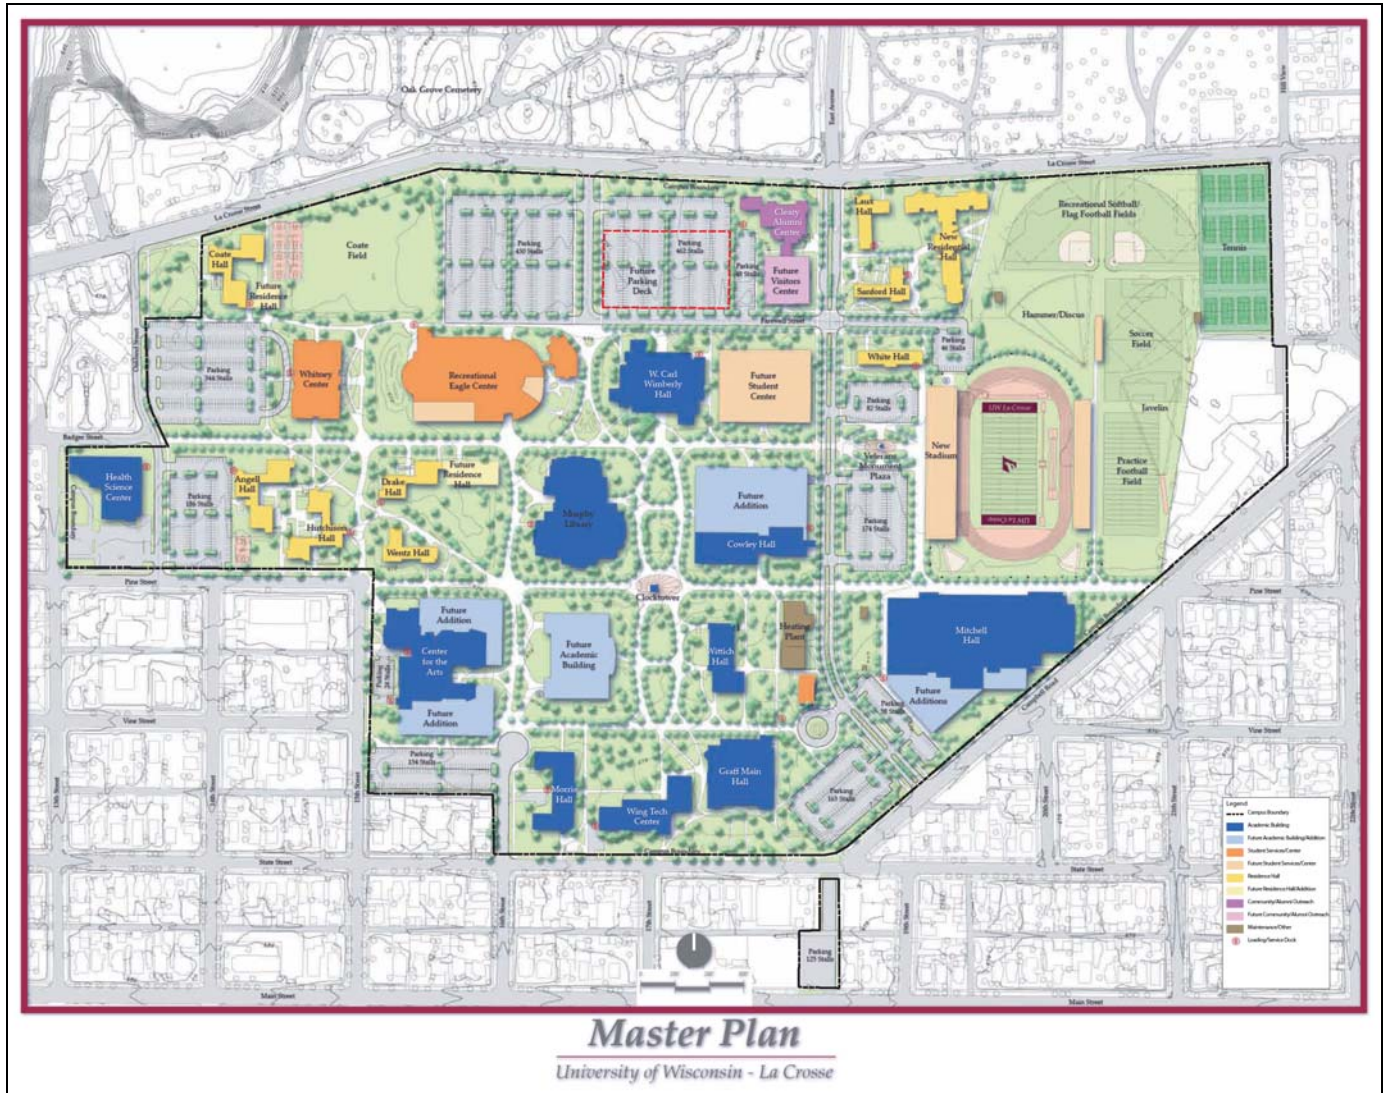
Shown on the following page is a graphic from the 2005 UW-L Master Plan representing the anticipated redevelopment of the campus over a 25 year timeframe.

- Design has begun for a new science facility. The project will be implemented in two phases and it will be located on an existing surface parking lot on the site of the existing science building (Cowley Hall) at the center portion of the plan. The existing building (shown in dark blue) will be demolished at the completion of the first phase of the project, and the remainder of the new facility will be constructed on the footprint of the existing building as part of phase II of the project. Phase 1 of this project (DFD #13B3H) was enumerated in the 2013-15 biennium.

- Additional Recreation and Sports Activities space is also planned, and that may vary in size and location from what is shown on the plan.
- Additions and renovations to Mitchell Hall and Center for the Arts will occur in future biennia. The plan shows additions to those buildings, although the final size and locations of those additions may vary from the plan.

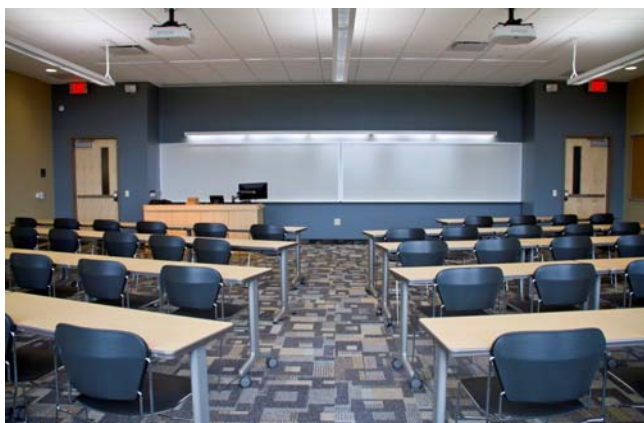
New classroom in recently completed Centennial Hall.

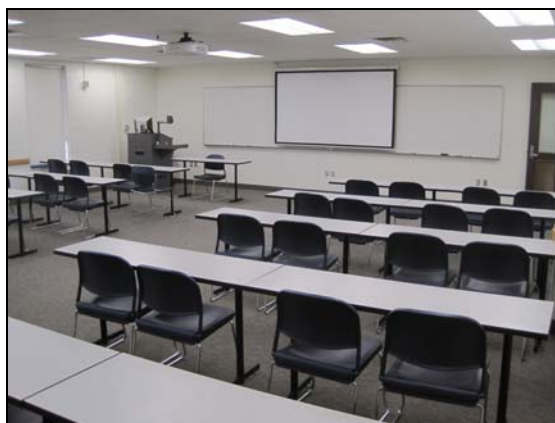
Two former Type 'B' classrooms converted to single Type 'A' classroom in Wimberly Hall.

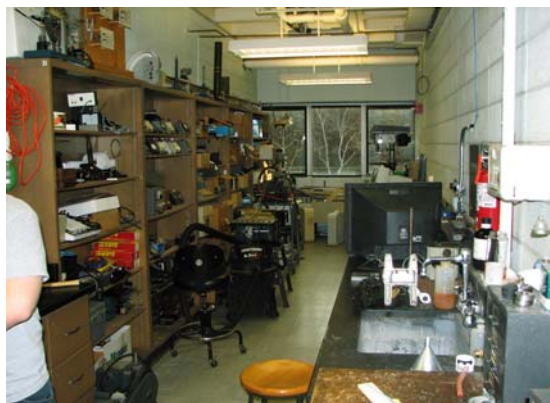
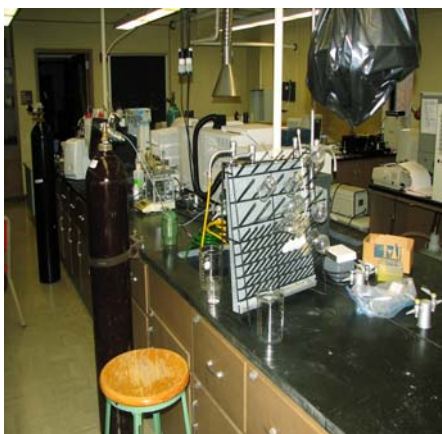
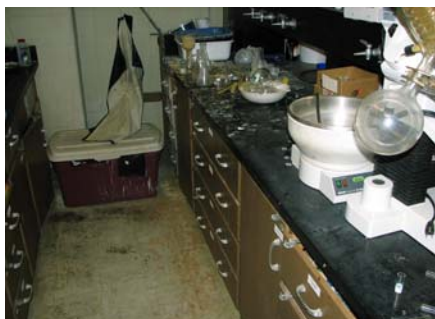
Photos on this page show various existing lab spaces in Cowley Hall

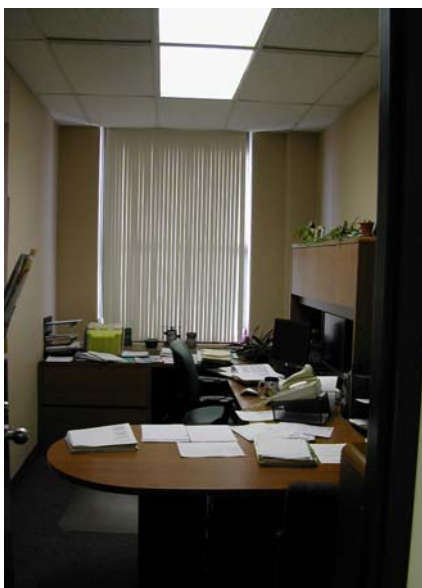
(At Left - Former storage closet converted to office)

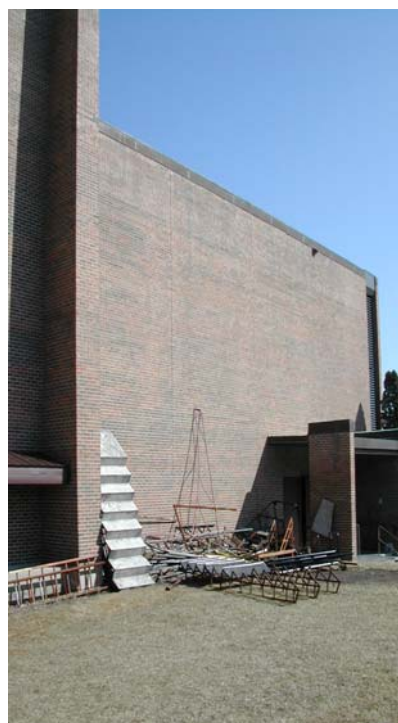
(At Right – Lack of storage for Theatre Arts results in items used for productions overflowing outside of the bldg)

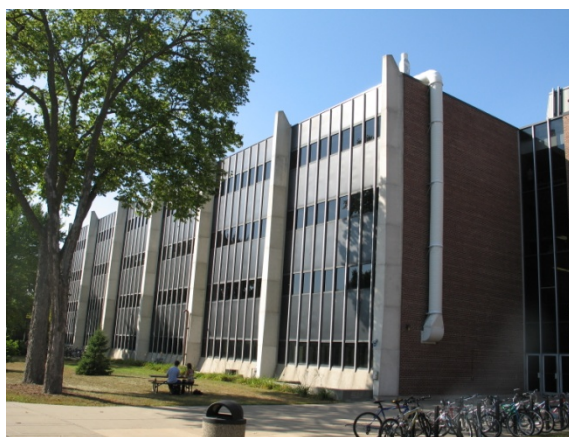
**Cowley Hall**

Cowley Hall, the university's academic science building, is another facility in need of extensive capital renewal. It was constructed in 1965 and has had no major renovation since then. As demand for access to coursework in the physical and life sciences, as well as faculty and student research, has continued to increase dramatically in recent years, the building's aged infrastructure and lack of space have become a barrier to the university's ability to deliver this instruction. But, unlike Wittich Hall, a significant amount of additional building space is required to accommodate the demand for access to the academic programs in the physical and life sciences. As such, the university, with the assistance of UW System Administration and the Division of State Facilities, recently completed a pre-planning study to determine the building program needs for a new academic science facility. The final report produced as a result of this study recommends the implementation of a two phase project that will completely replace Cowley Hall with a totally new facility. The ultimate goal of the project will be to provide the appropriate quantity and quality of space needed to deliver the academic programs in the physical and life sciences.

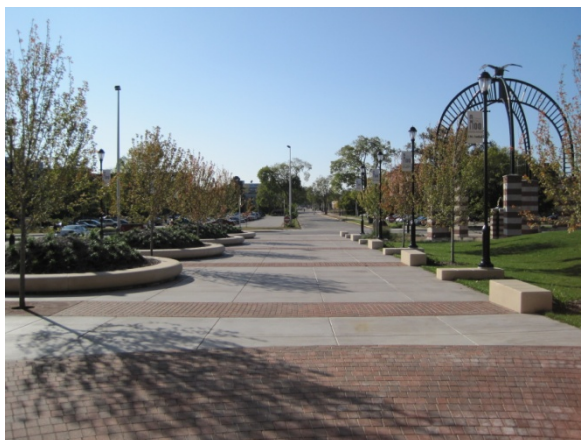
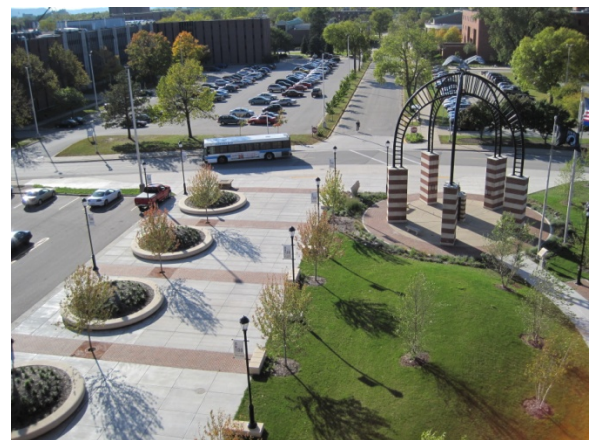
New pedestrian mall and gathering area outside the new Veterans Memorial Sports Fields Complex

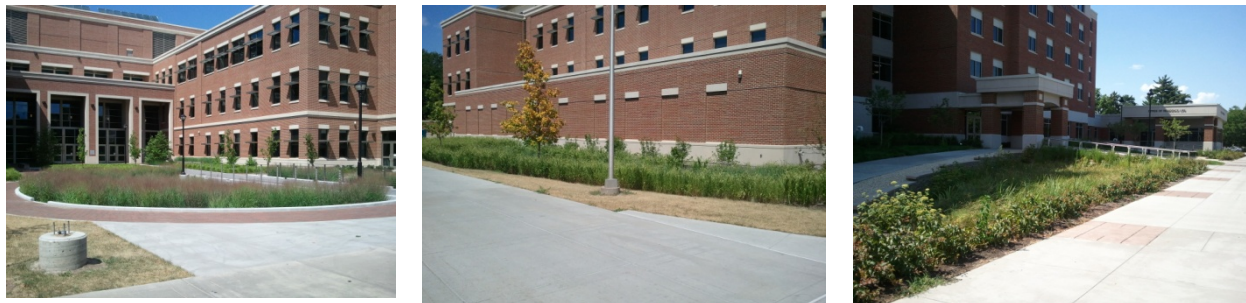
Various biofiltration basins at Centennial and Eagle Halls

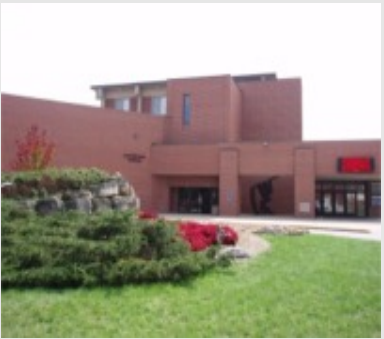
<b>Building Name</b>	CARTWRIGHT CENTER

The building has one aging passenger elevator that is not large enough to comply with current ADA requirements. There is ACM flooring, spray-on ceiling acoustical treatment and pipe insulation in the building, and due to the age of these materials, it takes very little disturbance of them to cause the material to become friable.

The building and its two additions consist of multiple levels that do not match on many floors. A series of stairs and ramps provide access between the levels, however, this makes ADA accessibility difficult to achieve. The finishes are mostly original to the building, and as such, are dated and worn out.

There has been a project designed to replace the sanitary waste system, as well as some of the domestic water supply system in the building. However, as the university is currently studying the feasibility of replacing the building, that project has been deferred.

The building has one freight elevator that is original to construction of the facility. It is beginning to experience increasing downtime due to maintenance, and it will eventually need to be replaced.

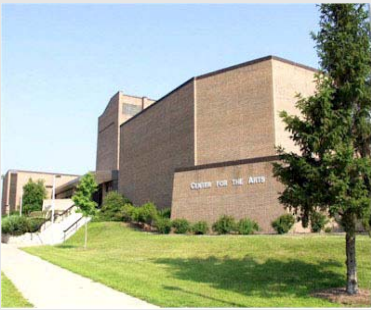
<b>Building Name</b>	CENTER FOR THE ARTS

Exterior stairs and retaining walls on south side of building are failing.

The building is not fully ADA compliant. In addition, the metal sculpture and ceramic lab areas are not compliant with current fire codes. The chimney serving the kilns has been inspected and determined to be unsafe to exhaust the carbon monoxide. The enclosures around the kilns are not constructed of noncombustible materials.

The interior finishes in the building are original to the construction of the facility. They are well beyond their expected life, and require replacement. The sections of casework in the various art labs are in an advanced state of deterioration and need replacement.

Main lighting systems in the recital hall are beyond expected life and are experiencing frequent problems. The systems will have to be replaced in the near future to avoid an unscheduled failure, which would result in shutdown of the performance venues.

Acid waste lines in art labs require replacement. Pipes are approximately 50% full and experience back-ups. Sink and faucet fixtures in art labs require replacement. Water heater in building is original and is experiencing increased maintenance issues.

The building, which has public performance events, does not have a passenger elevator. The freight elevator is used as a passenger elevator for those with health or mobility issues. It is not in a functional location to serve the public venues. Also, due to use and age of elevator, it experiences frequent out of service times. Elevator service company has recommended complete overhaul of elevator.

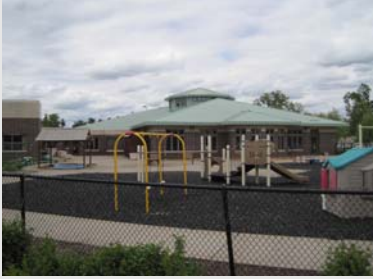
<b>Building Name</b>	CHILD CARE CENTER

The facility has experienced sporadic roof leaks during the spring melt-off. UW-L facilities staff are currently trying to determine the origin of the leaks.

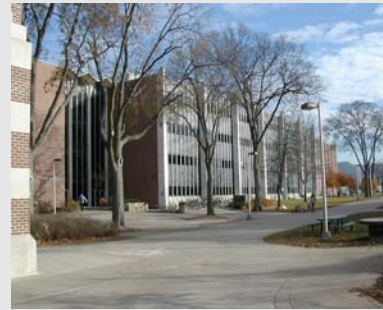
The windows are original to the 1965 construction of the building. They are single pane, they leak excessively, and are not energy efficient. The roof and curtain wall system at

the green house portion of the building leak continuously. Water is penetrating the building on the south wall and is evident on the wall of large lecture halls. The exterior slate panels on the north side of the building are stained and deteriorated.

Both the normal sanitary waste and the acid waste systems need replacement. Lines consistently clog. Supply system suffers continual leaks in risers.

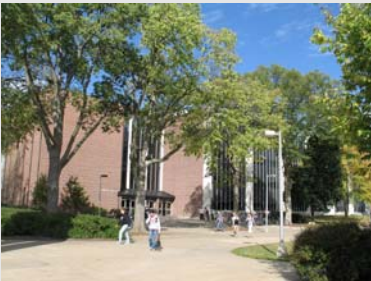
<b>Building Name</b>	COWLEY HALL ADDITION

The windows are original to the 1969 construction of the building. They are single pane, leak excessively and are not energy efficient. There are grading issues associated with the north end of the building that cause water to penetrate the building at the north entrance. The storefront window/entry system leaks and allows water penetration into the building.

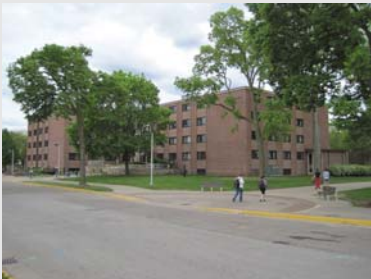
<b>Building Name</b>	DRAKE HALL

The lower level building suffered extensive physical damage, and the remainder of the building experienced extensive smoke contamination due to a fire in spring of 2012. The basement was reconstructed and all IT/Telecom and portions of the HVAC system were completely replaced, and the entire building was deep cleaned by a professional disaster recovery firm.

Building is not ADA compliant. Building is not equipped with fire suppression system. Building contains large amount of ACM flooring. As the tiles and mastic deteriorate, tiles break and flooring material can become friable. Replacement currently occurs on a "case by case" basis.

The tube bundles in the water heater have multiple leaks and need replacement. In addition, the building plumbing system (both supply and sanitary waste) is constructed of galvanized piping, so leak problems could occur in the future.

Building will eventually require complete renovation. An All Agency Project in 13-15 will replace the steam water heater with new, compliant, more efficient system.

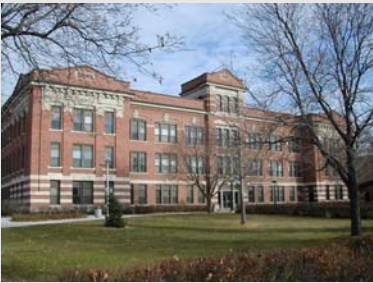
<b>Building Name</b>	GRAFF MAIN HALL

The building was completely remodeled in 1979 and has had no significant changes since then and the spaces occupied by some of the larger departments in the building do not function well. Staffing and services provided by these departments have changed considerably since the late 1970's but the physical space occupied by these departments has not been revised. The building is not completely ADA compliant, and this has caused some programs to change the location of their delivery within the building in the past.

The interior finishes in the building were mostly installed during the 1979 renovation, and so most are beyond their expected life. The windows that were installed in 1979 are also worn and require frequent repairs and they allow large amounts outside air and moisture to penetrate the building. Also, the building contains the university's largest auditorium and the finishes and seating in that space are well beyond their life expectancy.

No significant additions to the building are anticipated in the future. However, a complete renovation of the facility may be required in future biennia to correct functional and infrastructure deficiencies.

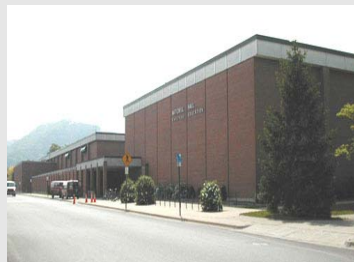
<b>Building Name</b>	MITCHELL HALL

Roof leaks are a continual problem, despite several recent repair attempts. The floor and wall finishes are well beyond their expected life. The gymnasium wood floor has many areas of repair and some planks are loose. The fieldhouse floor is completely gone in some locations and is beginning to deteriorate along entire track. The hollow metal doors and frames are rusting to the point they are allowing air and moisture penetration into the building. The existing windows are single, not energy efficient and the moving mechanical parts no longer function on them.

The building is not connected to the central campus chilled water system. Multiple individual cooling systems serve various portions of the building. Some units are in need of replacement. Some areas of building do not have cooling. Damper motors & control valves need to be replaced and upgraded to electric operation. Air handling system for pool area needs complete revision/overhaul, including reinstatement of heat recovery system that is currently offline.

It's difficult to provide the power required for the kinesiology and biomechanics labs. Lighting systems in gymnasium and fieldhouse are original to the building and are not energy efficient, and they are beginning to experience increasing downtime for unplanned repairs.

Existing galvanized supply system experiences frequent leaks requiring unscheduled building shutdown of system. Pipes are buried in masonry walls making diagnosis and access very difficult and costly. Pool water controls equipment well beyond expected life and does not work well.

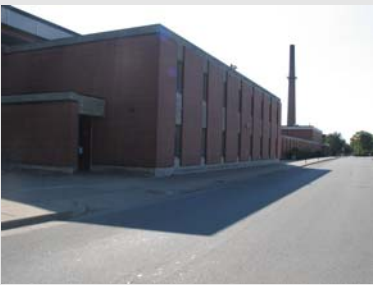
<b>Building Name</b>	MITCHELL HALL ADDITION

Roof leaks are a continual problem, despite several recent repair attempts. The floor and wall finishes are well beyond their expected life.

The building is not connected to the central campus chilled water system. Multiple individual cooling systems serve various portions of the building. Some units are in need of replacement. Some areas of building do not have cooling. Damper motors & control valves need to be replaced and upgraded to electric operation. Air handling system for pool area needs complete revision/overhaul, including reinstatement of heat recovery system that is currently offline.

Existing galvanized supply system experiences frequent leaks requiring unscheduled building shutdown of system. Pipes are buried in masonry walls making diagnosis and access very difficult and costly.

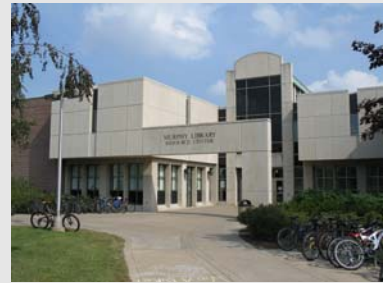
The condition of the building envelope has allowed water to penetrate the building. A Small Project has been approved to repair exterior brick wall and foundation joints and sealants as recommended by a building envelope study that was completed with the assistance of the DSF.

The majority of the buildings, including portions of this addition, are served by three main air handlers that are original to the 1969 construction of the building. As such, valves, dampers, actuators, etc. are beginning to wear out and unscheduled maintenance on the systems is occurring with greater frequency. In addition, some controls in the system are still original pneumatics that do not communicate with the campus EMS.

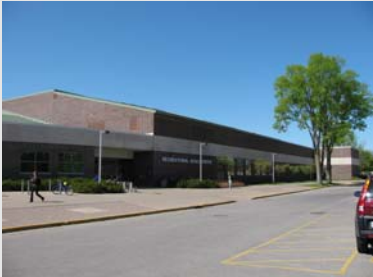
<b>Building Name</b>	RECREATIONAL EAGLE CENTER (REC)

The fire alarm panel has experienced multiple malfunctions since it was originally installed during construction of the building. The panel was considered obsolete soon after the building was constructed and as such, procurement of replacement parts and repair of the panel are difficult. Replacement of the panel is planned as an All Agency project.

Excessive humidity accumulation in the strength center is a continual problem. A study of the problem by a consulting engineer is in progress.

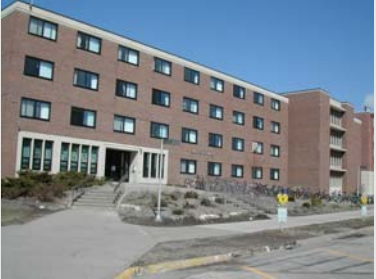
<b>Building Name</b>	SANFORD HALL

Building is not ADA compliant. Building is not equipped with fire suppression system. Building contains large amount of ACM flooring. As the tiles and mastic deteriorate, tiles break and flooring material can become friable. Replacement currently occurs on a "case by case" basis.

The tube bundles in the water heater have multiple leaks and need replacement. In addition, the building plumbing system (both supply and sanitary waste) is constructed of galvanized piping, so leak problems could occur in the future.

Building will eventually require complete renovation. A Small Project in Summer 2013 will replace the steam water heater with new, compliant, more efficient system.

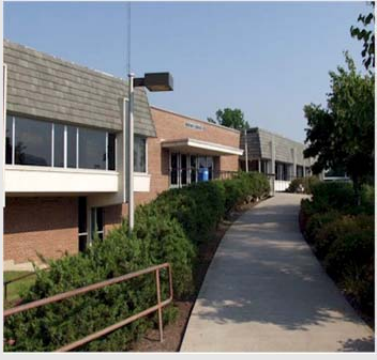
<b>Building Name</b>	WHITNEY CENTER

The existing wood shakes on the mansard roofs are beginning to fail and are needing replacement with increased frequency. The dish room floor safin is not functioning properly, and there are frequent leaks into a finished office area below.

The building has multiple air handlers and they are all original to the building construction in 1967. The units are experiencing increased maintenance issues, especially with dampers and freeze stats. Rehabilitation and/or replacement of the units and other components of the system will be required in coming years.

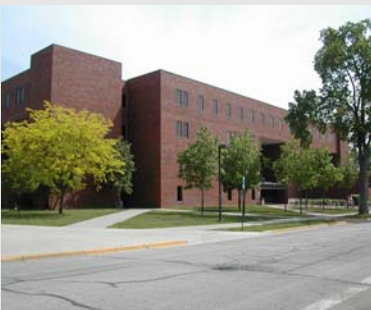
<b>Building Name</b>	WIMBERLY HALL

The finishes in the public spaces, offices, and many of the classrooms are well beyond their expected life and need replacement. Because the spray on ceiling finish contains asbestos, it is difficult to run IT and telecommunications cabling, install overhead projects, change out light fixtures, etc. The building does not have a recognizable entrance, which is especially problematic for the Small Business Development Center. The condition of the exterior building envelope is resulting in water and insect penetration into the building.

Most of the equipment and furnishings are original to the construction of the building and so they are well beyond their expected life.

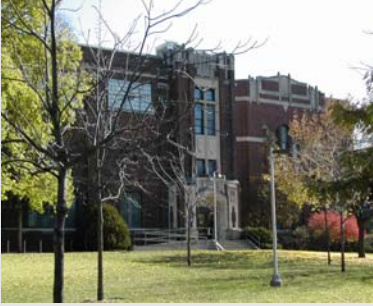
<b>Building Name</b>	WITTICH HALL

Spaces are not sized appropriately and the entire building does not function well due to critical infrastructure deficiencies.

All finishes are completely worn out, well beyond their life expectancy and very difficult to maintain. The windows leak and are in an advanced state of deterioration. The roof leaks and the old skylights allow water and air penetration in to the building.

Entire plumbing system needs replacement. Supply system continuously experiences leaks, and waste system experiences frequent back-ups.

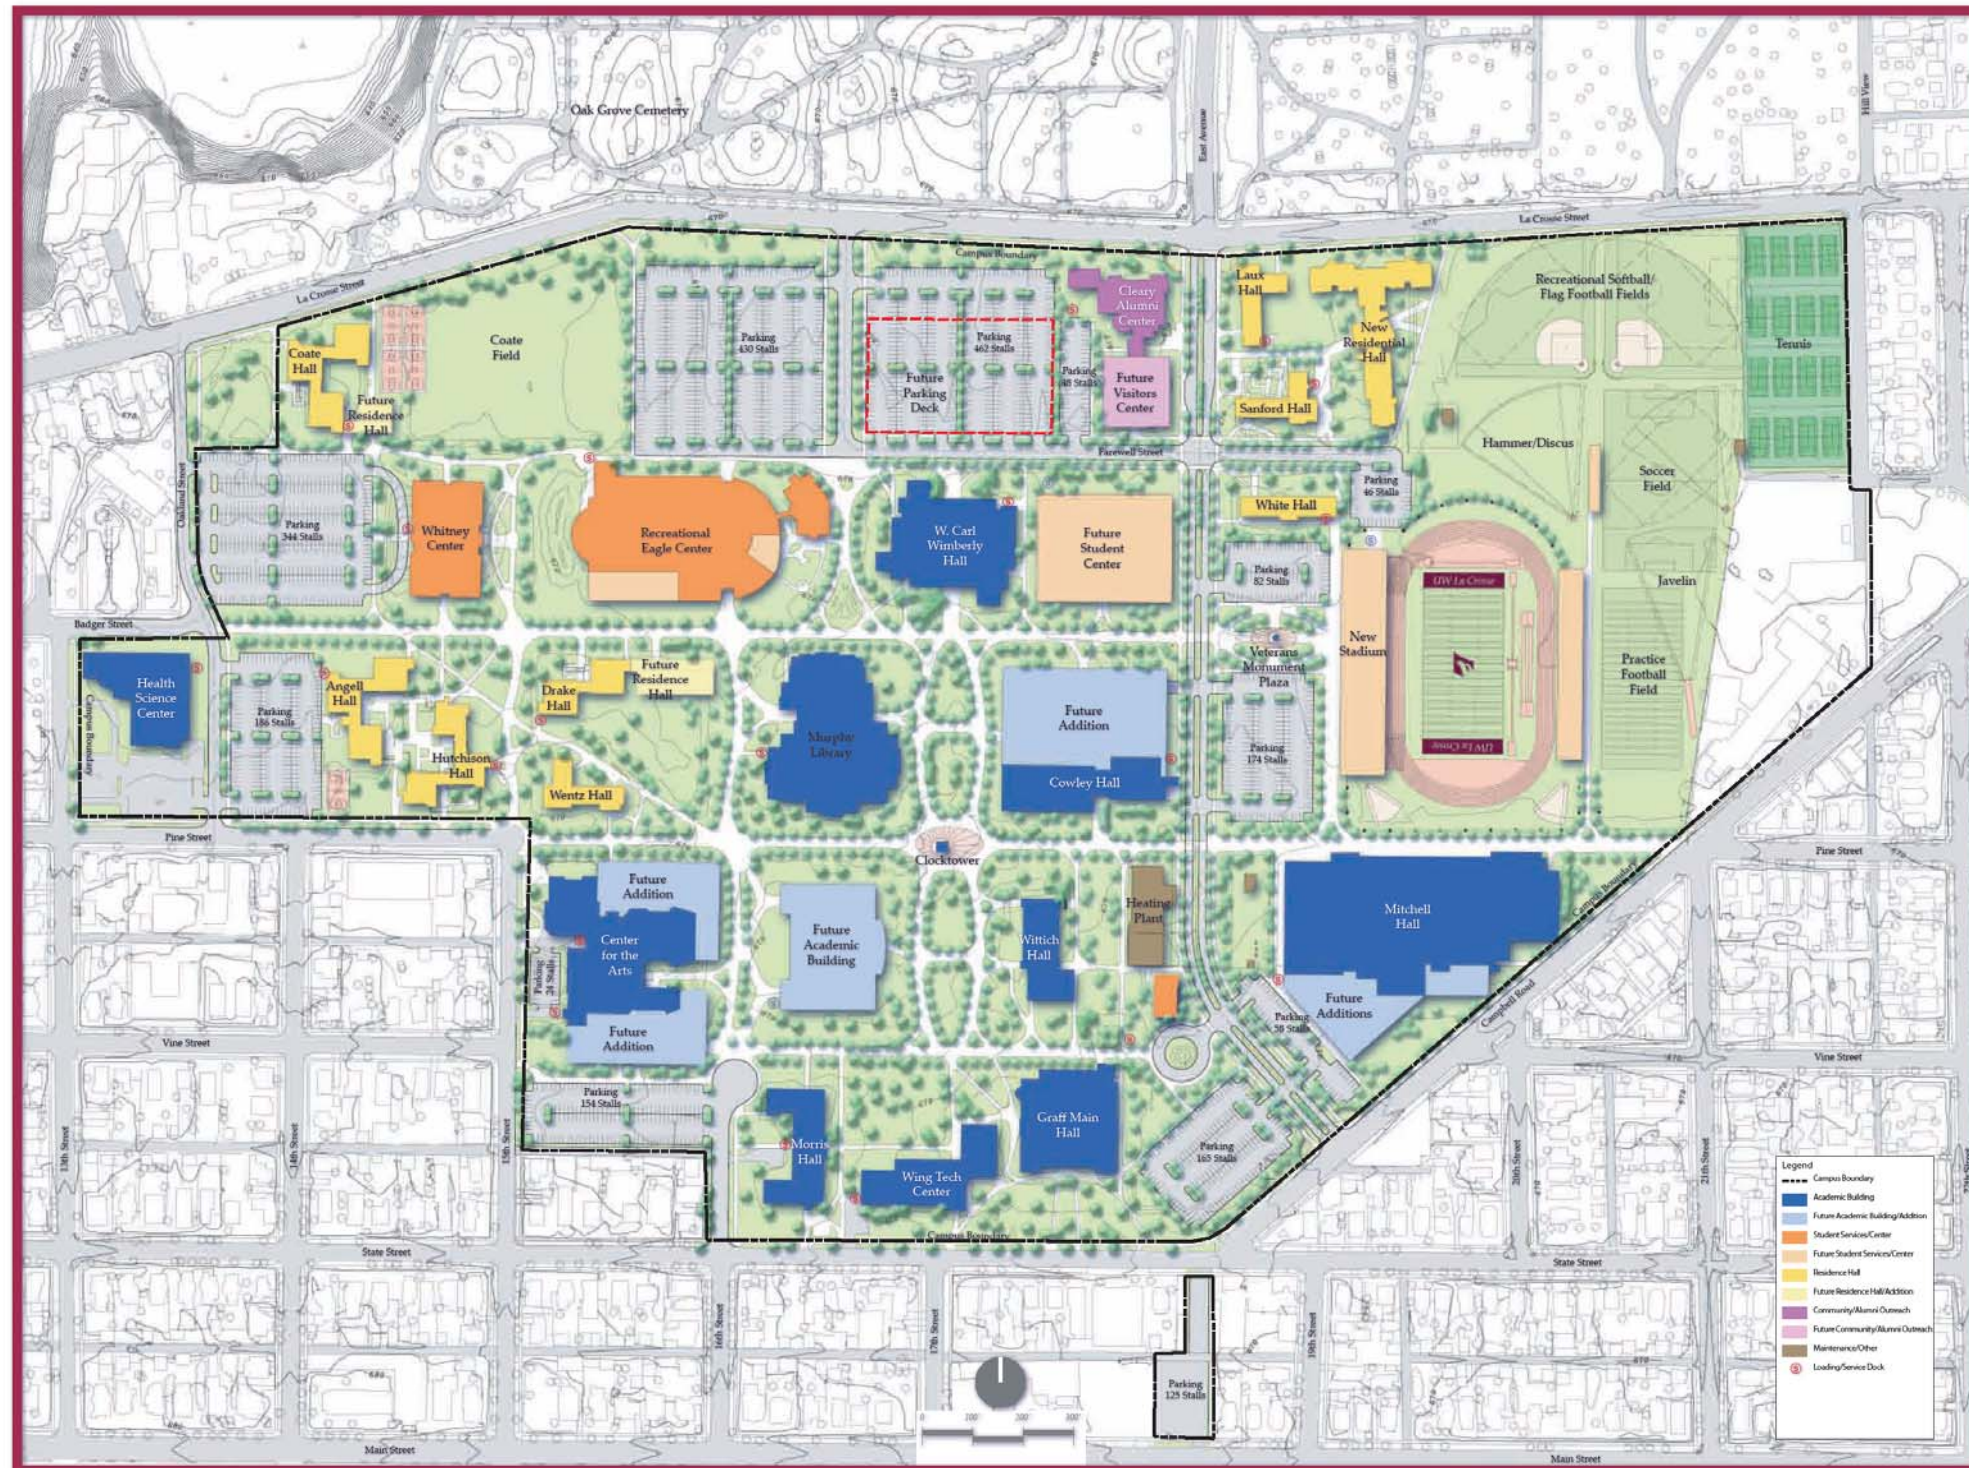
**Master Plan**  
University of Wisconsin - La Crosse

The illustration shown at left is the UW-L Master Plan. It was developed through a public and collaborative process that spanned over a period of approximately 1 ½ years, and was finalized in 2005. It has served as a roadmap for development of major projects on campus that have occurred since its completion. These projects include Reuter Hall, Veterans Memorial Sports Fields Complex, Centennial Hall, and the new Parking Ramp and Police Services Building.
