CAMPUS PHYSICAL DEVELOPMENT PLAN

2021 – 27 Capital Budget

UNIVERSITY *of* WISCONSIN
LA CROSSE

University of Wisconsin – La Crosse
July 10, 2020

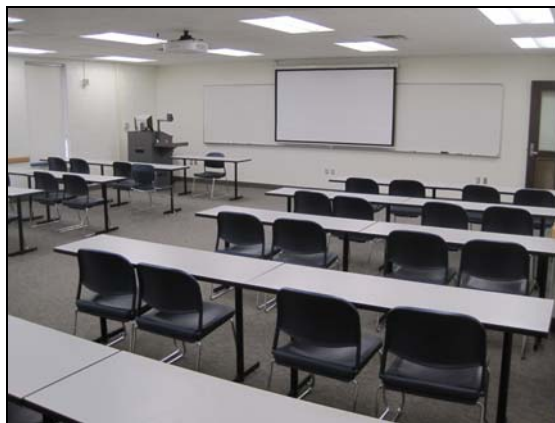
Two former Type 'B' classrooms converted to single Type 'A' classroom in Wimberly Hall.

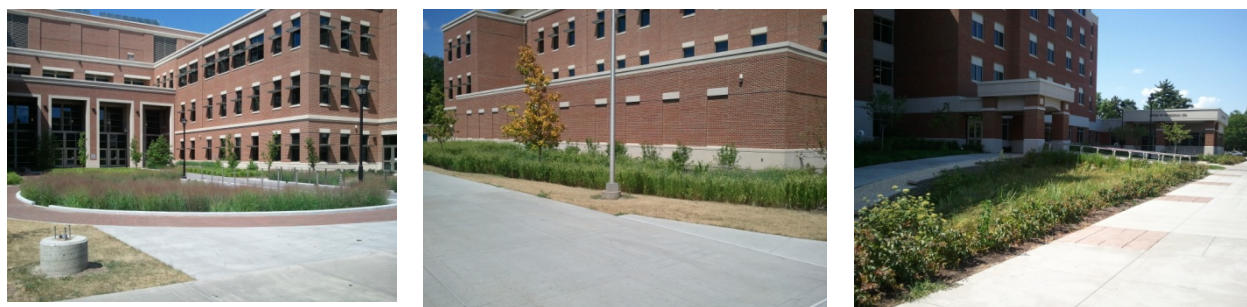
Various biofiltration basins at Centennial and Eagle Halls

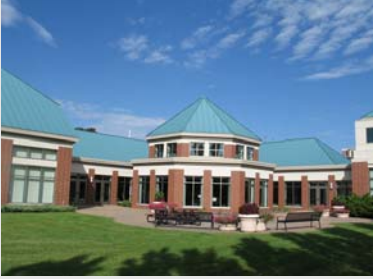
Building and window sealant joints have recently been replaced.

The lighting dimming system is failing. The building does not have an emergency generator and relies on a battery inverter system for emergency power. This system is very expensive to maintain.

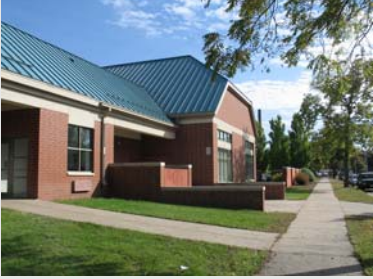
Building Name	CLEARY ALUMNI & FRIENDS CENTER ADDITION

Building and window sealant joints have recently been replaced.

The lighting dimming system is failing. The building does not have an emergency generator and relies on a battery inverter system for emergency power. This system is very expensive to maintain.

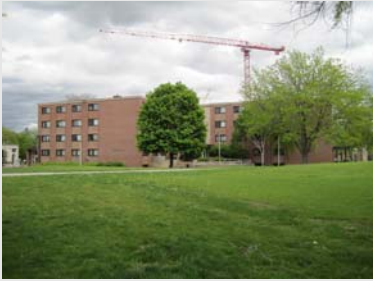
Building Name	COATE HALL

Building functions as a freshmen style residence hall, but the condition and relative function in comparison to the newer halls on Campus have deteriorated to a level that is inappropriate because it will cause harm to the quality and effectiveness of the Residence Life program and may impact enrollment growth.

Building is not ADA compliant. Building is not equipped with fire suppression system. Building contains large amount of ACM flooring. As the tiles and mastic deteriorate, tiles break and flooring material can become friable. Replacement currently occurs on a "case by case" basis.

Building is designed and functions as a basic 1960's freshman style residence hall. The bedrooms are small, the bathrooms and showers are small and not private or semi-private, and study spaces are small and inadequate in comparison to modern residence halls.

The building plumbing system (both supply and sanitary waste) is constructed of galvanized piping, so leak problems could occur in the future.

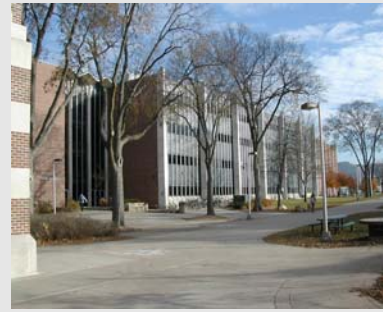
The windows are original to the building. They are single pane; they leak excessively, and are not energy efficient. The roof and curtain wall system at the green house portion of the building leak continuously. Water is penetrating the building on the south wall and is evident on the wall of large lecture halls. The exterior slate panels on the north side of the building are and deteriorated.

Both the normal sanitary waste and the acid waste systems need replacement. Lines consistently clog. Supply system suffers continual leaks in risers.

Most casework, furnishings, and other equipment are original to the building and are in need of replacement as they are completely worn out. Some new furnishings and casework have been purchased through Lab and Classroom Mod program.

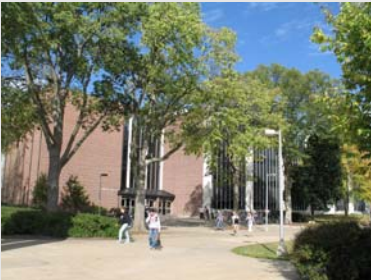
Building Name	COWLEY HALL ADDITION					
Building No.	285-0E-0009A					
Building Type	ACADEMIC, OFFICE					
Constructed Addition(s)	1969	Floors	AG 4	UG 1

The windows are original to the building. They are single pane; they leak excessively, and are not energy efficient. The roof and curtain wall system at the green house portion of the building leak continuously. Water is penetrating the building on the south wall and is evident on the wall of large lecture halls. The exterior slate panels on the north side of the building are and deteriorated.

Both the normal sanitary waste and the acid waste systems need replacement. Lines consistently clog. Supply system suffers continual leaks in risers.

Most casework, furnishings, and other equipment are original to the building and are in need of replacement as they are completely worn out. Some new furnishings and casework have been purchased through Lab and Classroom Mod program.

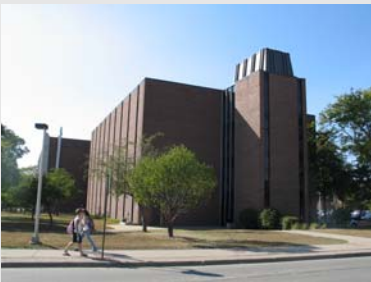
Building Name	COWLEY HALL ADDITION					
Building No.	285-0E-0009B					
Building Type	ACADEMIC, WET & DRY LAB					
Constructed Addition(s)	1970	Floors	AG 4	UG 1

The windows are original to the building. They are single pane; they leak excessively, and are not energy efficient. The roof and curtain wall system at the green house portion of the building leak continuously. Water is penetrating the building on the south wall and is evident on the wall of large lecture halls. The exterior slate panels on the north side of the building are and deteriorated.

Both the normal sanitary waste and the acid waste systems need replacement. Lines consistently clog. Supply system suffers continual leaks in risers.

Most casework, furnishings, and other equipment are original to the building and are in need of replacement as they are completely worn out. Some new furnishings and casework have been purchased through Lab and Classroom Mod program.

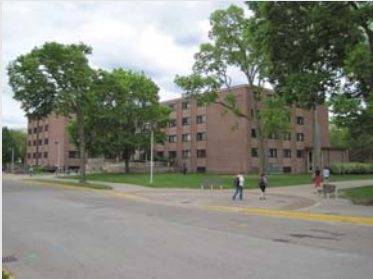
Building Name	DRAKE HALL

Building functions as a freshmen style residence hall, but the condition and relative function in comparison to the newer halls on Campus have deteriorated to a level that is inappropriate because it will cause harm to the quality and effectiveness of the Residence Life program and may impact enrollment growth.

The lower level building suffered extensive physical damage, and the remainder of the building experienced extensive smoke contamination due to a fire in spring of 2012. The basement was reconstructed and all IT/Telecom and portions of the HVAC system were completely replaced, and the entire building was deep cleaned by a professional disaster recovery firm.

Building is not ADA compliant. Building is not equipped with fire suppression system. Building contains large amount of ACM flooring. As the tiles and mastic deteriorate, tiles break and flooring material can become friable. Replacement currently occurs on a "case by case" basis.

Building is designed and functions as a basic 1960's freshman style residence hall. The bedrooms are small, the bathrooms and showers are small and not private or semi-private, and study spaces are small and inadequate in comparison to modern residence halls.

The building plumbing system (both supply and sanitary waste) is constructed of galvanized piping, so leak problems could occur in the future.

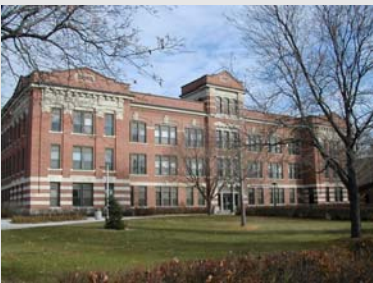
Building Name	GRAFF MAIN HALL

The building was completely remodeled in 1979 and has had no significant changes since then and the spaces occupied by some of the larger departments in the building do not function well. Staffing and services provided by these departments have changed considerably since the late 1970's but the physical space occupied by these departments has not been revised. The building is not completely ADA compliant, and this has caused some programs to change the location of their delivery within the building in the past.

The interior finishes in the building were mostly installed during the 1979 renovation, and so most are beyond their expected life. The windows that were installed in 1979 are also worn and require frequent repairs and they allow large amounts outside air and moisture to penetrate the building. A 2011 study showed the building needs significant envelope repairs.

The only heat in the building is floor mounted steam fed radiant heat at the perimeter of the building. There is no reheat available in the interior of the building, so during the cooling season it is extremely difficult to keep the occupants in the interior of the building comfortable. Also, the condensate return lines in the west side of the building are undersized which results in constant failure of steam traps and severe pounding within the return lines that is so loud it completely interrupts work in the offices and classrooms on that side of the building. In addition, the controls are all old pneumatic which provide little fine tuning or real-time control over the multiple systems in the building.

As requirements for power utilized by growing departments in the building increases, overload related circuit interruption is occurring with increasing frequency. The emergency generator is aging and the emergency service is at its maximum capacity. Both should be replaced and upgraded.

As with all university buildings, the equipment and furnishings are replaced with operational funds when available. However, as budgets are tight, the building contains a large amount of equipment and furnishings that are well beyond their expected life.

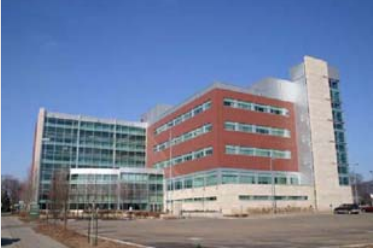
Building Name	HEALTH SCIENCE CENTER

The roof will need to be replaced in the next few years.

No known major issues, but finished and furniture are aging.

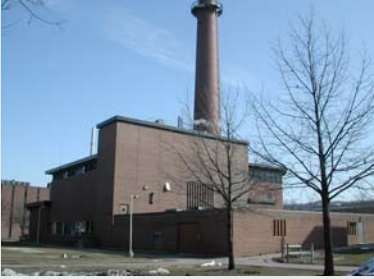
Building Name	HEATING PLANT

The Heating Plant building was constructed in 1967 along with a campus distribution piping system designed to feed steam to the main campus buildings. Although when it was constructed it was located on the northern edge of campus, it is now located in the heart of the main campus. It replaced an existing heating plant that at that time was then renovated to become the childcare center. An addition to the building was constructed in 1997 to house the newly established campus chilled water plant. Another addition was completed in 2005 to house a third chiller and additional cooling towers. Another addition was constructed in 2006 to accommodate a pollution filtration system (baghouse) for the coal fired boilers in the heating plant. In 2012, the smaller third boiler was replaced with two packaged unit boilers for use as summer or trim boilers.

There are currently ongoing projects to increase backup diesel fuel storage, replace the gas trains on the original boilers and replace the RO system.

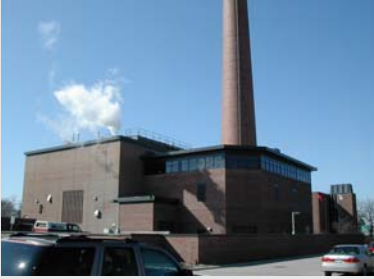
Building Name	HEATING PLANT ADDITION - BAGHOUSE

The baghouse has been removed from service as part of the Fuel Reliability Project. The plan is to investigate placing an additional/replacement boiler in the space in a future biennium.

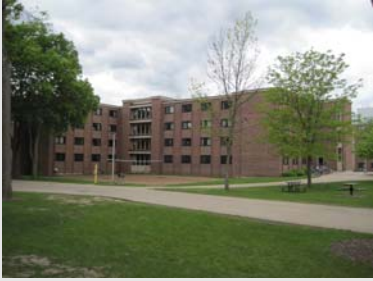
Building Name	HUTCHISON HALL

Building functions as a freshmen style residence hall, but the condition and relative function in comparison to the newer halls on Campus have deteriorated to a level that is inappropriate because it will cause harm to the quality and effectiveness of the Residence Life program and may impact enrollment growth.

The building plumbing system (both supply and sanitary waste) is constructed of galvanized piping, so leak problems could occur in the future.

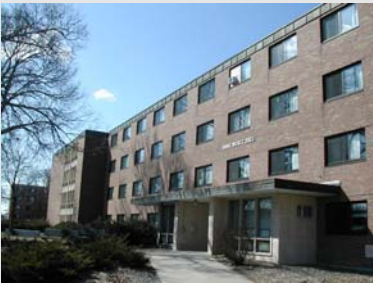
Building Name	LAUX HALL

The building plumbing system was replaced with the 2019 renovation.

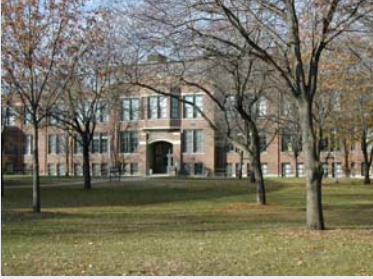
Building Name	MORRIS HALL					
Building No.	285-0E-0003					
Building Type	ACADEMIC, DRY LAB					
Constructed Addition(s)	1939	Floors	AG 2 1/2	UG 1

The emergency generator is aging and the emergency service is at its maximum capacity. Both should be replaced and upgraded.

No known major issues with condition of elevator, but it is in an inconvenient location for access by members of the public who are utilizing the facility.

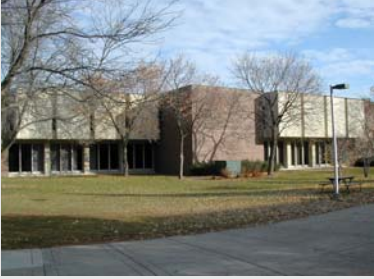
Building Name	MURPHY LIBRARY

Building finishes are aging and in need of upgrade or replacement.

The majority of the building is served by three main air handlers that are original to the 1969 construction of the building. As such, valves, dampers, actuators, etc. are beginning to wear out and unscheduled maintenance on the systems is occurring with greater frequency. There is an ongoing issue with the heating hot water circulation in the building. In addition, some controls in the system are still original pneumatics that do not communicate with the campus EMS.

The emergency generator is aging and the emergency service is at its maximum capacity. Both should be replaced and upgraded.

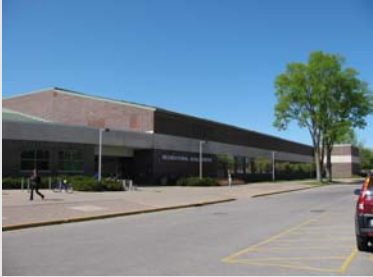
Building Name	RECREATIONAL EAGLE CENTER (REC)

The roof on the main portion of the building will need to be replaced in the near future.

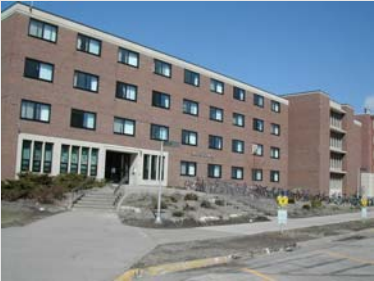
Building Name	SANFORD HALL

Building is not ADA compliant. Building is not equipped with fire suppression system. Building contains large amount of ACM flooring. As the tiles and mastic deteriorate, tiles break and flooring material can become friable. Replacement currently occurs on a "case by case" basis.

The building plumbing system (both supply and sanitary waste) is constructed of galvanized piping, so leak problems could occur in the future.

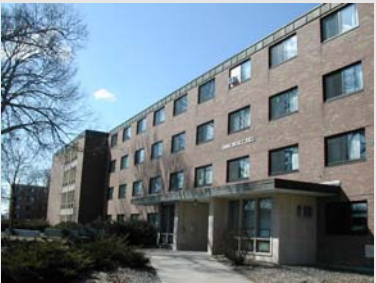
Building Name	WENTZ HALL

Building is not ADA compliant. Building is not equipped with fire suppression system. Building contains large amount of ACM flooring. As the tiles and mastic deteriorate, tiles break and flooring material can become friable. Replacement currently occurs on a "case by case" basis.

The building plumbing system (both supply and sanitary waste) is constructed of galvanized piping, so leak problems could occur in the future.

The elevator is in satisfactory condition, but is not ADA compliant to current standards.

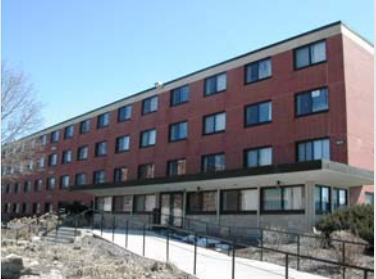
Building Name	WHITE HALL

Building is not ADA compliant. Building is not equipped with fire suppression system. Building contains large amount of ACM flooring. As the tiles and mastic deteriorate, tiles break and flooring material can become friable. Replacement currently occurs on a "case by case" basis.

The building plumbing system (both supply and sanitary waste) is constructed of galvanized piping, so leak problems could occur in the future.

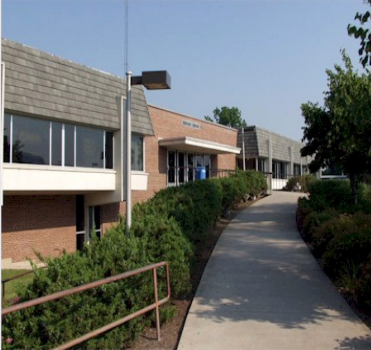
Building Name		WHITNEY CENTER

The existing wood shakes on the mansard roofs are beginning to fail and are needing replacement with increased frequency.

The building has multiple air handlers and they are all original to the building construction in 1967. The units are experiencing increased maintenance issues, especially with dampers and freeze stats. Rehabilitation and/or replacement of the units and other components of the system will be required in coming years.

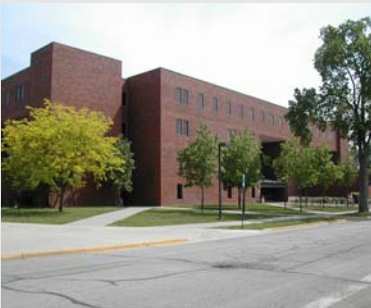
Building Name	WIMBERLY HALL

The finishes in the public spaces, offices, and many of the classrooms are well beyond their expected life and need replacement. Because the spray on ceiling finish contains asbestos, it is difficult to run IT and telecommunications cabling, install overhead projects, change out light fixtures, etc. .

The emergency generator is aging and the emergency service is at its maximum capacity. Both should be replaced and upgraded.

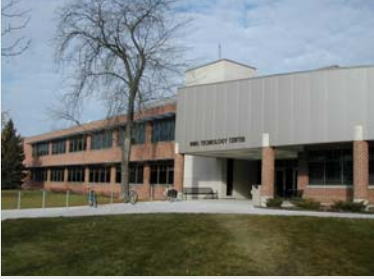
The building roof is leaking and holding water in the layers of insulation and needs to be replaced.

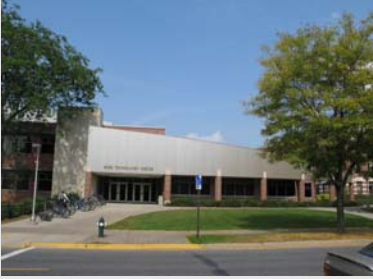
Building Name	WING TECHNOLOGY CENTER ADDITION					
Building No.	285-0E-0002A					
Building Type	ACADEMIC, DRY LAB					
Constructed Addition(s)	1999	Floors	AG 1	UG 1

The building roof is leaking and holding water in the layers of insulation and needs to be replaced.

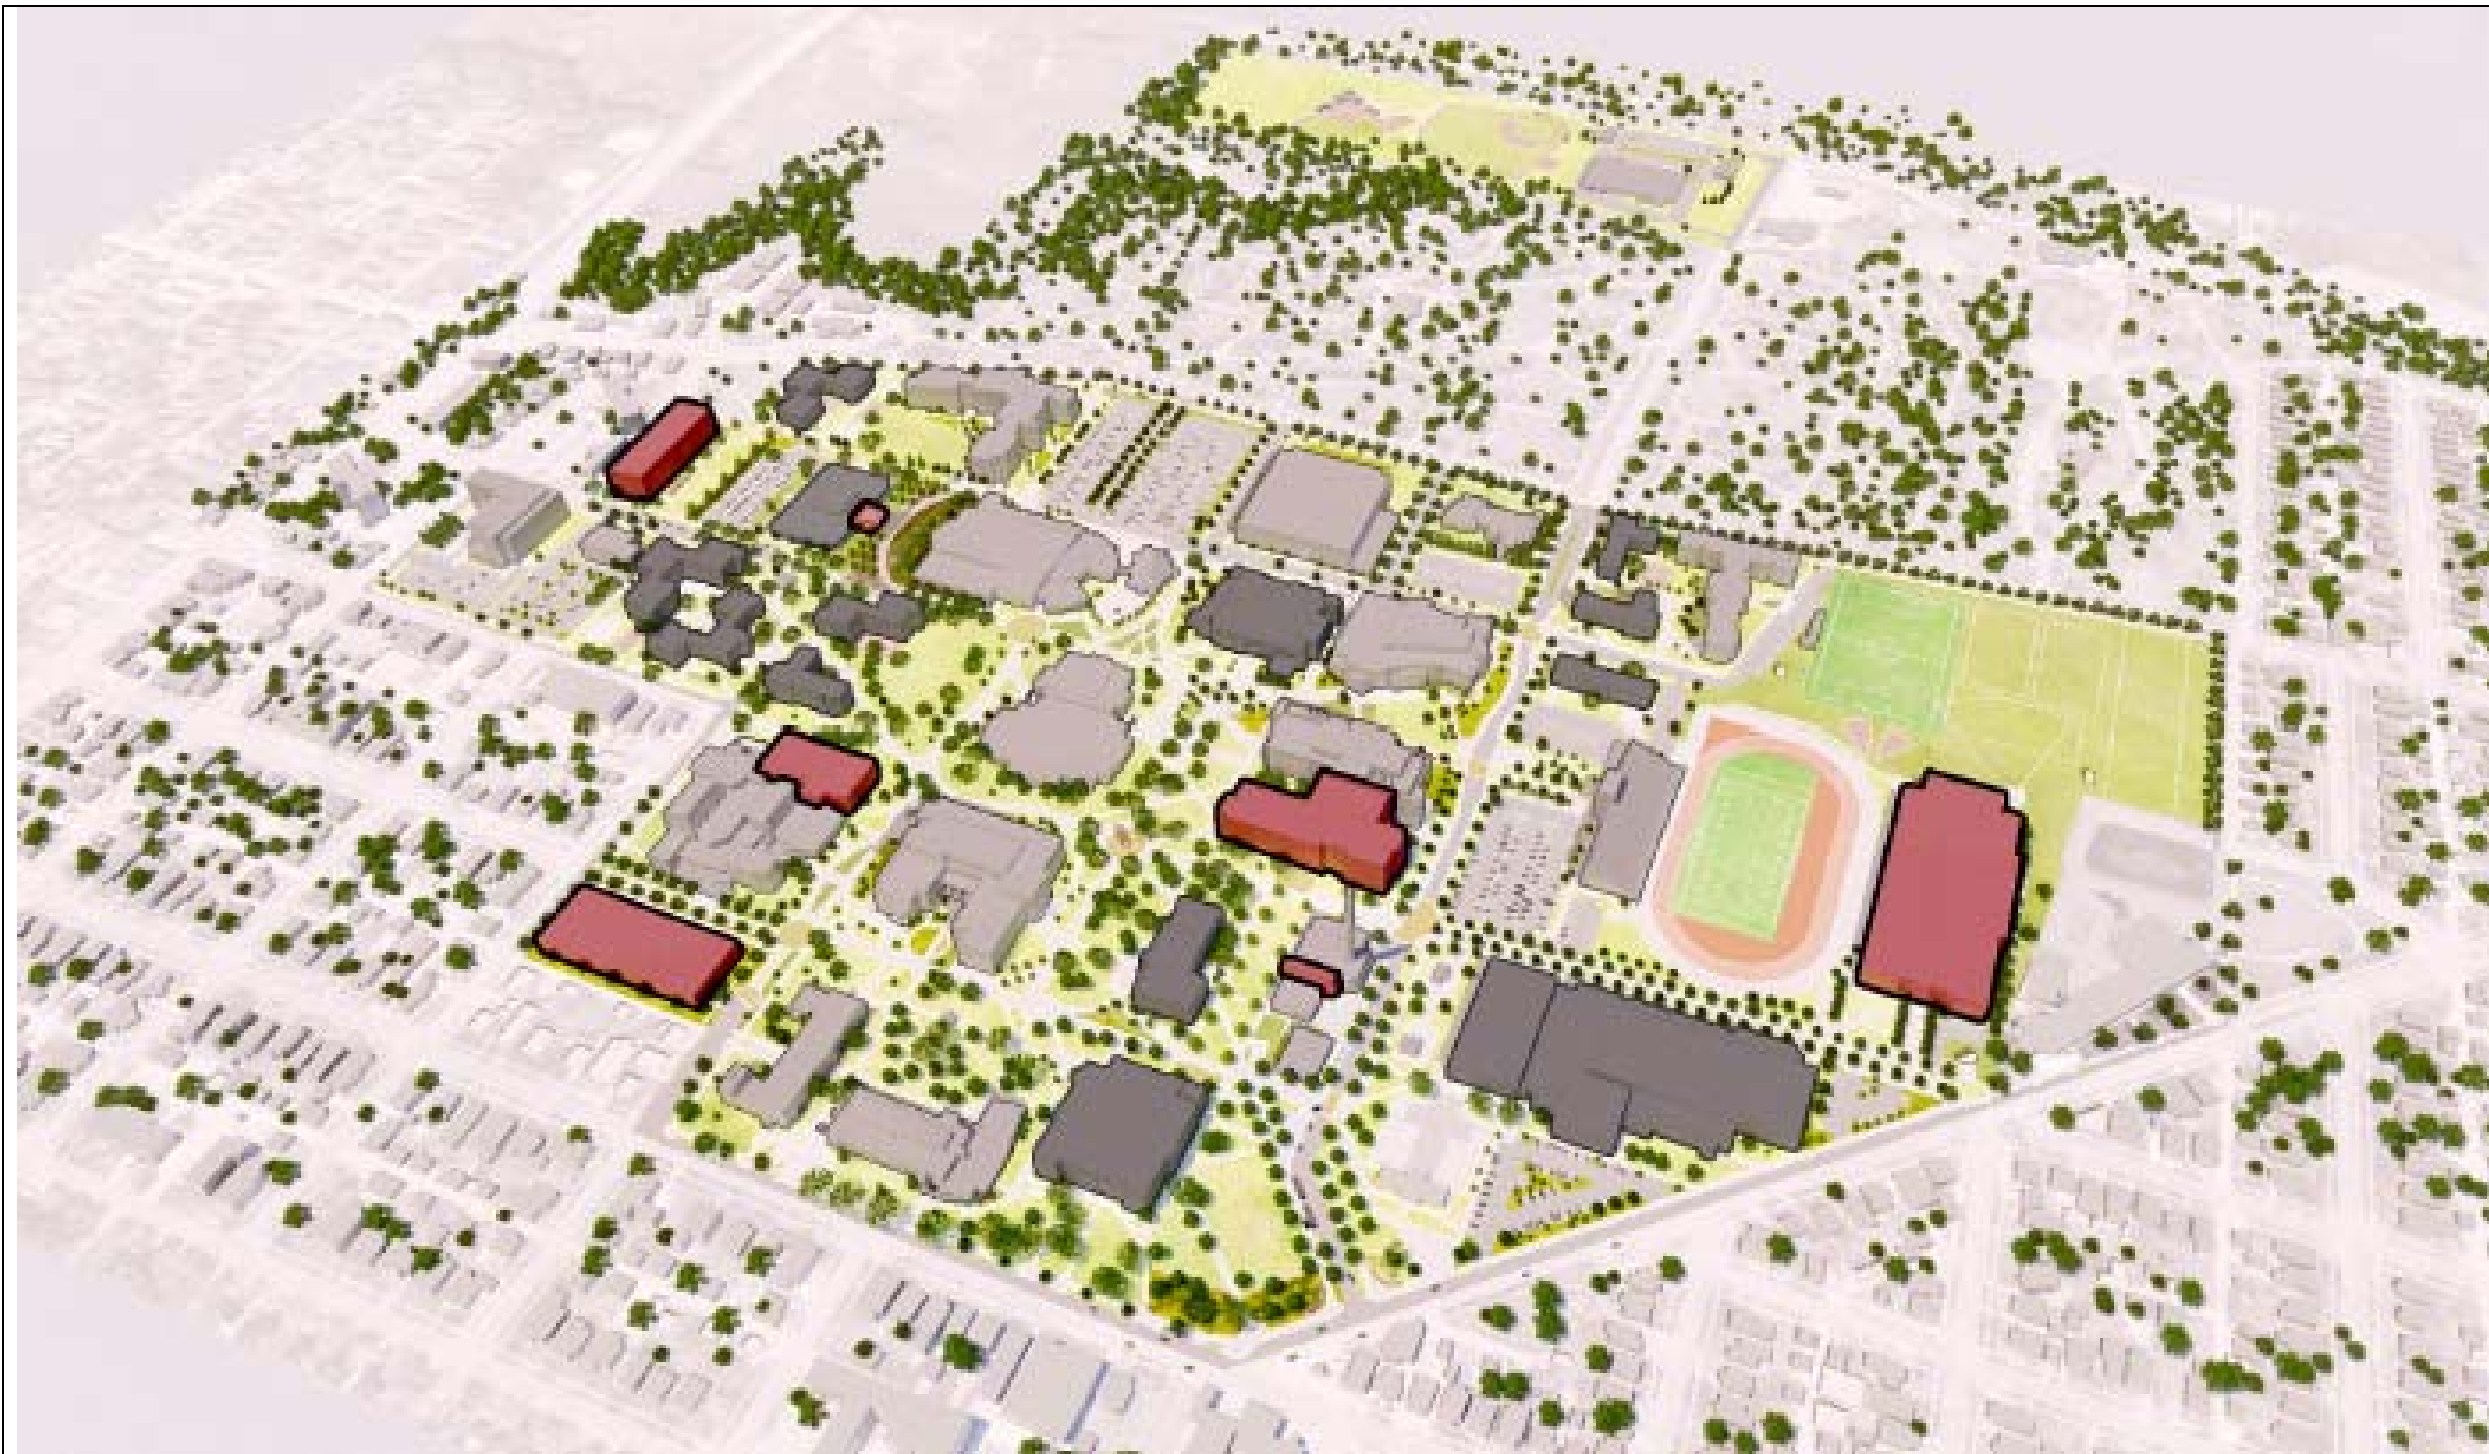
The illustration shown at left is the updated UWL Master Plan. The 2018 Campus Master Plan Update seeks to continue to build a modern UW-La Crosse campus that is an attractive learning environment for our students, faculty, staff, and host community. The master plan update will improve facilities through the construction of modern classrooms and state-of-the-art laboratories, within both modern buildings and adaptive reuse of historic structures. Residence halls will be renovated and new athletic and recreation facilities will be constructed. The campus master plan update seeks to maintain the UW-La Crosse campus as the pride of La Crosse and western Wisconsin.
