# CAMPUS PHYSICAL DEVELOPMENT PLAN

2023 – 29 Capital Budget

University of Wisconsin – La Crosse  
July 1, 2022

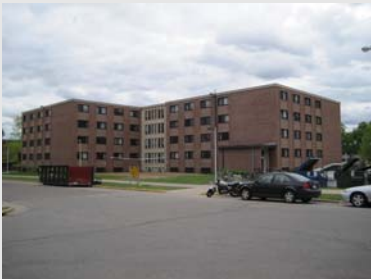
<b>Building Name</b>	ANGELL HALL

Building is not ADA compliant. Building is not equipped with fire suppression system. Building contains large amount of ACM flooring. As the tiles and mastic deteriorate, tiles break, and flooring material can become friable. Replacement currently occurs on a "case by case" basis.

The building plumbing system (both supply and sanitary waste) is constructed of galvanized piping, so leak problems could occur in the future.

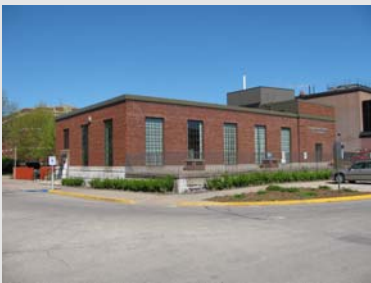
There are some issues with water infiltration at the building perimeter.

The caulk joints and seals on the windows are failing, allowing moisture infiltration.

Building water heater is experiencing frequent maintenance issues. Will require replacement.

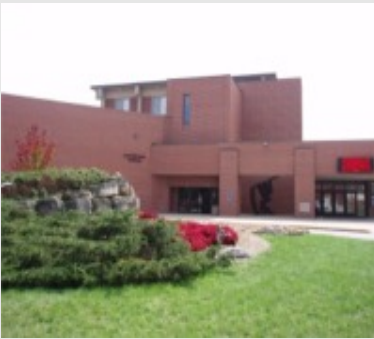
<b>Building Name</b>	CARTWRIGHT CENTER

The building has one aging passenger elevator. There is ACM flooring, spray-on ceiling acoustical treatment and pipe insulation in the building, and due to the age of these materials, it takes little disturbance of them to cause the material to become friable.

The building and its two additions consist of multiple levels that do not match on many floors. A series of stairs and ramps provide access between the levels; however, this makes ADA accessibility difficult to achieve. The finishes are mostly original to the building, and as such, are dated and worn out.

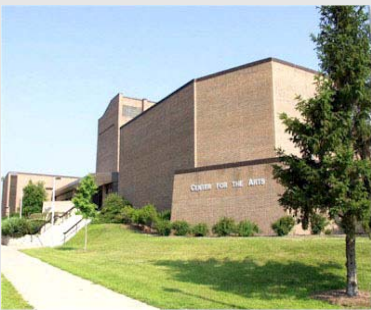
The building is not fully ADA compliant. In addition, the metal sculpture and ceramic lab areas are not compliant with current fire codes. The stairwell handrails are not compliant with current code and could pose potential fall hazards.

The interior finishes in the building are original to the construction of the facility. They are well beyond their expected life and require replacement. The sections of casework in the various art labs are in an advanced state of deterioration and need replacement.

The emergency generator is aging, and the emergency service is at its maximum capacity. Both should be replaced and upgraded.

Acid waste lines in art labs require replacement. Pipes are approximately 50% full and experience back-ups. Sink and faucet fixtures in art labs require replacement. Water heater in building is original and is experiencing increased maintenance issues. Water service main experienced a leak and was subsequently patch. This will require a total replacement.

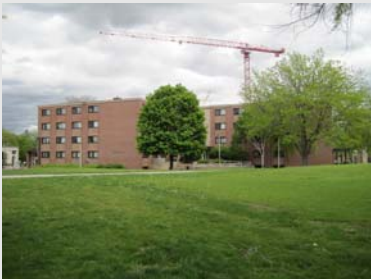
<b>Building Name</b>	COATE HALL

<b>Building No.</b>	285-0E-0071						
<b>Building Type</b>	HOUSING, DORMITORY						
<b>Constructed Addition(s)</b>	1966	<b>Floors</b>		<b>AG</b>	<b>UG</b>		
				4	1		
<b>ASF</b>	48,344	<b>GSF</b>	76,527	<b>GPR</b>	0 %	<b>PR</b>	100 %
<b>CENTRAL UTILITY CONNECTIONS</b>				<b>HISTORICAL</b>			
<b>CW</b>	<input type="checkbox"/>	<b>ELEC</b>	<input checked="" type="checkbox"/>	<b>C. AIR</b>	<input type="checkbox"/>	<b>US</b>	<input type="checkbox"/>
<b>HPS</b>	<input checked="" type="checkbox"/>	<b>FIBER</b>	<input checked="" type="checkbox"/>	<b>N. GAS</b>	<input type="checkbox"/>	<b>WI</b>	<input type="checkbox"/>
<b>WATER</b>	<input type="checkbox"/>	<b>SEWER</b>	<input type="checkbox"/>				
<b>D</b>				<b>FUNCTIONAL RATING</b>			<b>PHYSICAL RATING</b>
							iv
<i>Building Profile ratings based on the Postsecondary Education Facilities Inventory and Classification Manual (FICM): 2006 Edition</i>

Building equipment is original to construction. Furnishings are continually being replaced by Resident Life as budget allows.

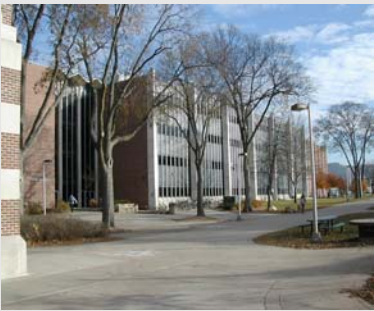
<b>Building Name</b> COWLEY HALL

<b>Background and History</b> Cowley Hall was built in 1965 as the campus science building. The building was named after Milford Cowley, a long-time chairperson of the chemistry department. It received office and lab/classroom additions in 1969 and 1970. No significant capital has been invested in the facility since then. It still serves as the campus science building, for dry labs, classrooms and faculty offices.			<b>Architectural</b> The windows are original to the building. They are single pane; they leak excessively and are not energy efficient. The roof and curtain wall system at the green house portion of the building leak continuously. Water is penetrating the building on the south wall and is evident on the wall of large lecture halls. The exterior slate panels on the north side of the building are and deteriorated.		
<b>Occupant(s) and Use(s)</b> Multiple departments in the physical and life sciences, along with labs and classrooms occupy the building. It is the building that was used to teach all basic and graduate programs in the physical sciences prior to the completion of Prairie Springs Science Center.			<b>Mechanical</b> Mechanical systems are supporting activities that they were not designed to support. Condensing units that provide AC for specialized areas are not energy efficient. Building contains multiple individual cooling systems to serve unique needs that have evolved since installation of units. A considerable number of systems beyond useful life. Controls need updating.

<b>Code and Health/Safety</b> The existing finishes in the building contain lead paint and asbestos. The building is not ADA compliant. The existing pipe coverings contain asbestos and mold. The fire shutters separating the hallways from the stairwells are nonfunctioning.			<b>Conveying</b> Elevators were refurbished but both are slow, and neither are fully ADA compliant.		
			<b>Equipment and Furnishings</b> Most casework, furnishings, and other equipment are original to the building and need replacement as they are completely worn out. Some new furnishings and casework have been purchased through Lab and Classroom Mod program.

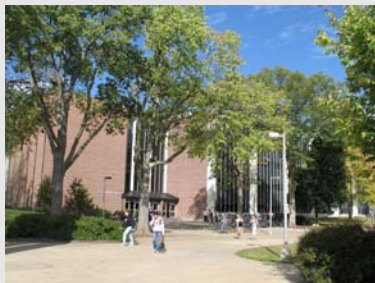
<b>F</b>	<b>FUNCTIONAL RATING</b>	<b>PHYSICAL RATING</b>	<b>vi</b>
----------	--------------------------	------------------------	-----------

Most casework, furnishings, and other equipment are original to the building and need replacement as they are completely worn out. Some new furnishings and casework have been purchased through Lab and Classroom Mod program.

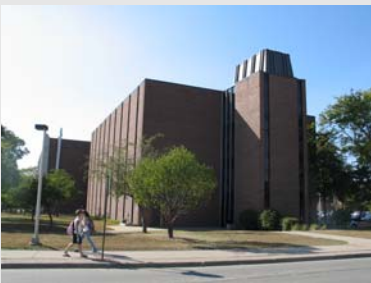
<b>Building Name</b>	COWLEY HALL ADDITION

<b>F</b>	<b>FUNCTIONAL RATING</b>	<b>PHYSICAL RATING</b>	<b>vi</b>
<i>Building Profile ratings based on the Postsecondary Education Facilities Inventory and Classification Manual (FICM): 2006 Edition</i>

Most casework, furnishings, and other equipment are original to the building and need replacement as they are completely worn out. Some new furnishings and casework have been purchased through Lab and Classroom Mod program.

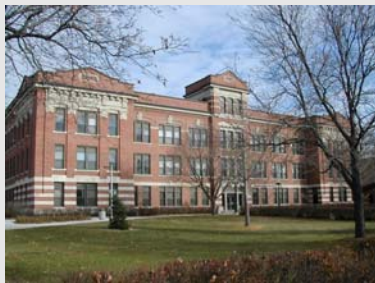
<b>C</b>	<b>FUNCTIONAL RATING</b>	<b>PHYSICAL RATING</b>	<b>iv</b>
Building Profile ratings based on the Postsecondary Education Facilities Inventory and Classification Manual (FICM): 2006 Edition

As with all university buildings, the equipment and furnishings are replaced with operational funds when available. However, as budgets are tight, the building contains a large amount of equipment and furnishings that are well beyond their expected life.

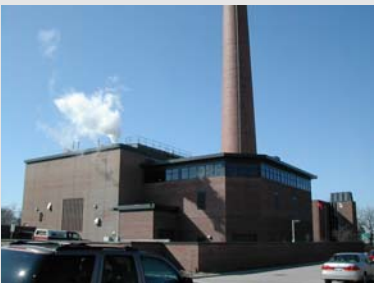
<b>Building Name</b>	HEATING PLANT ADDITION - BAGHOUSE

The baghouse has been removed from service as part of the Fuel Reliability Project. The plan is to investigate placing an additional/replacement boiler in the space in a future biennium.

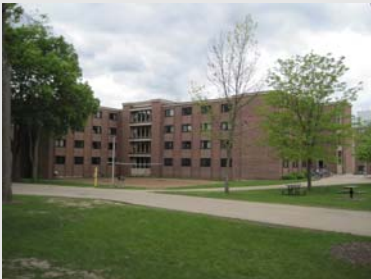
<b>Building Name</b>	HUTCHISON HALL

Building functions as a first-year style residence hall, but the condition and relative function in comparison to the newer halls on Campus have deteriorated to a level that is inappropriate because it will cause harm to the quality and effectiveness of the Residence Life program and may impact enrollment growth.

Building is not ADA compliant. Building is not equipped with fire suppression system. Building contains large amount of ACM flooring. As the tiles and mastic deteriorate, tiles break, and flooring material can become friable. Replacement currently occurs on a "case by case" basis.

Building is designed and functions as a basic 1960's first-year style residence hall. The bedrooms are small, the bathrooms and showers are small and not private or semi-private, and study spaces are small and inadequate in comparison to modern residence halls.

The building plumbing system (both supply and sanitary waste) is constructed of galvanized piping, so leak problems could occur in the future.

Building equipment is original to construction. Furnishings are continually being replaced by Resident Life as budget allows.

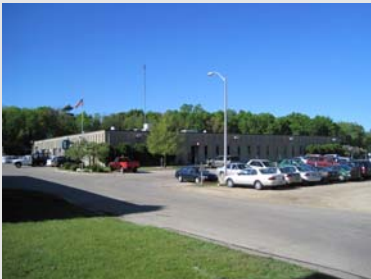
<b>Building Name</b>	MAINTENANCE & STORES BUILDING

The building hollow metal doors are also rusted and deteriorated to the point they are allowing air and moisture penetration to the building.

The building's HVAC system is not connected to the campus steam and chilled water loop due the building's distance from the main campus. All HVAC equipment is original to the construction of the building and is starting to experience increased maintenance issues. It is anticipated the replacement of components of the HVAC system will be warranted in coming biennia. The casing on the back-up boiler is cracked, making operation dangerous.

The university continues to replace equipment necessary to the operations of the physical plant out of operational funds as they are available.

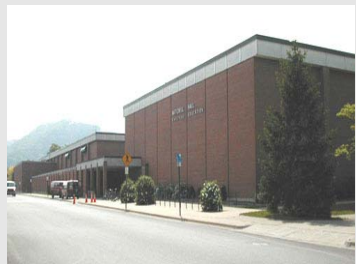
The floor and wall finishes are well beyond their expected life. The gymnasium wood floor has many areas of repair, and some planks are loose. The hollow metal doors and frames are rusting to the point they are allowing air and moisture penetration into the building. The existing windows are single pane, not energy efficient and the moving mechanical parts no longer function on them. The finishes in the existing restrooms should be upgraded.

The New Fieldhouse Project brought chilled water to the building, but did not create a functional building chilled water system. Multiple individual cooling systems serve various portions of the building. Some units need replacement. Some areas of building do not have cooling. Damper motors & control valves need to be replaced and upgraded to electric operation. Air handling system for pool area needs complete revision/overhaul, including reinstatement of heat recovery system that is currently offline.

It is difficult to provide the power required for the kinesiology and biomechanics labs. The emergency generator is aging, and the emergency service is at its maximum capacity. Both should be replaced and upgraded.

Much of the equipment and furnishings are well beyond expected life. Departments replace equipment and furnishings as budget carry over funds become available.

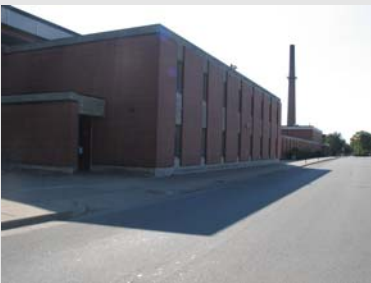
The floor and wall finishes are well beyond their expected life. The gymnasium wood floor has many areas of repair, and some planks are loose. The hollow metal doors and frames are rusting to the point they are allowing air and moisture penetration into the building. The existing windows are single pane, not energy efficient and the moving mechanical parts no longer function on them. The finishes in the existing restrooms should be upgraded.

The New Fieldhouse Project brought chilled water to the building, but did not create a functional building chilled water system. Multiple individual cooling systems serve various portions of the building. Some units need replacement. Some areas of building do not have cooling. Damper motors & control valves need to be replaced and upgraded to electric operation. Air handling system for pool area needs complete revision/overhaul, including reinstatement of heat recovery system that is currently offline.

It is difficult to provide the power required for the kinesiology and biomechanics labs. The emergency generator is aging, and the emergency service is at its maximum capacity. Both should be replaced and upgraded.

Much of the equipment and furnishings are well beyond expected life. Departments replace equipment and furnishings as budget carry over funds become available.

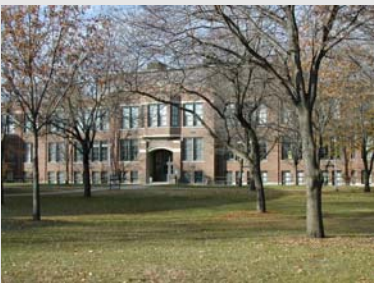
The emergency generator is aging, and the emergency service is at its maximum capacity. Both should be replaced and upgraded.

No known major issues with condition of elevator, but it is in an inconvenient location for access by members of the public who are utilizing the facility.

Much of the equipment and furnishings are well beyond expected life. Departments replace equipment and furnishings as budget carry over funds become available.

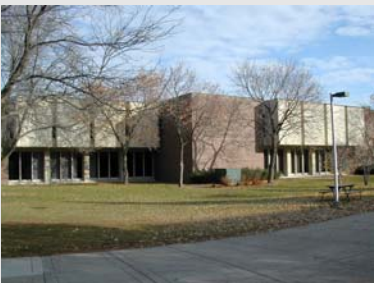
An exterior storm sewer issue caused major flooding incidents in the last couple of years, leading to an ongoing insurance claim issue. A project was recently completed to remedy the storm sewer issue.

Building finishes are aging and in need of upgrade or replacement.

Most of the building is served by three main air handlers that are original to the 1969 construction of the building. As such, valves, dampers, actuators, etc. are beginning to wear out and unscheduled maintenance on the systems is occurring with greater frequency. There is an ongoing issue with the heating hot water circulation in the building. In addition, some controls in the system are still original pneumatics that do not communicate with the campus EMS.

The emergency generator is aging, and the emergency service is at its maximum capacity. Both should be replaced and upgraded.

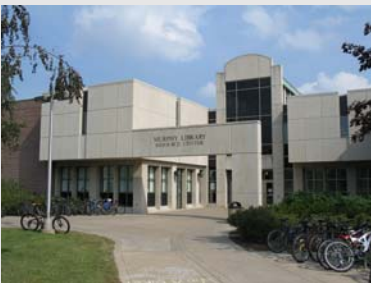
An exterior storm sewer issue caused major flooding incidents in the last couple of years, leading to an ongoing insurance claim issue. A project was recently completed to remedy the storm sewer issue.

Building finishes are aging and in need of upgrade or replacement.

The majority of the building is served by three main air handlers that are original to the 1969 construction of the building. As such, valves, dampers, actuators, etc. are beginning to wear out and unscheduled maintenance on the systems is occurring with greater frequency. There is an ongoing issue with the heating hot water circulation in the building. In addition, some controls in the system are still original pneumatics that do not communicate with the campus EMS.

The emergency generator is aging, and the emergency service is at its maximum capacity. Both should be replaced and upgraded.

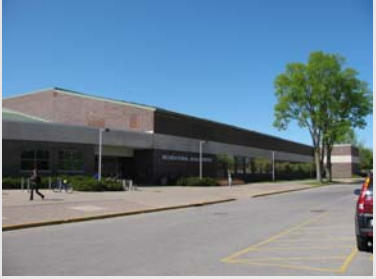
<b>Building Name</b>	RECREATIONAL EAGLE CENTER (REC)

There are no known major issues. Some of the finishes are aging and due for replacement or refreshing.

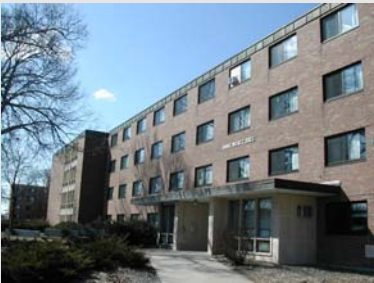
<b>Building Name</b>	WENTZ HALL

The elevator is in satisfactory condition but is not ADA compliant to current standards.

Building equipment is original to construction. Furnishings are continually being replaced by Resident Life as budget allows.

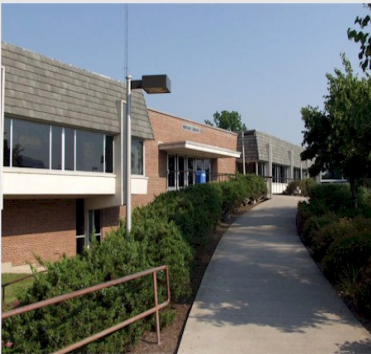
<b>Building Name</b>		WHITNEY CENTER

The windows are not energy efficient, the entrance doors leak, and daylight can be seen through the jambs.

The existing wood shakes on the mansard roofs are beginning to fail and are needing replacement with increased frequency.

The building has multiple air handlers, and they are all original to the building construction in 1967. The units are experiencing increased maintenance issues, especially with dampers and freeze stats. Rehabilitation and/or replacement of the units and other components of the system will be required in coming years.

Much of the foodservice equipment is outdated and subject to frequent failures and repairs.

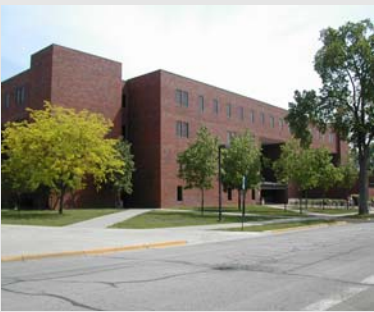
The building envelope will need repairs due to age and wear.

The finishes in the public spaces, offices, and many of the classrooms are well beyond their expected life and need replacement. Because the spray on ceiling finish contains asbestos, it is difficult to run IT and telecommunications cabling, change out light fixtures, etc.

The emergency generator is aging, and the emergency service is at its maximum capacity. Both should be replaced and upgraded.

Most of the equipment and furnishings are original to the construction of the building and so they are well beyond their expected life.

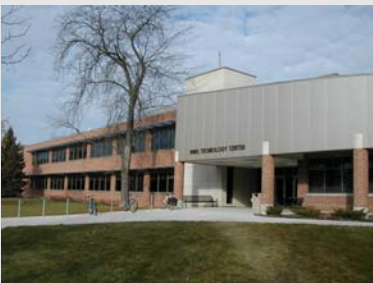
No known major issues.

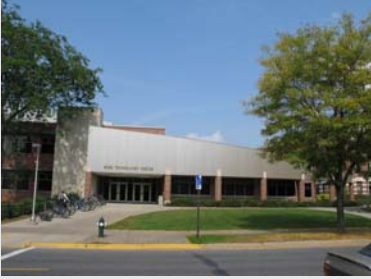
No known significant issues.

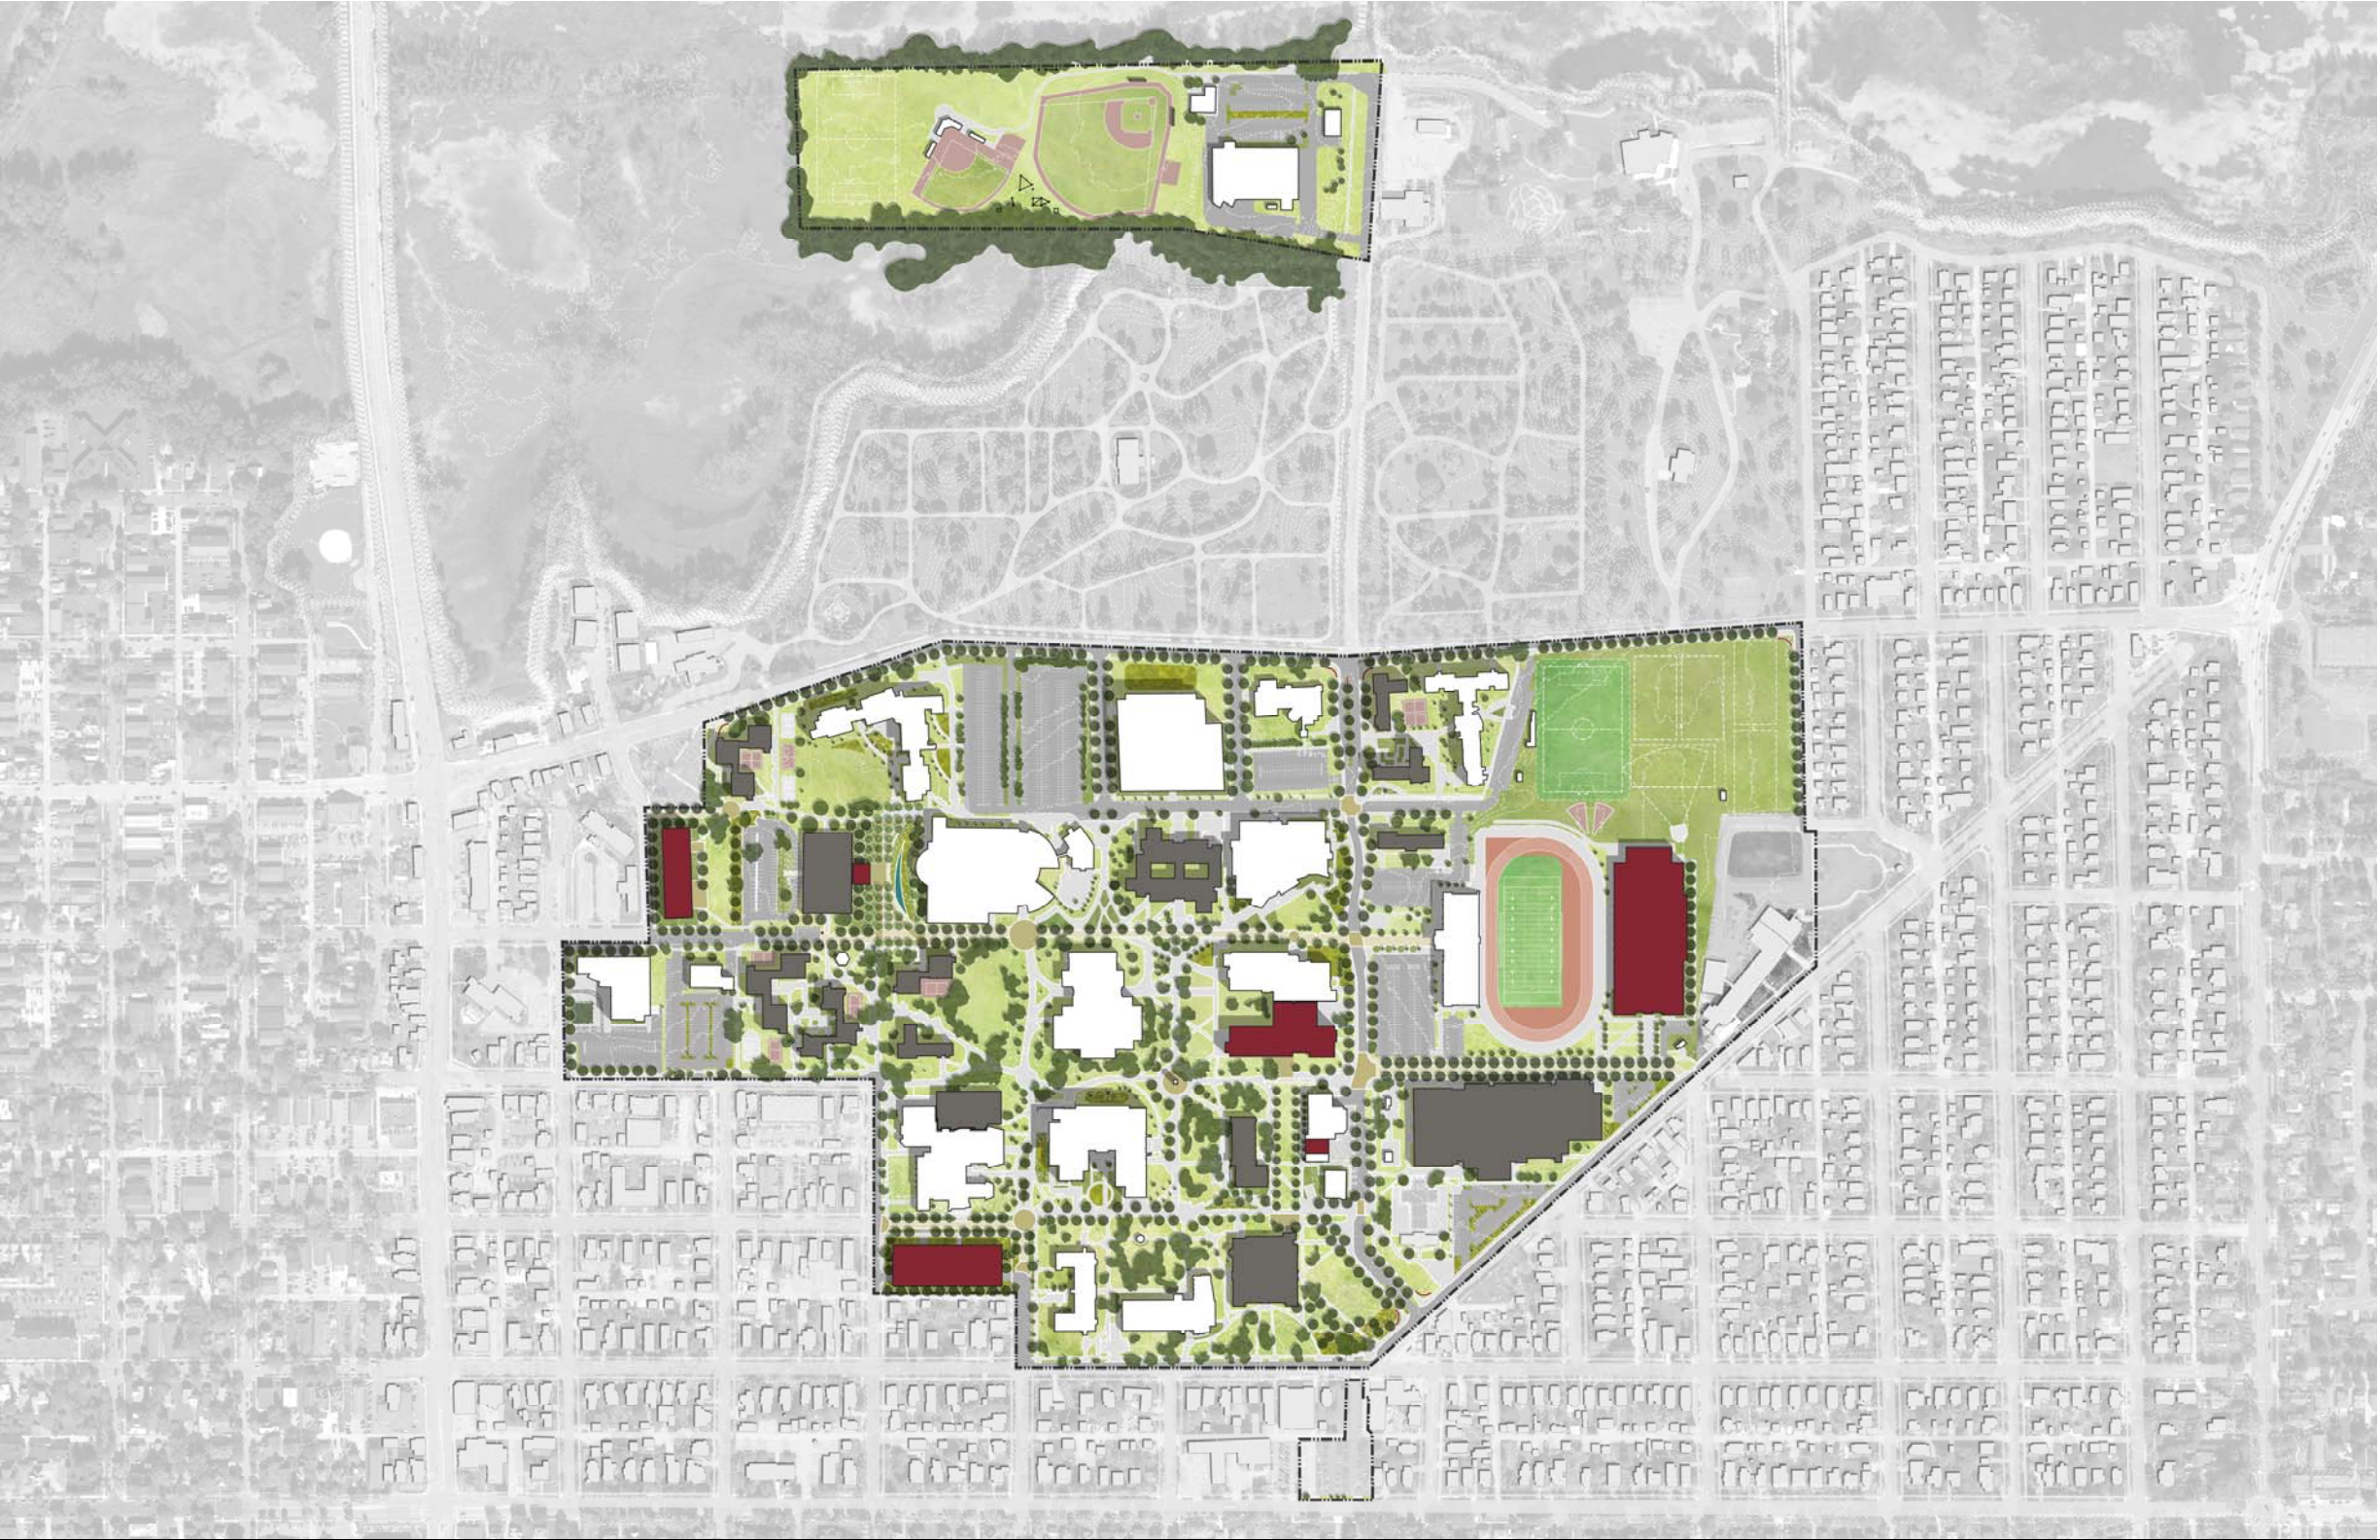
LONG-TERM DEVELOPMENT PLAN

The illustration shown at left is the updated UWL Master Plan. The 2018 Campus Master Plan Update seeks to continue to build a modern UW-La Crosse campus that is an attractive learning environment for our students, faculty, staff, and host community. The master plan update will improve facilities through the construction of modern classrooms and state-of-the-art laboratories, within both modern buildings and adaptive reuse of historic structures. Residence halls will be renovated, and new athletic and recreation facilities will be constructed. The campus master plan update seeks to maintain the UWL campus as the pride of La Crosse and western Wisconsin.
