MEETING NOTES

Meeting Date: Thursday, July 21, 2016 – 1:00pm – 2:30pm
 DFD Project Number: 14I2O
 Project: Wittich Hall Renovation
 Location: 153 Murphy, UW-La Crosse
 Purpose: Executive Committee Summary Meeting

EXECUTIVE COMMITTEE SUMMARY – 7/21

FACILITY CONDITION ASSESSMENT

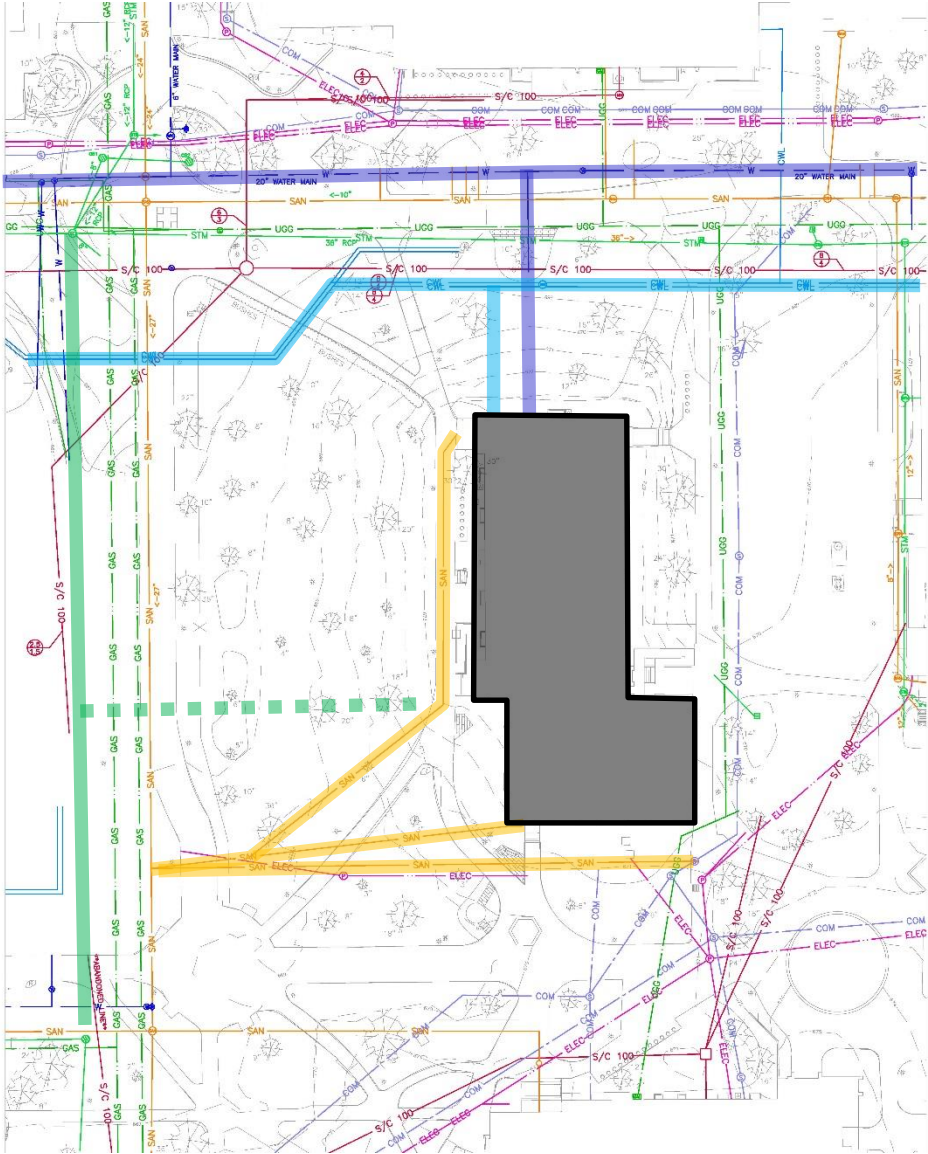
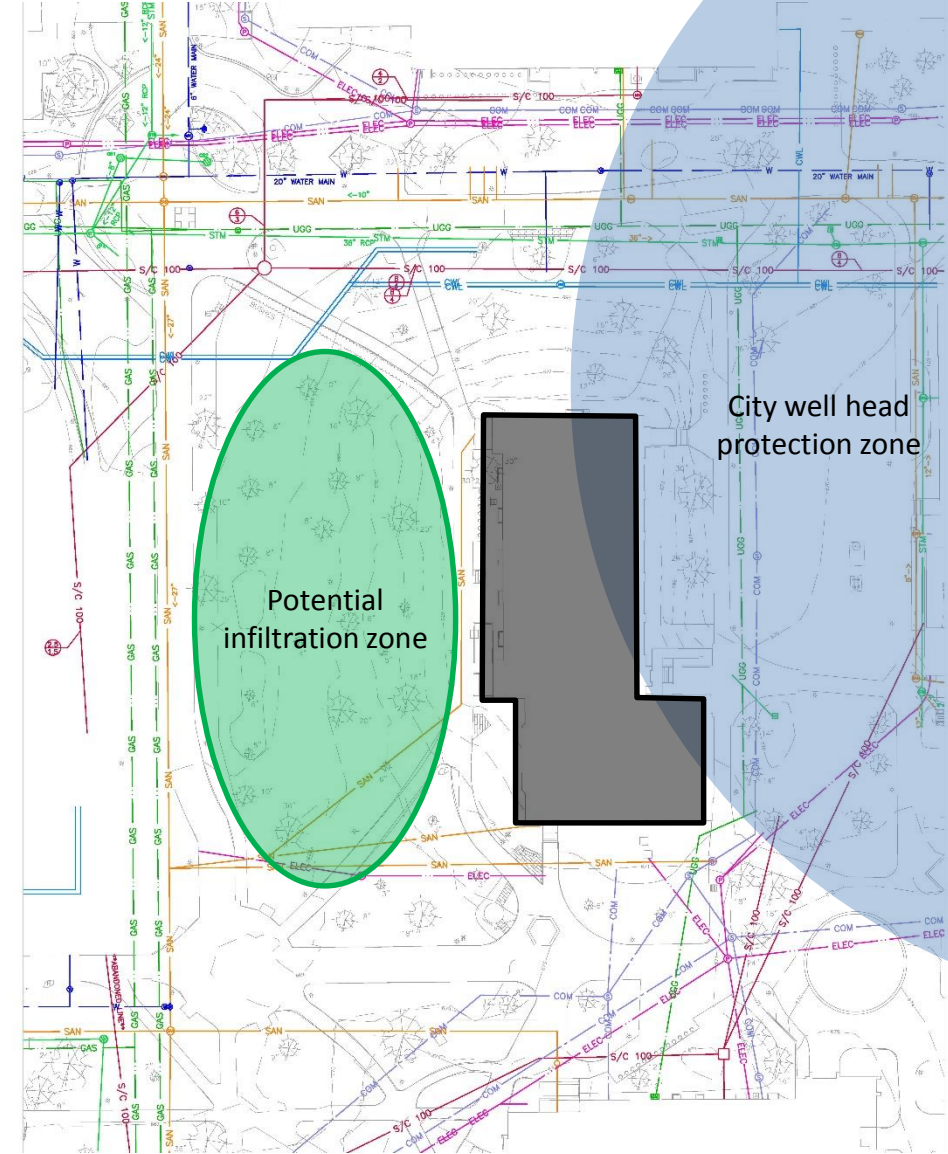
Site Utilities & Stormwater

- Water Main Original – Replace and add redundant feed.
- New Chilled water
- Sanitary and storm to be separated. Sanitary replaced
- Storm – explore rain gardens

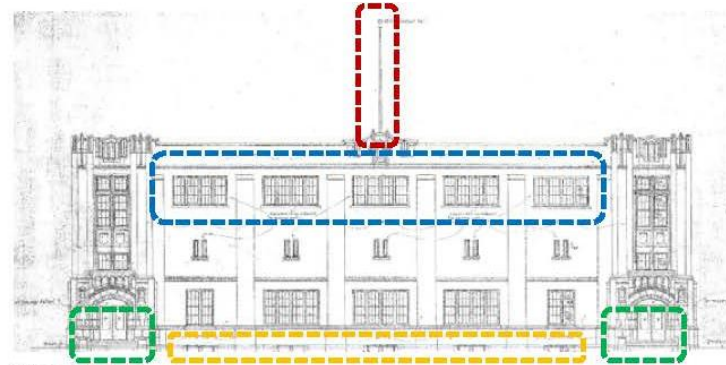
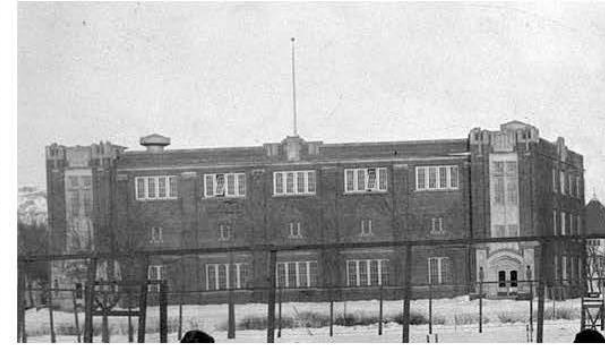
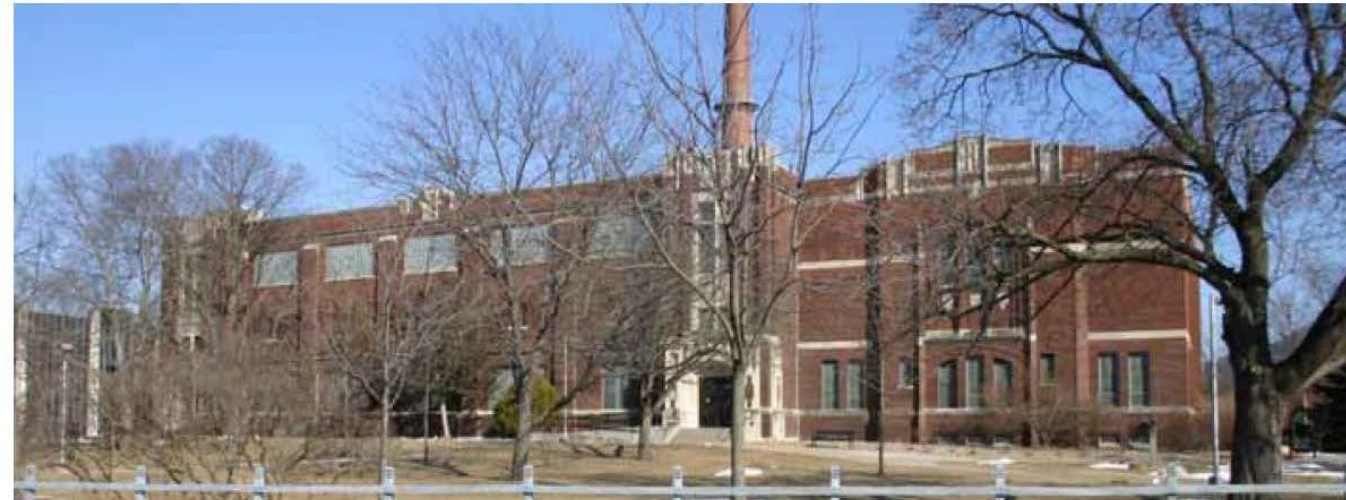
Then & Now - Exterior

- Track level windows have been replaced with glass block.
- Entrance doors have been replaced with aluminum storefront systems.
- Spire has been removed.
- Entrance stairs have been replaced.
- Seat walls have been removed.
- Wood screens appear to be intact.
- Wood windows at lower floors and stairs appear to be original.
- Lower level (sub-grade) windows have been replaced with glass block

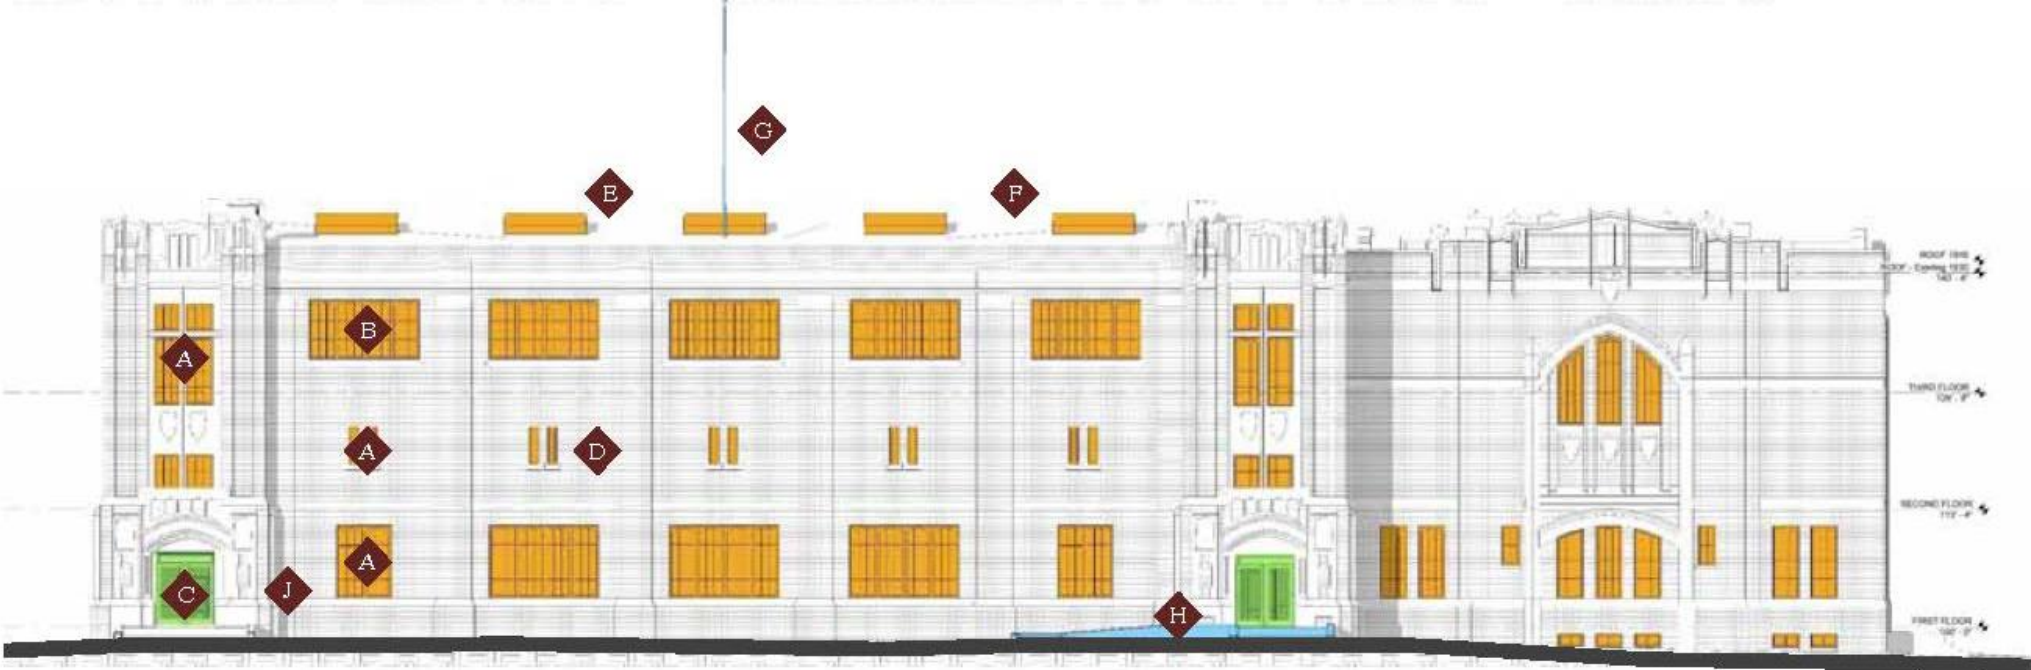
HISTORIC REVIEW – TREATMENTS & FOCUS – DRAFT

A	Replace wood window with metal clad wood windows – fixed double hung
B	Replace glass block windows with metal clad wood windows – fixed double hung
C	Replace aluminum storefront entrance with wood metal-clad wood entrance
D	Clean existing brick and limestone masonry

E	Restore/Recreate original skylights
F	Replace entire roofing system and flashings
G	Restore/Recreate original pole/spire
H	Remove existing concrete stair/ramp and recreate original seat walls
I	Screen windows?

J	Replace broken limestone panel
---	--------------------------------

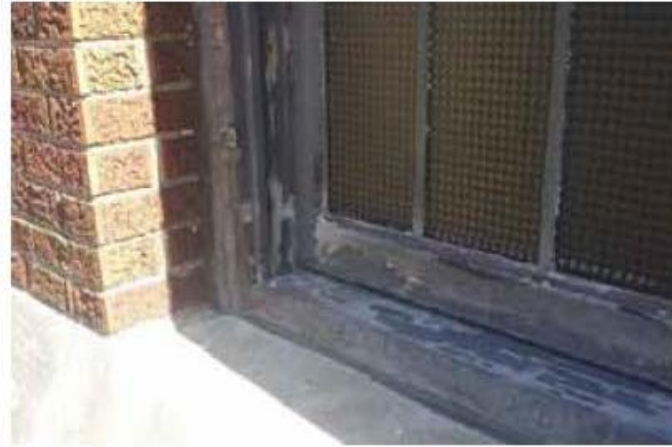
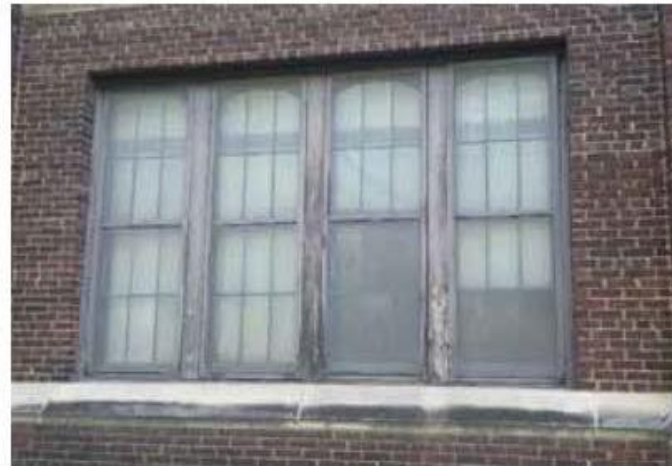
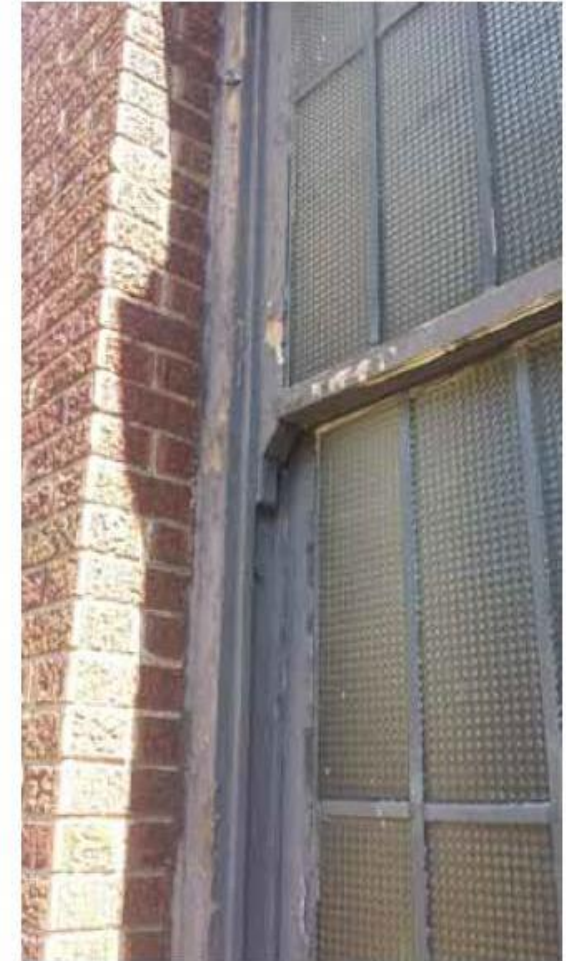
Exterior Treatments - Windows

- Restoration vs Replacement
- Operable vs In-operable
- Wood Only
- Metal-Clad Exterior/Wood Interior
- Screens
- Insulated Glass vs Single Pane
- Lead Paint Abatement?
- Asbestos Caulking?

- d. Windows for the building are not rotting, but the paint is peeling. We will have to see what the Historical Society says about what we need to do with these windows or if we can replace them or not.

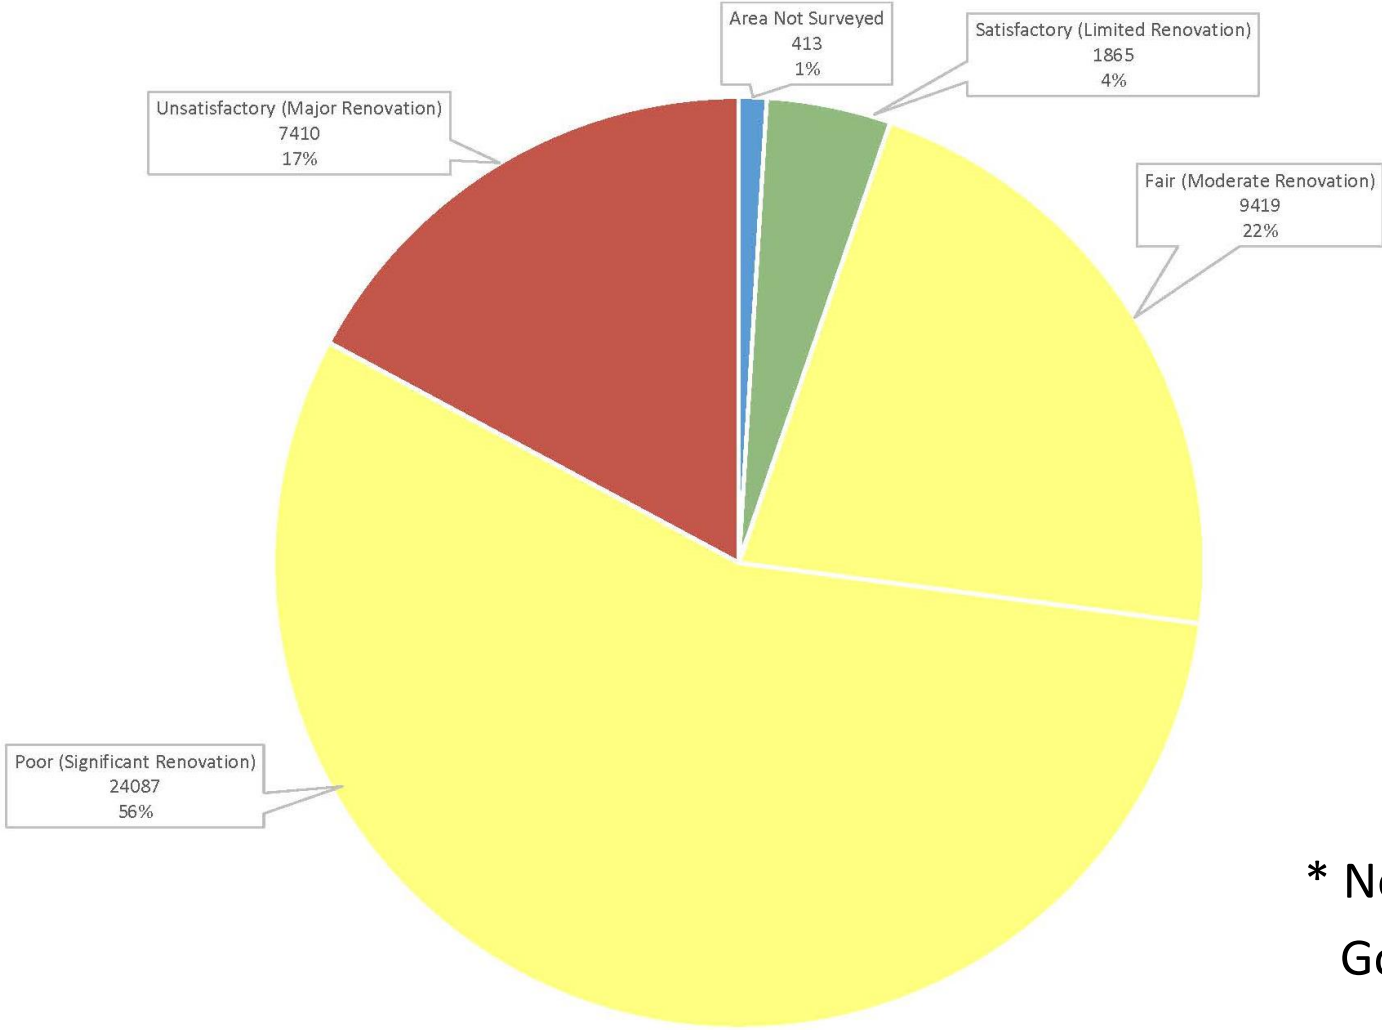
INTERIOR CONDITION

- d. The interior of the building is generally in poor condition. There are some materials in the building that have some value and may be repurposed in the new schemes.

* No spaces were listed as in Good Condition

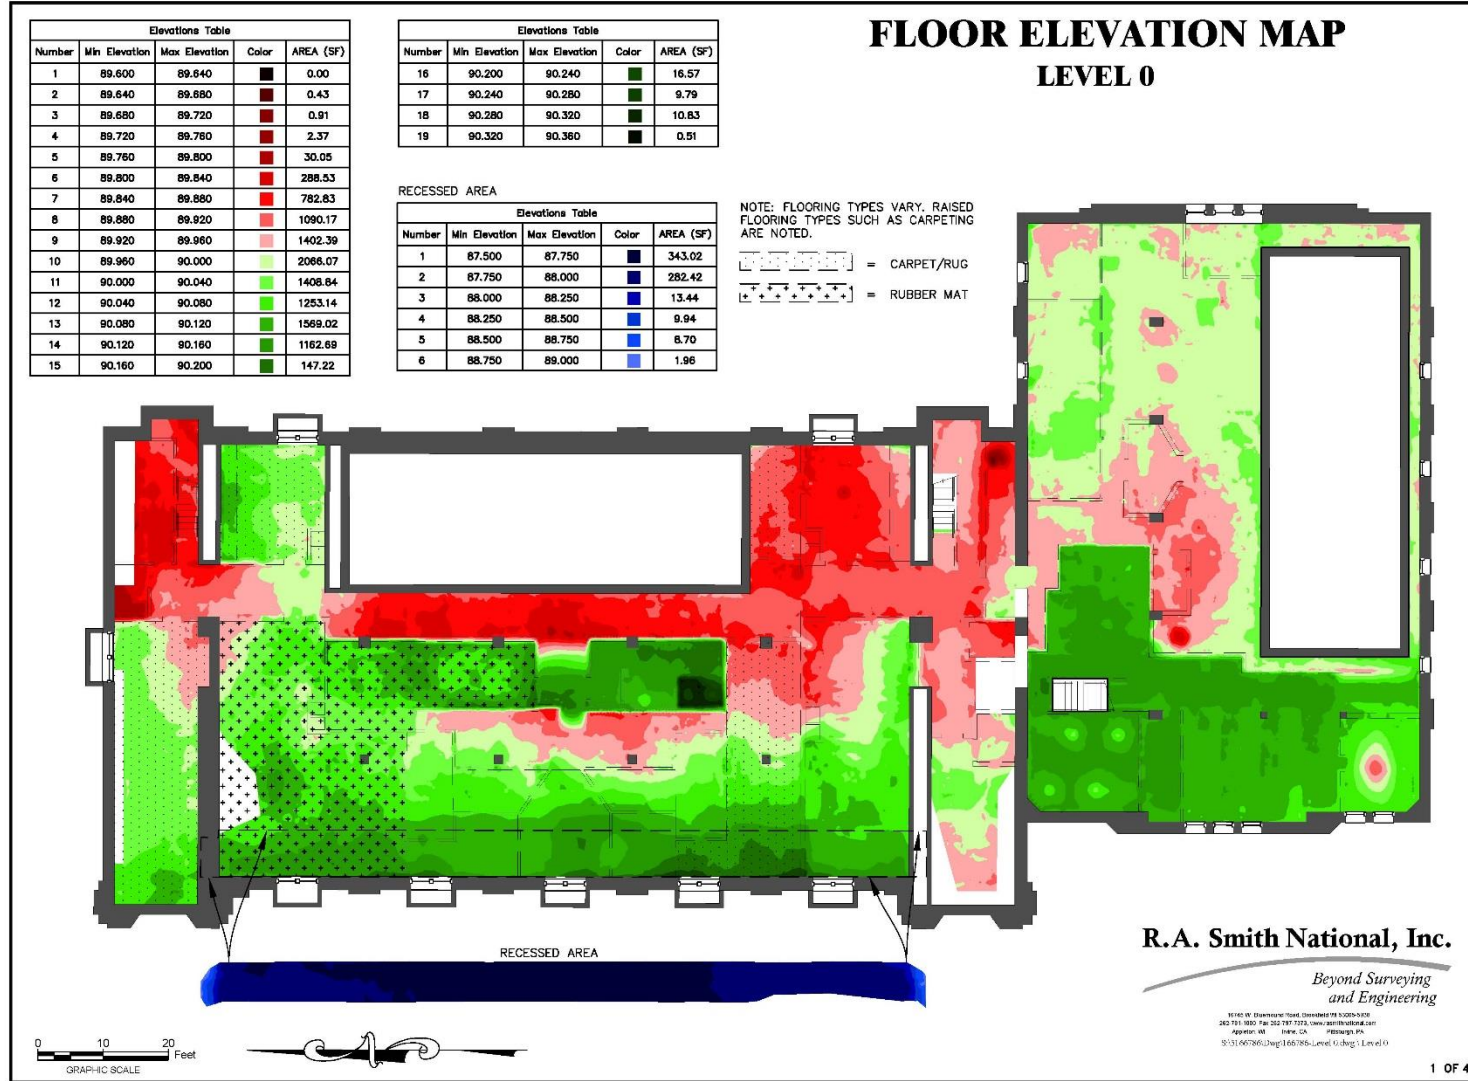
FACILITY CONDITION ASSESSMENT – FLOOR FLATNESS

- e. Floor flatness plans indicate no major issue on the upper levels. The lower level floors have a 4" pitch across the level. This may not be a huge issue with the amount of flooring that needs to be dug up to replace plumbing piping.

- Laser scans revealed level changes of 4" in a span of 40 feet in some locations of the Lower Level
- Some variation is due to existing floor finishes, rubber flooring in some spaces
- Depending on final floor finishes selected, leveling will need to be done to bring the building up to current standards. Portions of slab will be removed for underslab piping replacement.
