WISCONSIN HISTORICAL SOCIETY REVIEW 2 – 1/5/17

ARO EBERLE
ARCHITECTS

WITTICH HALL

WHS REVIEW 2 AGENDA

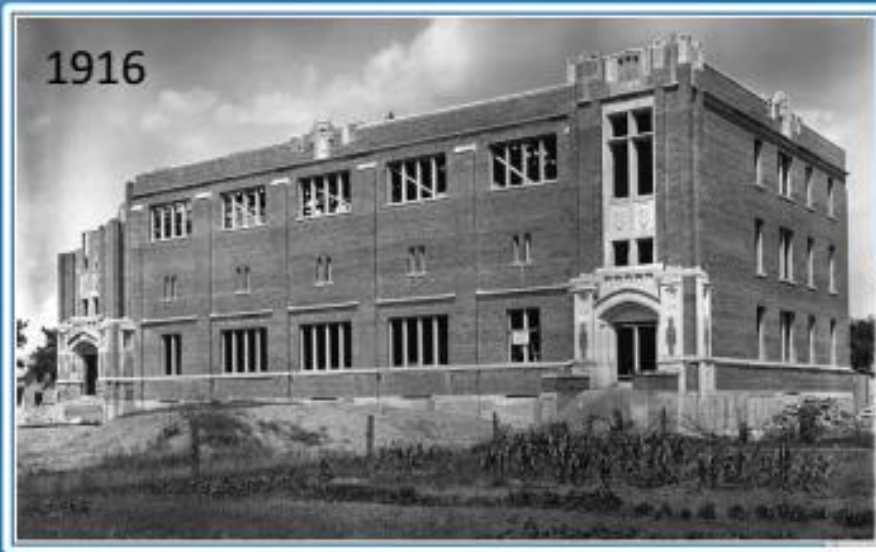
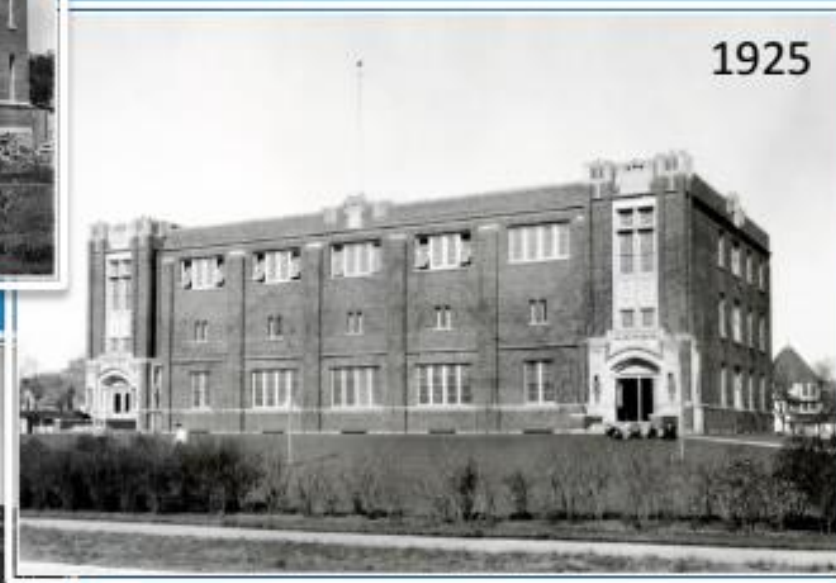
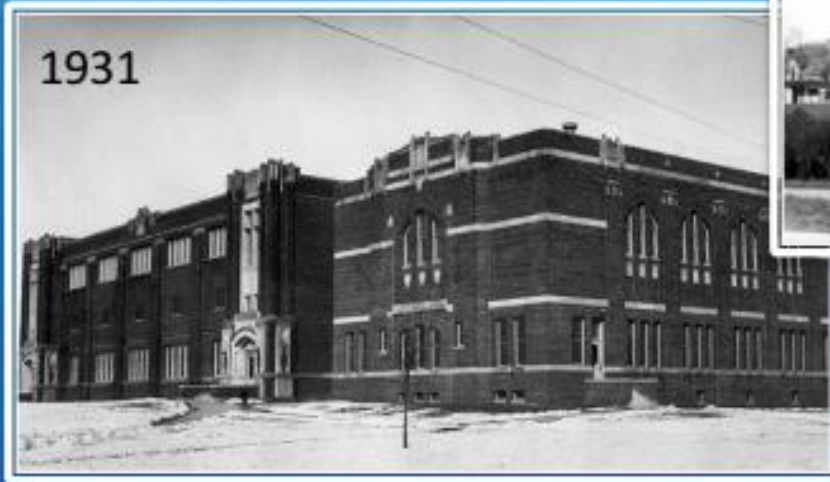
WEST ELEVATION – HISTORICAL PERSPECTIVE

Historical Context

1. Open views of building
2. Stately presence of building on a hill
3. Building is grounded

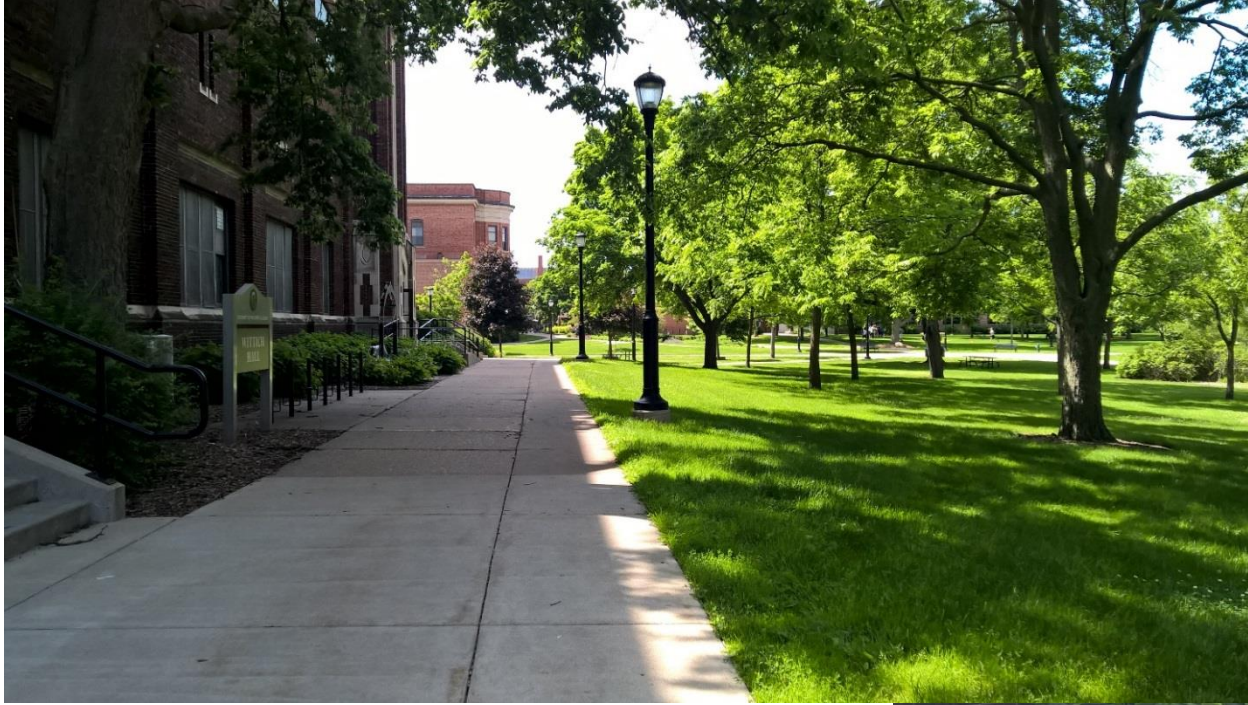
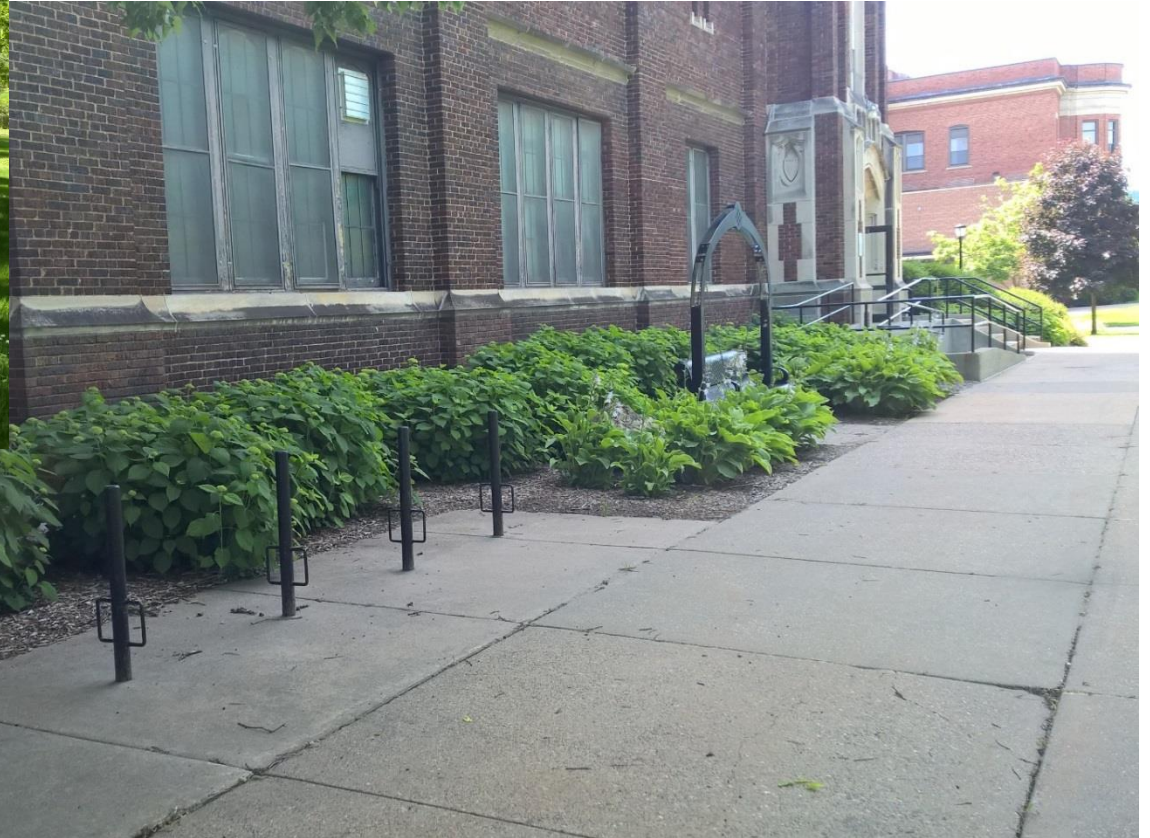
WEST FOUNDATION CURRENT

Current building is obscured by dense vegetation

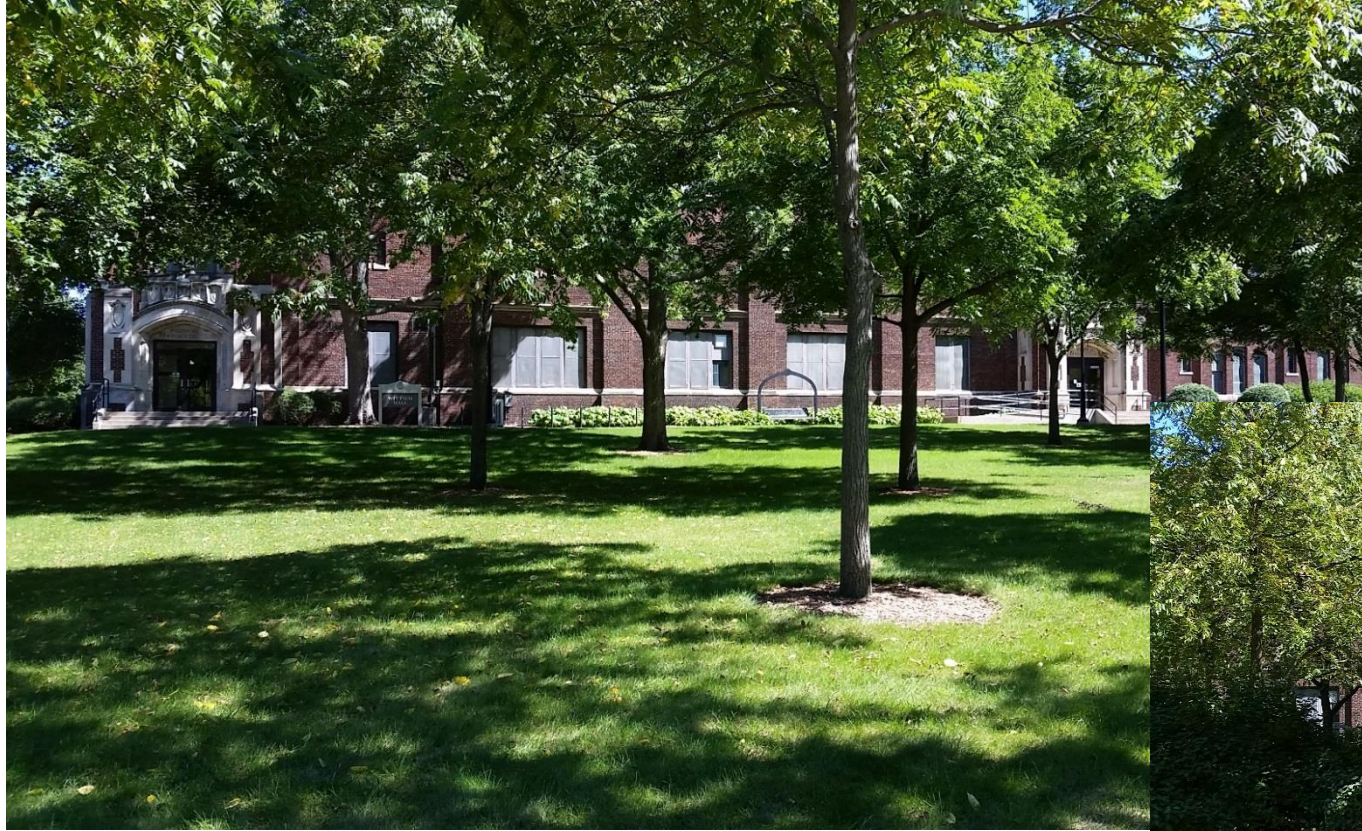
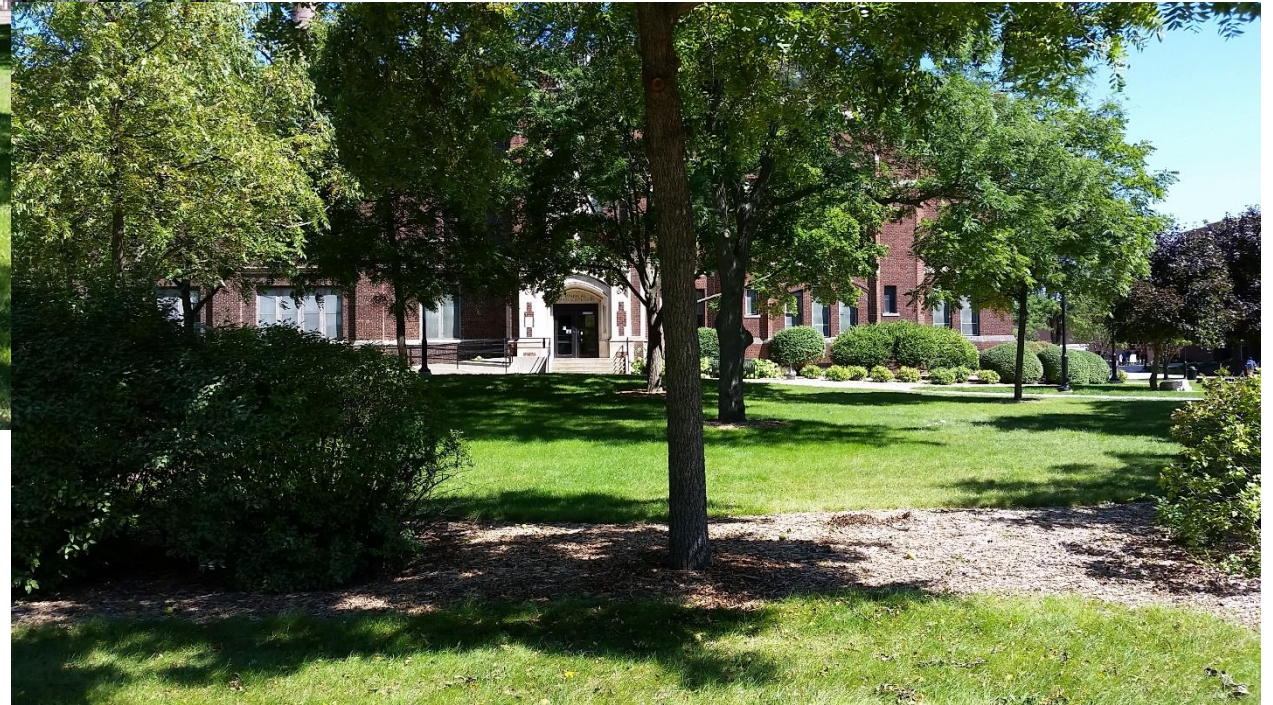
WEST ELEVATION – CURRENT VIEW FROM MALL

Current building is obscured by dense vegetation

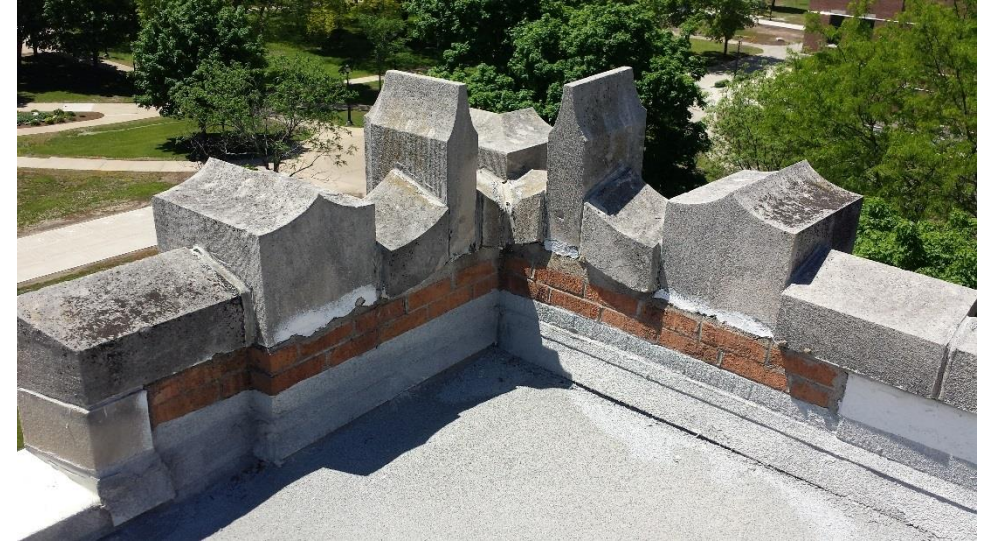
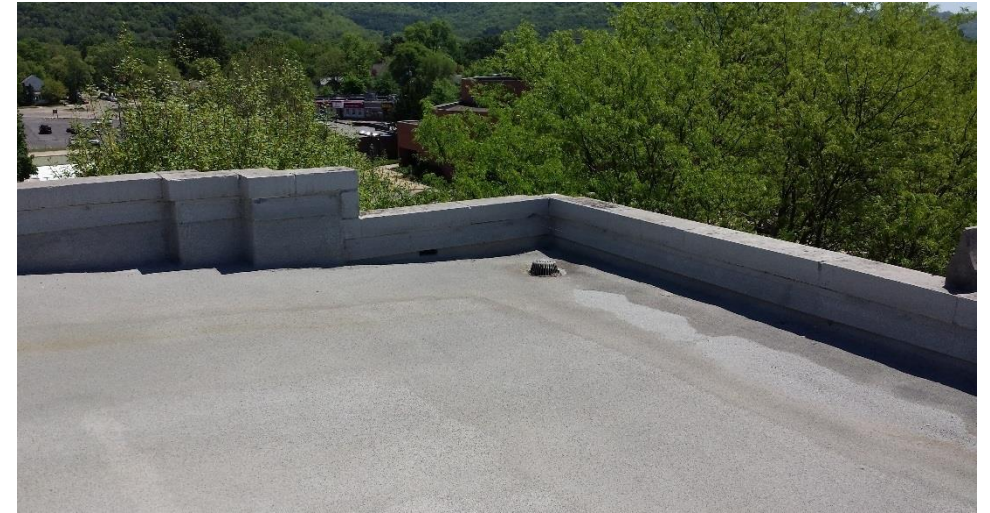
EXTERIOR RESTORATION/REHABILITATION - ROOFS

- Existing Construction (1916)
- Existing Construction (1930)
- Plaster Restoration @ Ceilings
- Proposed Scope
 - Complete Re-Roof
 - New Flashings
 - Added Insulation Thickness Where Possible
- Light Monitors
- Thermal Performance Evaluation

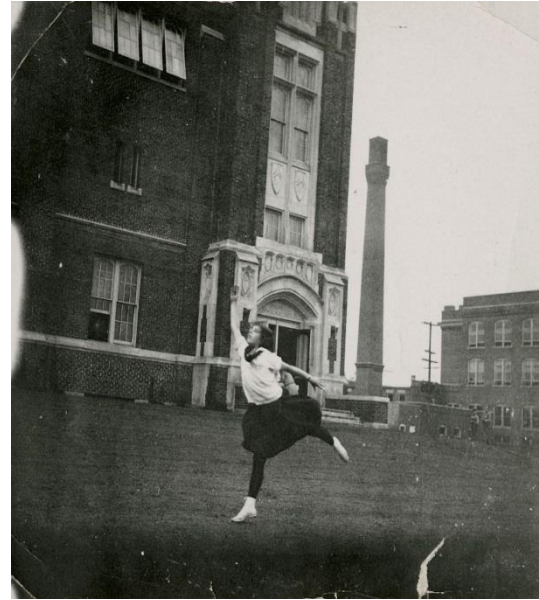
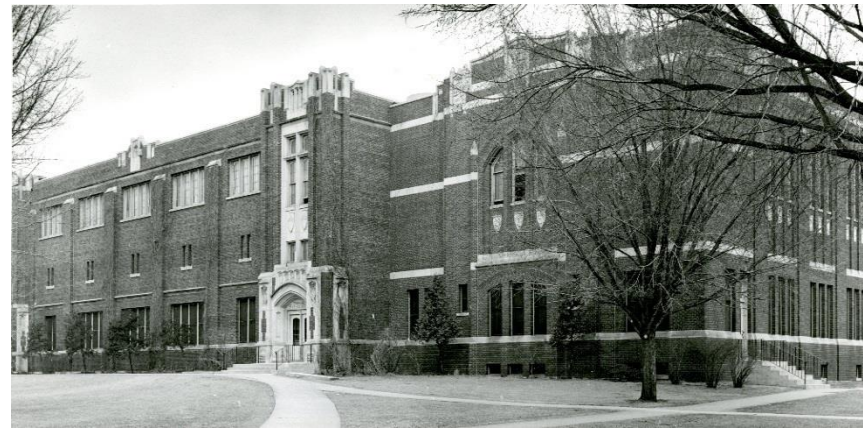
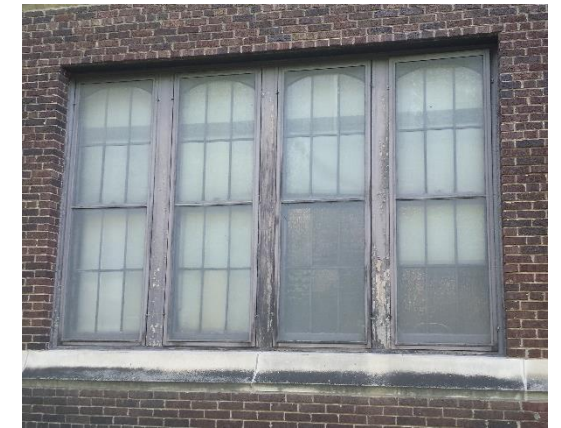
EXTERIOR RESTORATION/REHABILITATION - WINDOWS

- Window Evolution
- Replacements & Retrofits
 - Over 50% are Non-Original Units
- Historic Profiles
 - 1916 vs 1930
- Sash Lugs
 - 1930 Addition Only
- Glass Type
 - Clear (Diffused Original)
 - Visible Light Trans: 72%

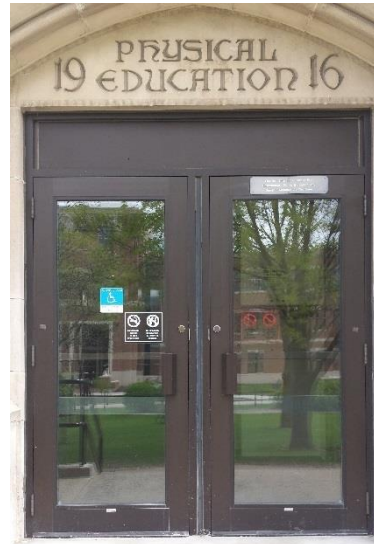
EXTERIOR RESTORATION/REHABILITATION - DOORS

- Existing Construction
- Historic Profiles
 - Exterior Casings
 - Interior Casings
- Proposed Scope
 - 100% Replacement
 - Metal-Clad Wood Doors

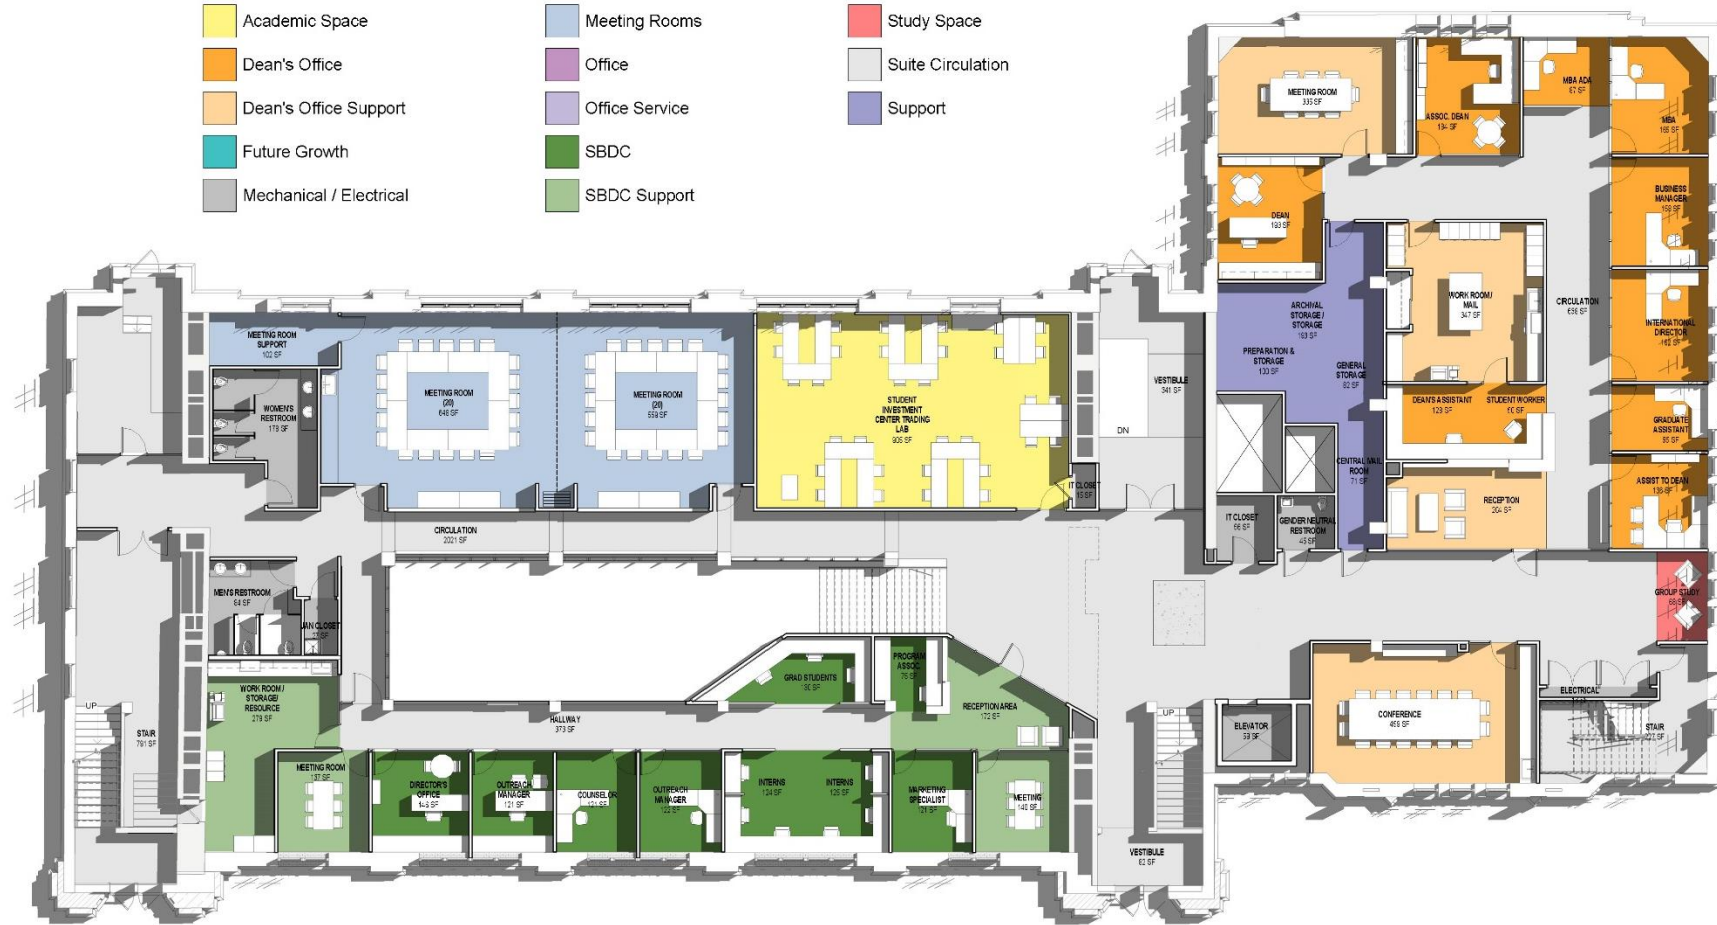
GROUND FLOOR

- | | | |

| Academic Space | Meeting Rooms | Study Space |
| Dean's Office | Office | Suite Circulation |
| Dean's Office Support | Office Service | Support |
| Future Growth | SBDC | |
| Mechanical / Electrical | SBDC Support | |

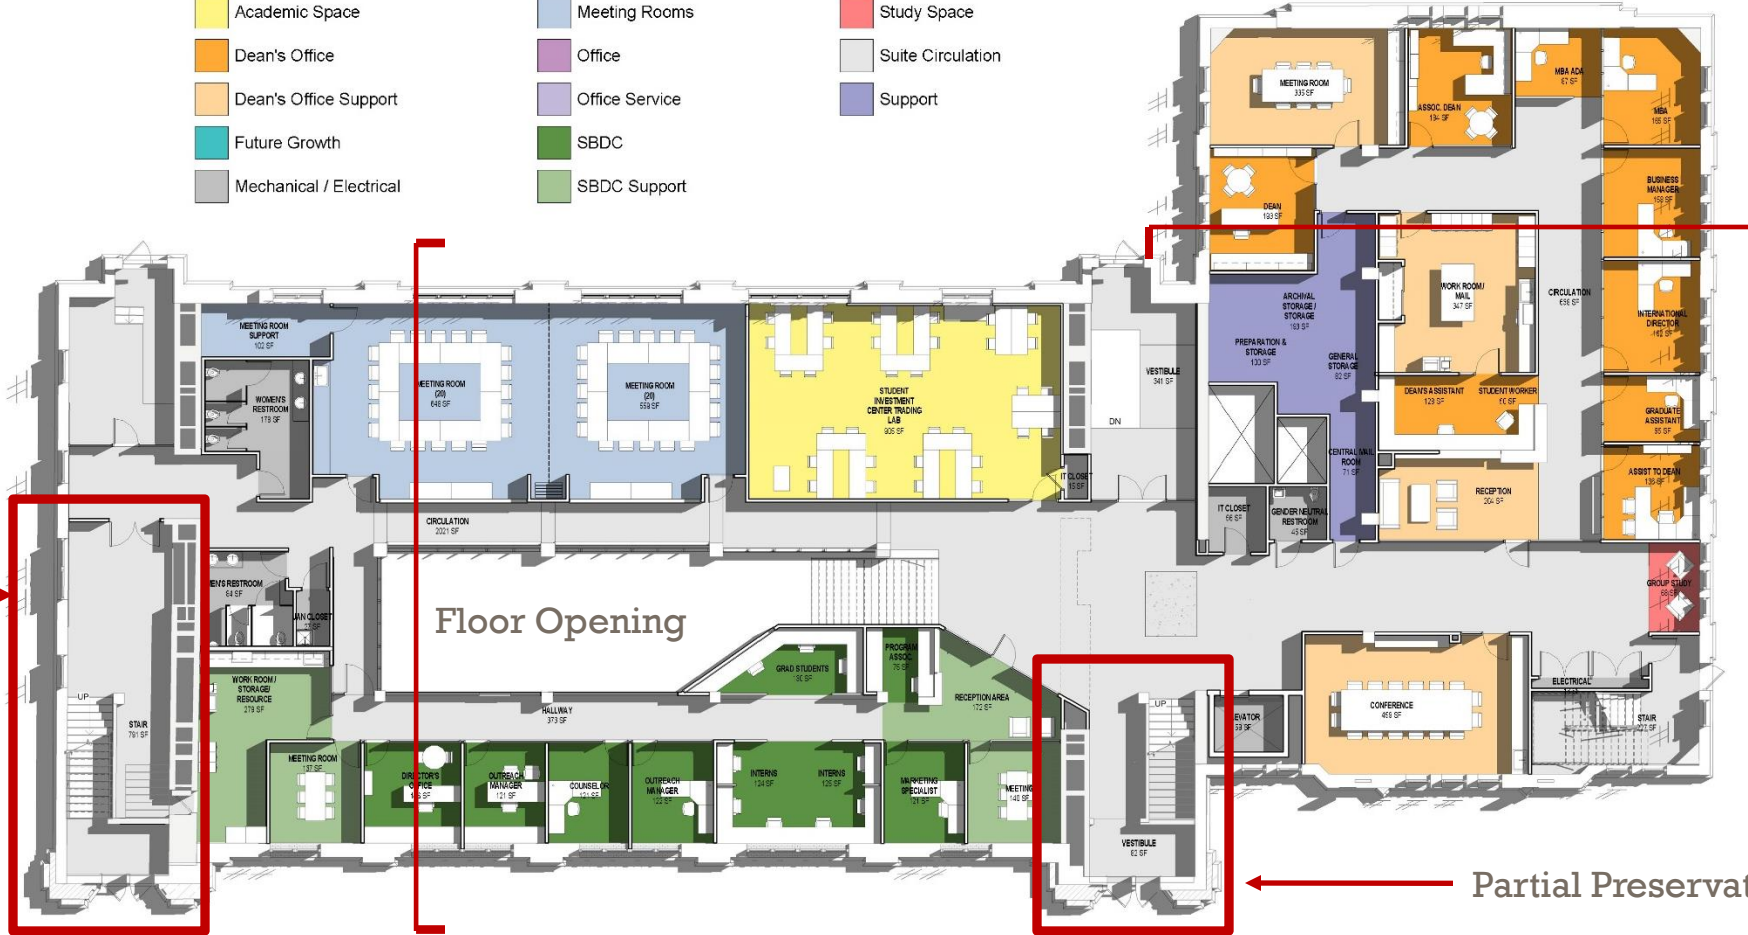
Full Preservation

Partial Preservation

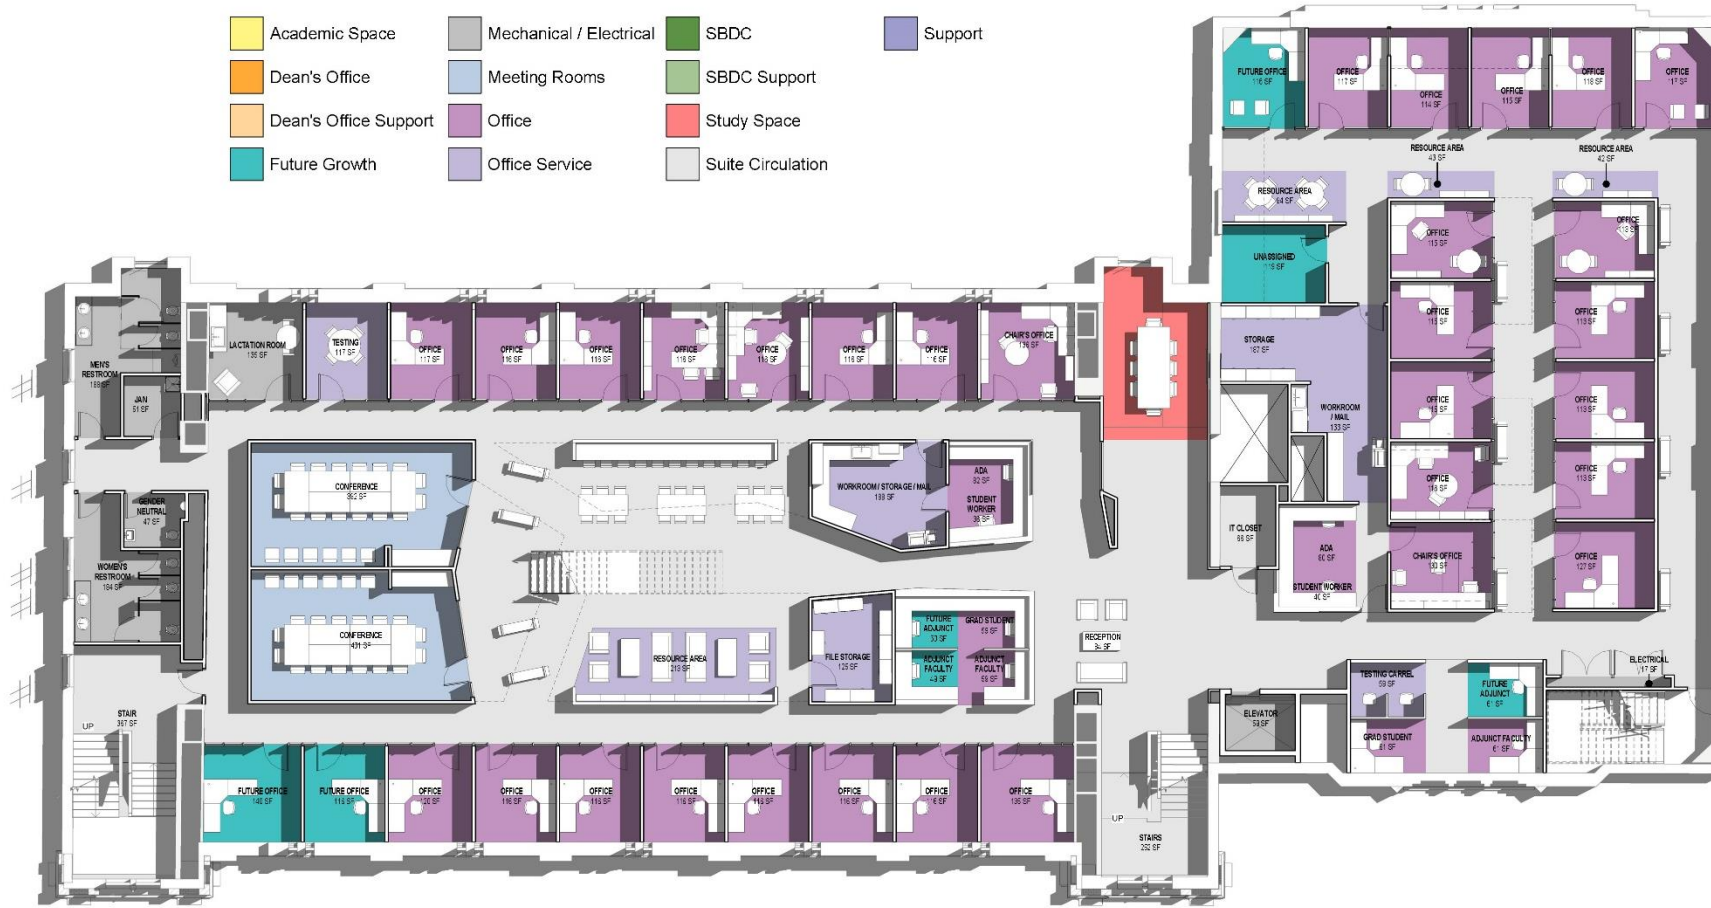
SECOND FLOOR

- | | | | |

| Academic Space | Mechanical / Electrical | SBDC | Support |
| Dean's Office | Meeting Rooms | SBDC Support | |
| Dean's Office Support | Office | Study Space | |
| Future Growth | Office Service | Suite Circulation | |

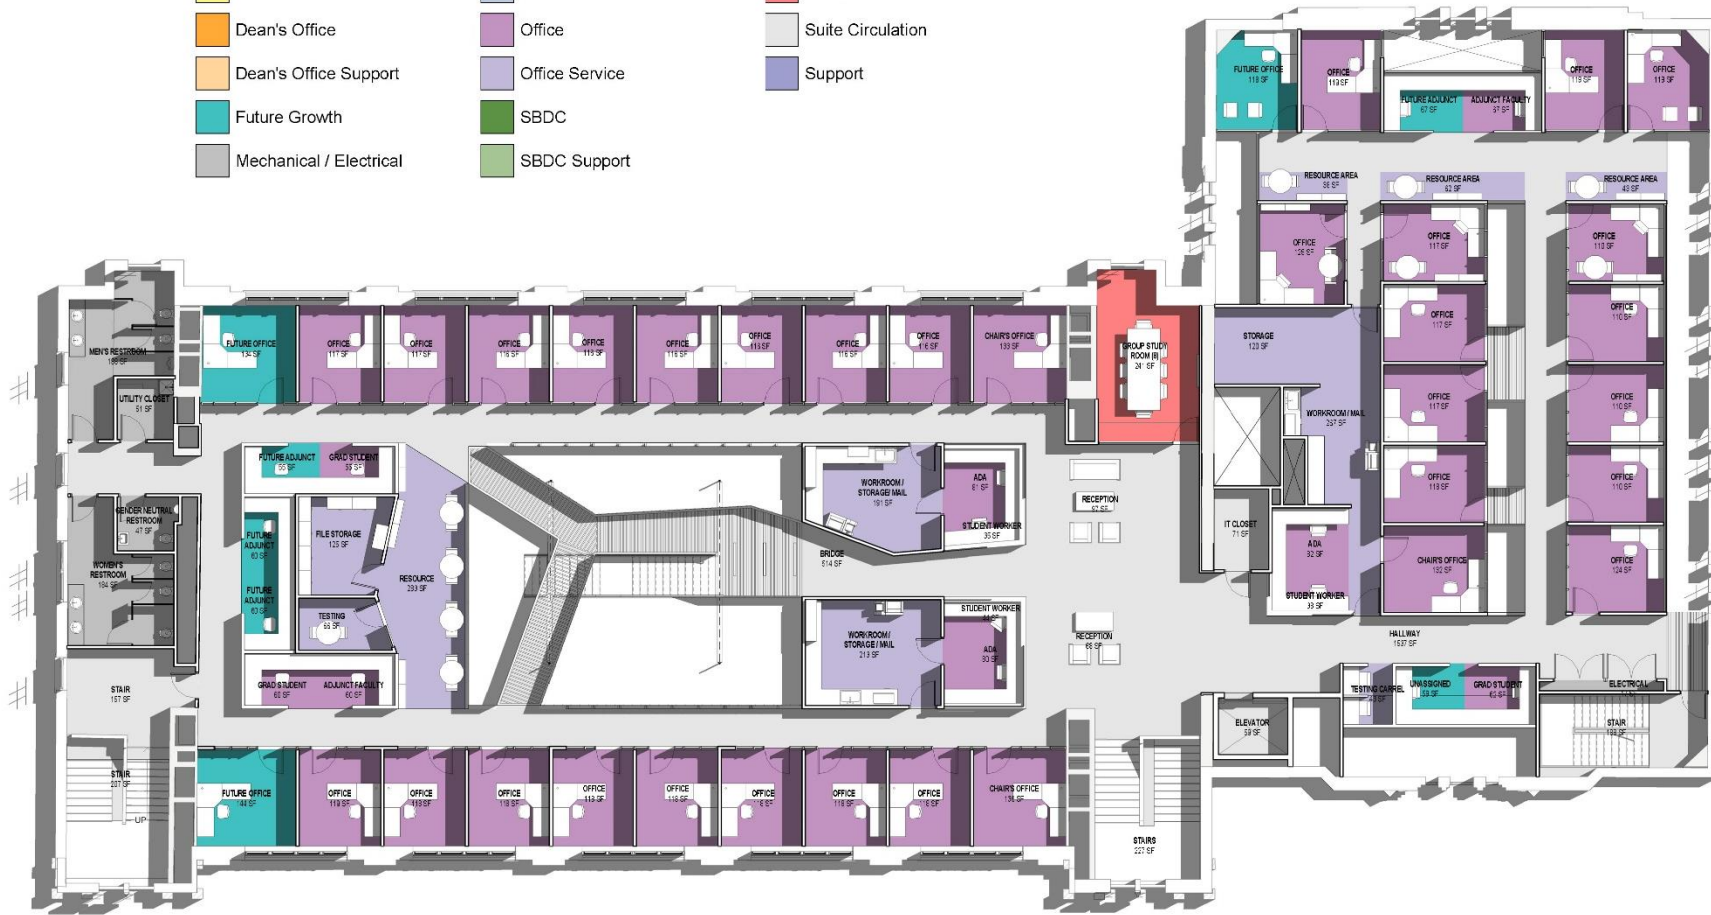
THIRD FLOOR

- Academic Space
- Dean's Office
- Meeting Rooms
- Office
- Study Space
- Suite Circulation
- Future Growth
- SBDC
- Mechanical / Electrical
- SBDC Support
- Support
