**Meeting Date:** Thursday, January 5th, 2017 – 10:30-12:00  
**DFD Project Number:** 14120  
**Project:** Wittich Hall Renovation  
**Location:** DFD – 101 East Wilson St. Room 721  
**Purpose:** Wittich Hall – Review Meeting  
**Prepared by:** Michael Eberle, AIA

WISCONSIN HISTORICAL SOCIETY REVIEW 2 – 1/5/17

WITTICH HALL

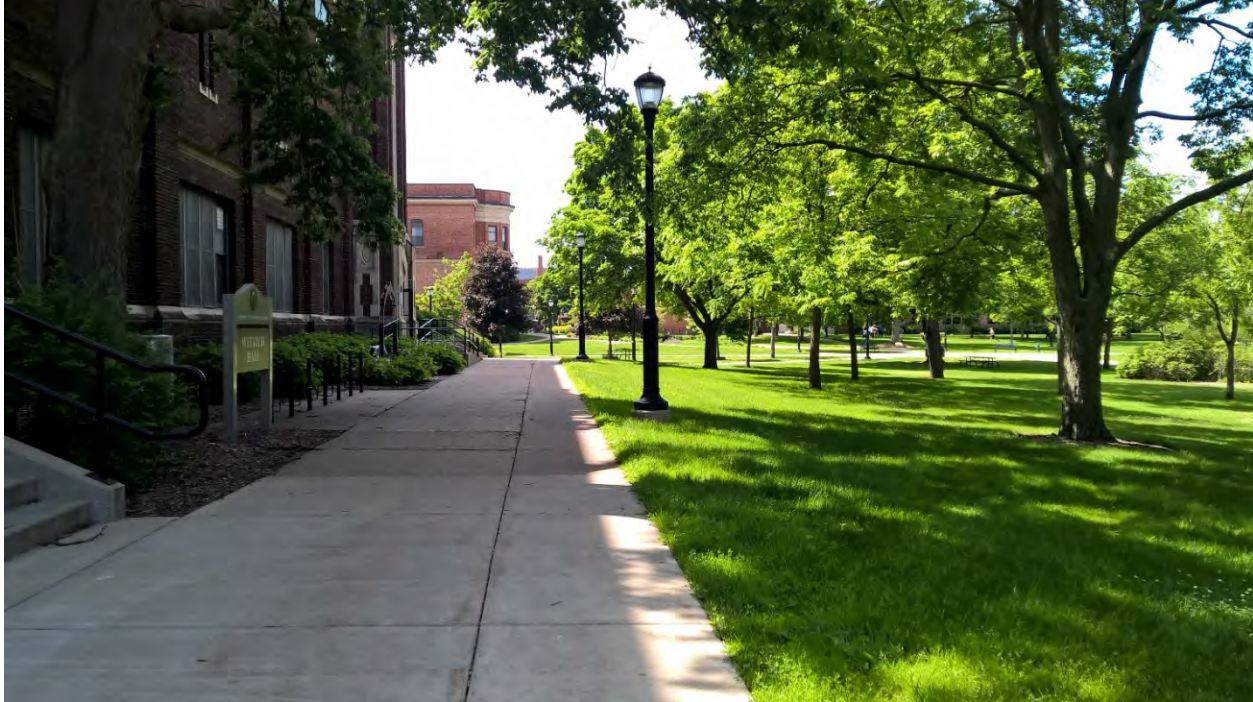
# WEST FOUNDATION CURRENT

Current building is obscured by dense vegetation

1. Nate Novak reviewed the site work agenda and site goals.
2. Current vegetation and historic context was reviewed including removal of trees along the west side of the building.
  - a. Removal of trees will reestablish focus on the primary west side entries.

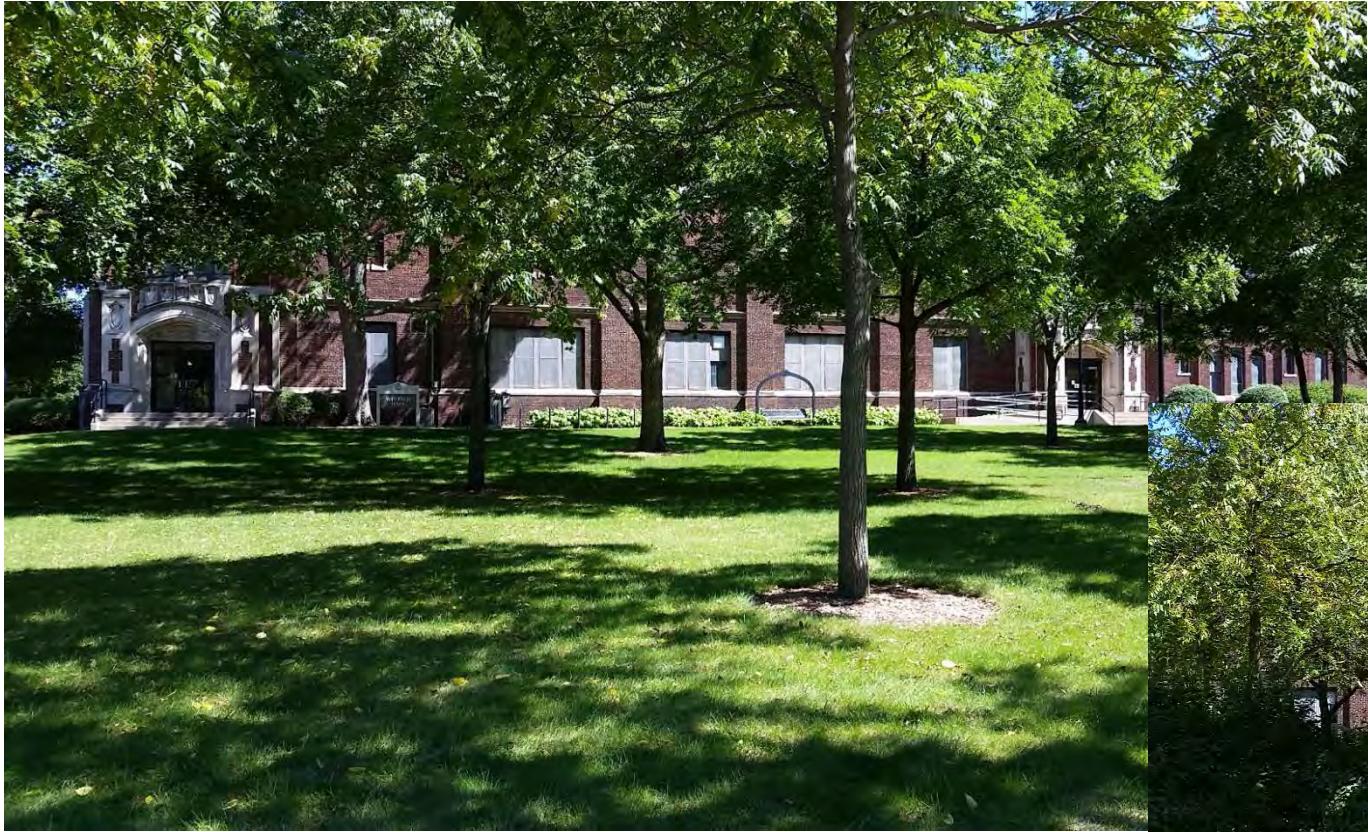
# WEST ELEVATION – CURRENT VIEW FROM MALL

Current building is obscured by dense vegetation

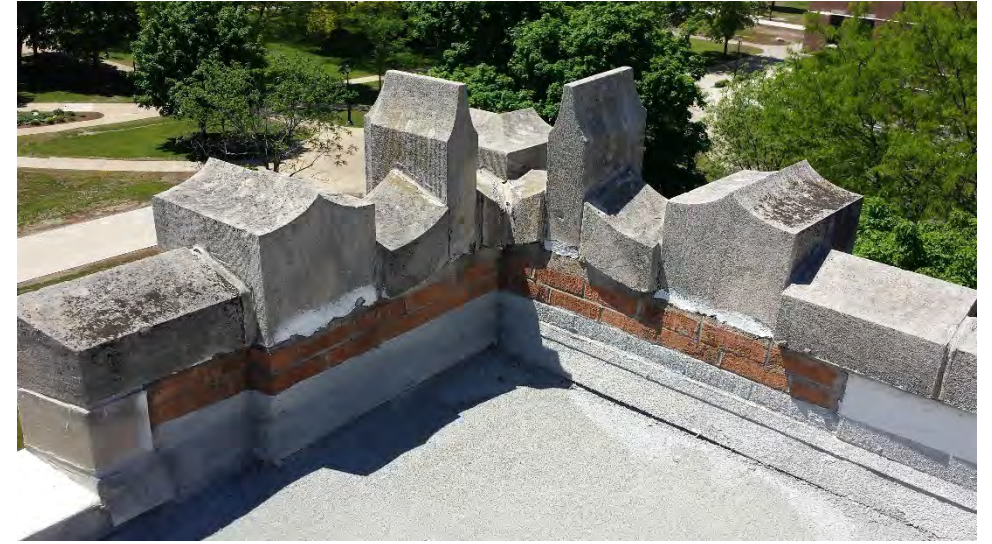
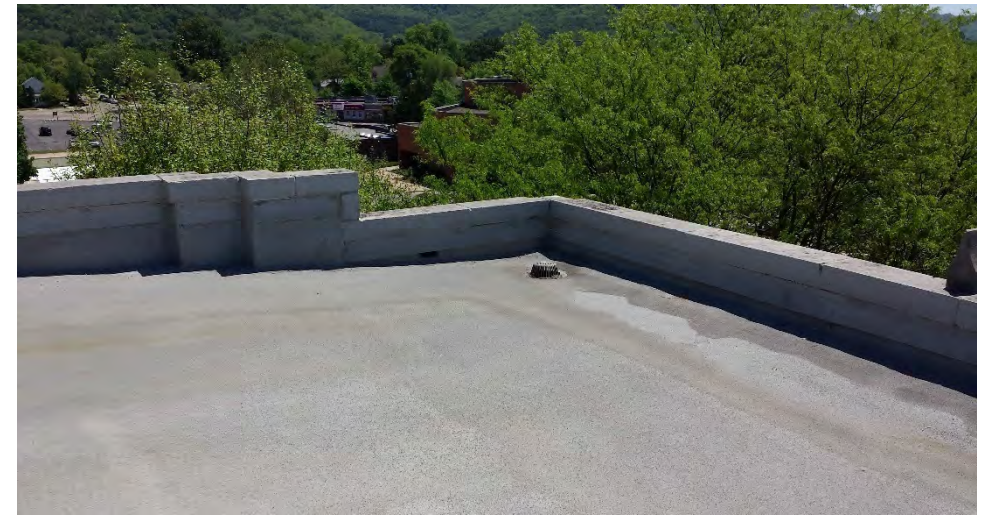
# EXTERIOR RESTORATION/REHABILITATION - ROOFS

- Existing Construction (1916)
- Existing Construction (1930)
- Plaster Restoration @ Ceilings
- Proposed Scope
  - Complete Re-Roof
  - New Flashings
  - Added Insulation Thickness Where Possible
- Light Monitors
- Thermal Performance Evaluation

Historic Structure Report: Page  
40  
Preservation Plan: Pages 32-33  
Drawings: AD104, A104

- Insulation thickness ranges from 2" to 2 3/4" (4" min. recommended). Challenges with vertical height at various parapets.
- 1930 Gymnasium has 1 3/4" structural wood decking that was originally exposed and has since been covered (highlighted in yellow).
- Verification needed if plywood sheathing was installed at back of parapets as detailed (highlighted in green).
- Installation of vapor barrier membrane will be included in roofing work (shown in red) along with flashing beneath stone coping

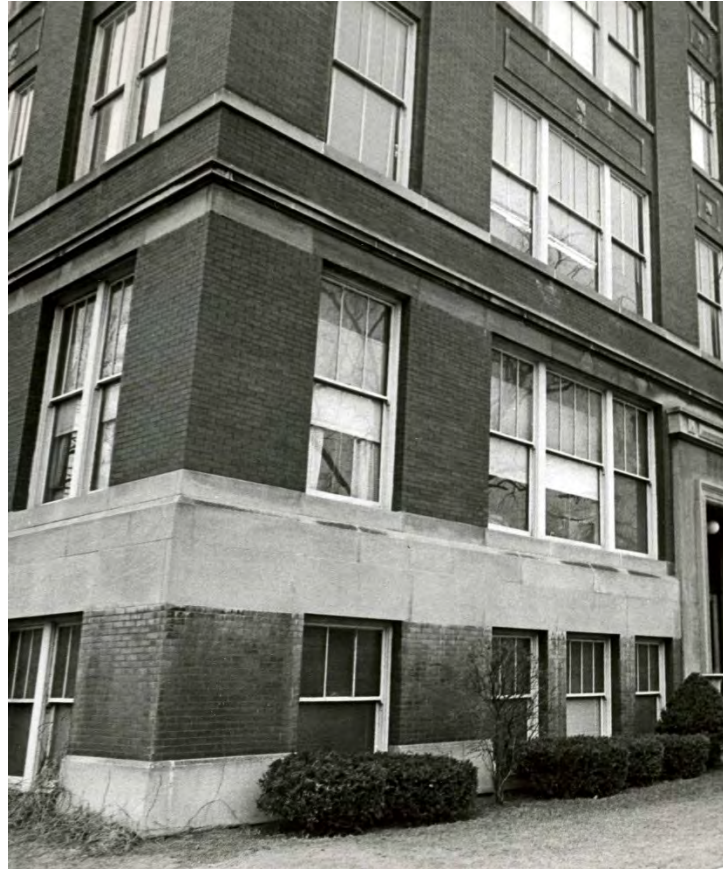
UW-Stout Harvey Hall – Historic Photo

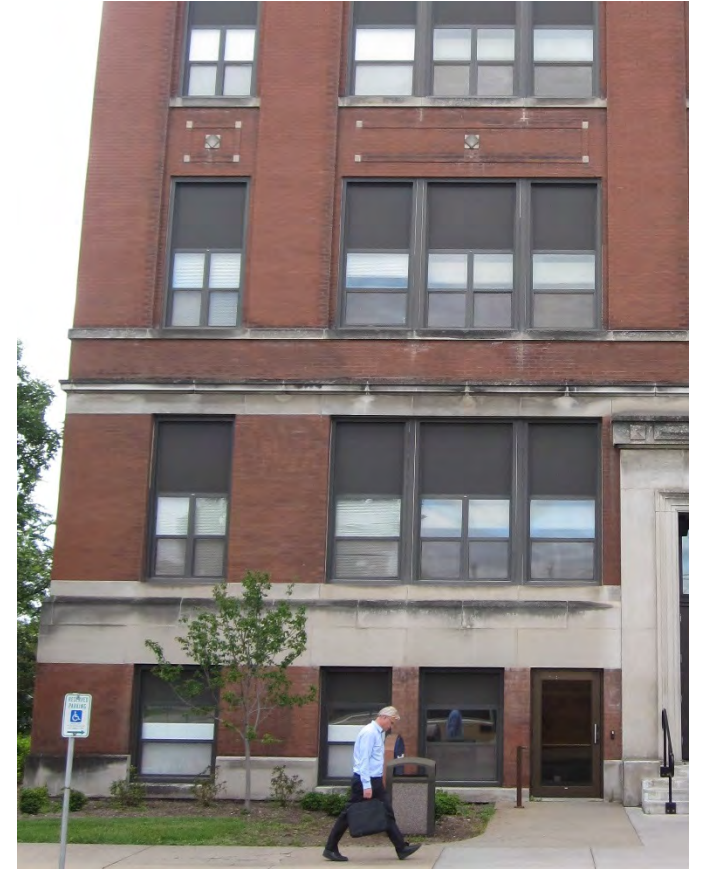
UW-Stout Harvey Hall – Prior to Renovation

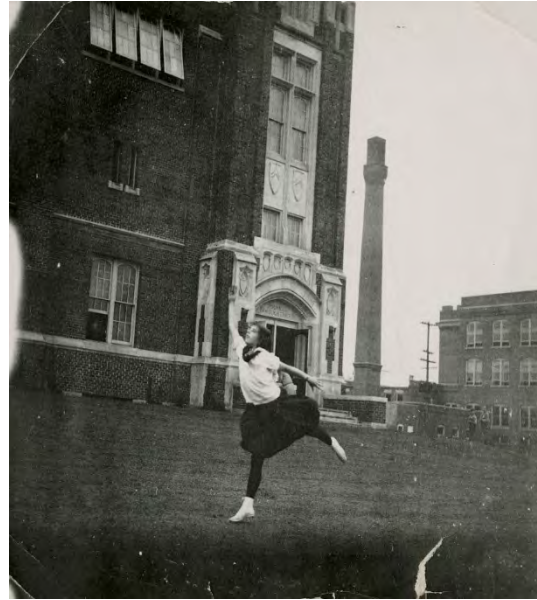
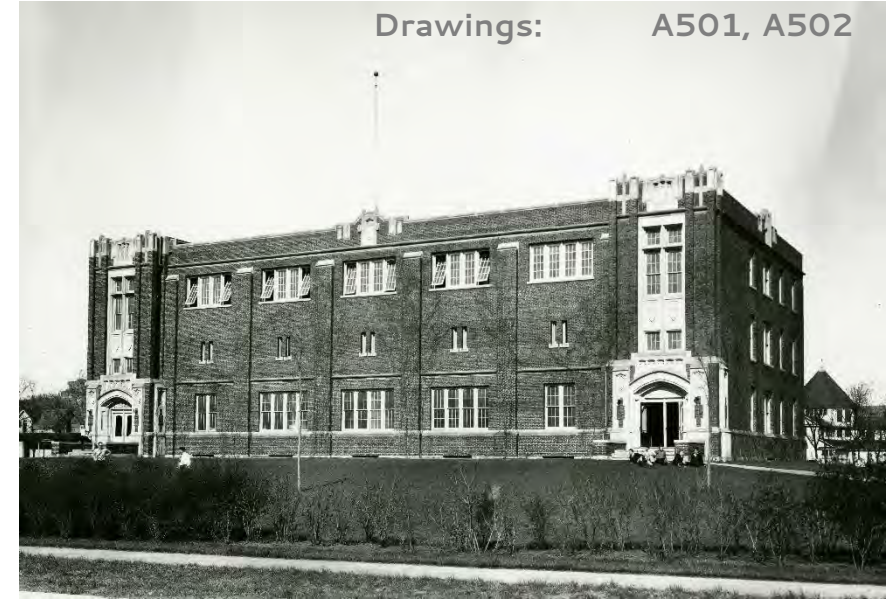
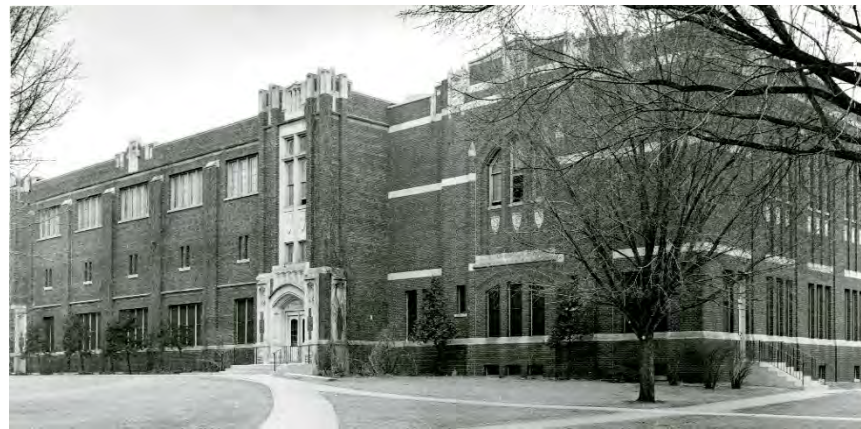
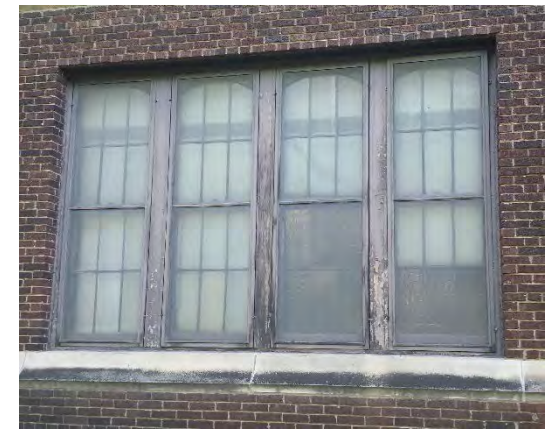
- Window Evolution
- Replacements & Retrofits
  - Over 50% are Non-Original Units
- Historic Profiles
  - 1916 vs 1930
- Sash Lugs
  - 1930 Addition Only
- Glass Type
  - Clear (Diffused Original)
  - Visible Light Trans: 72%

- b. Mike presented before / after Harvey Hall window photos.
  - c. He noted that there is a difference in the window detailing between the 2 wings. The 1930s wing has sash lugs and the 1916 does not. The interior profile of the window sashes varies slightly between the two wings of the building and will be considered for replication as the design moves forward. The proposal is to replicate original design and uniqueness of each wing.

- d. All original windows had diffused glass. Per previous discussion, the team will proceed with clear insulated glass at all windows. No color glass is anticipated. Glass with a Visual Light Transmittance (VLT) of 72% was noted as being the compromise between DFD / WHS on previous projects this team has worked on.

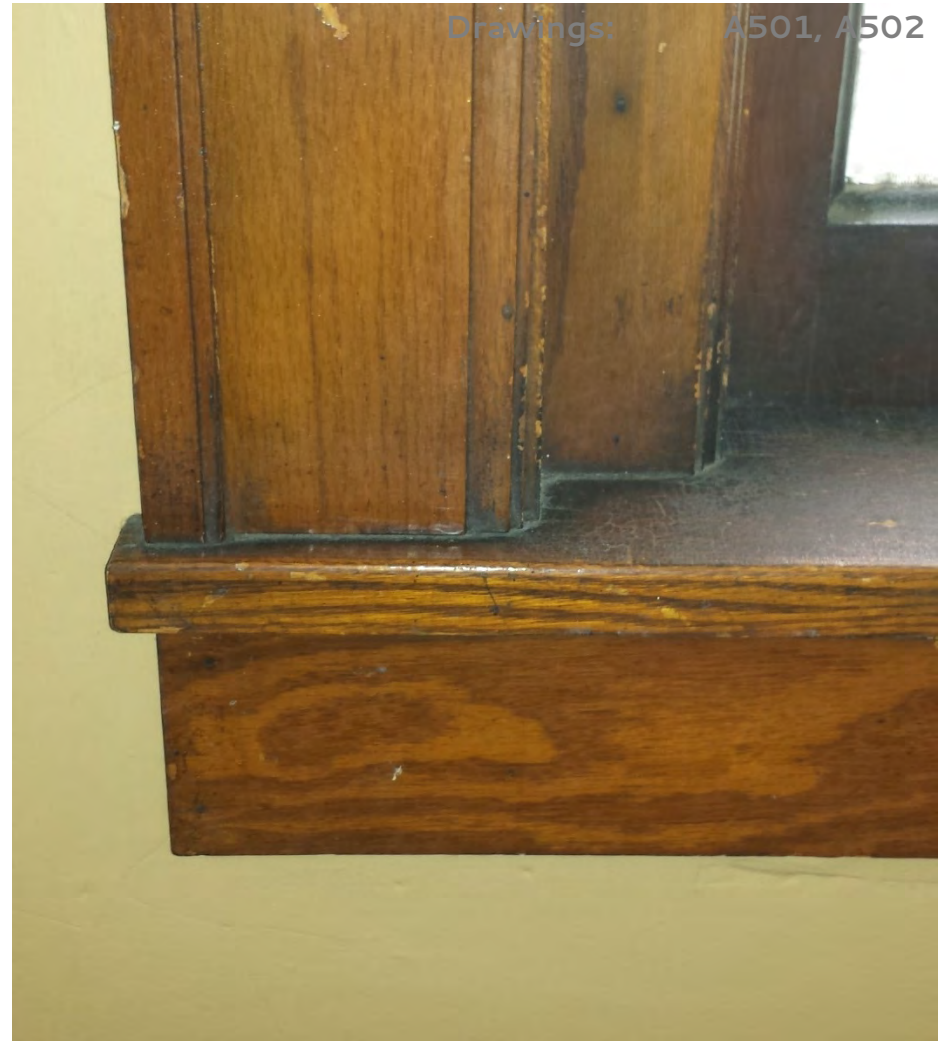
Wittich Hall – Original/Existing Window

- c. Jen noted that windows are a “character defining feature” of the building. If repair and restoration of the original windows will not be considered, then replacement units with details matching as closely as possible to the original would be an acceptable strategy for this project to proceed.

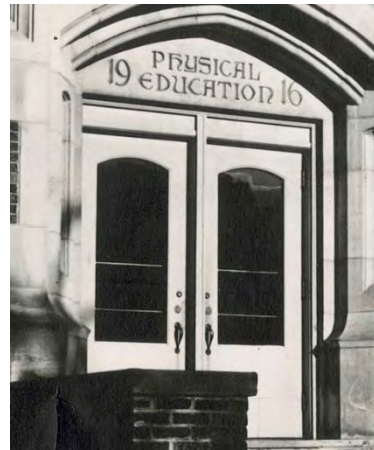
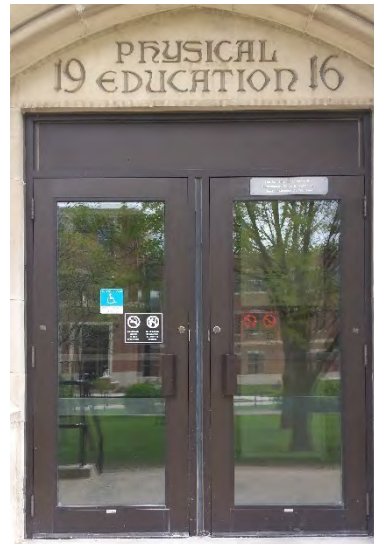
- Existing Construction
  - Historic Profiles
    - Exterior Casings
    - Interior Casings
- Proposed Scope
  - 100% Replacement
  - Metal-Clad Wood Doors

7. The scope of the door work was reviewed.
- a. Replacement of all the doors are planned with metal clad wood doors matching the details of the original.

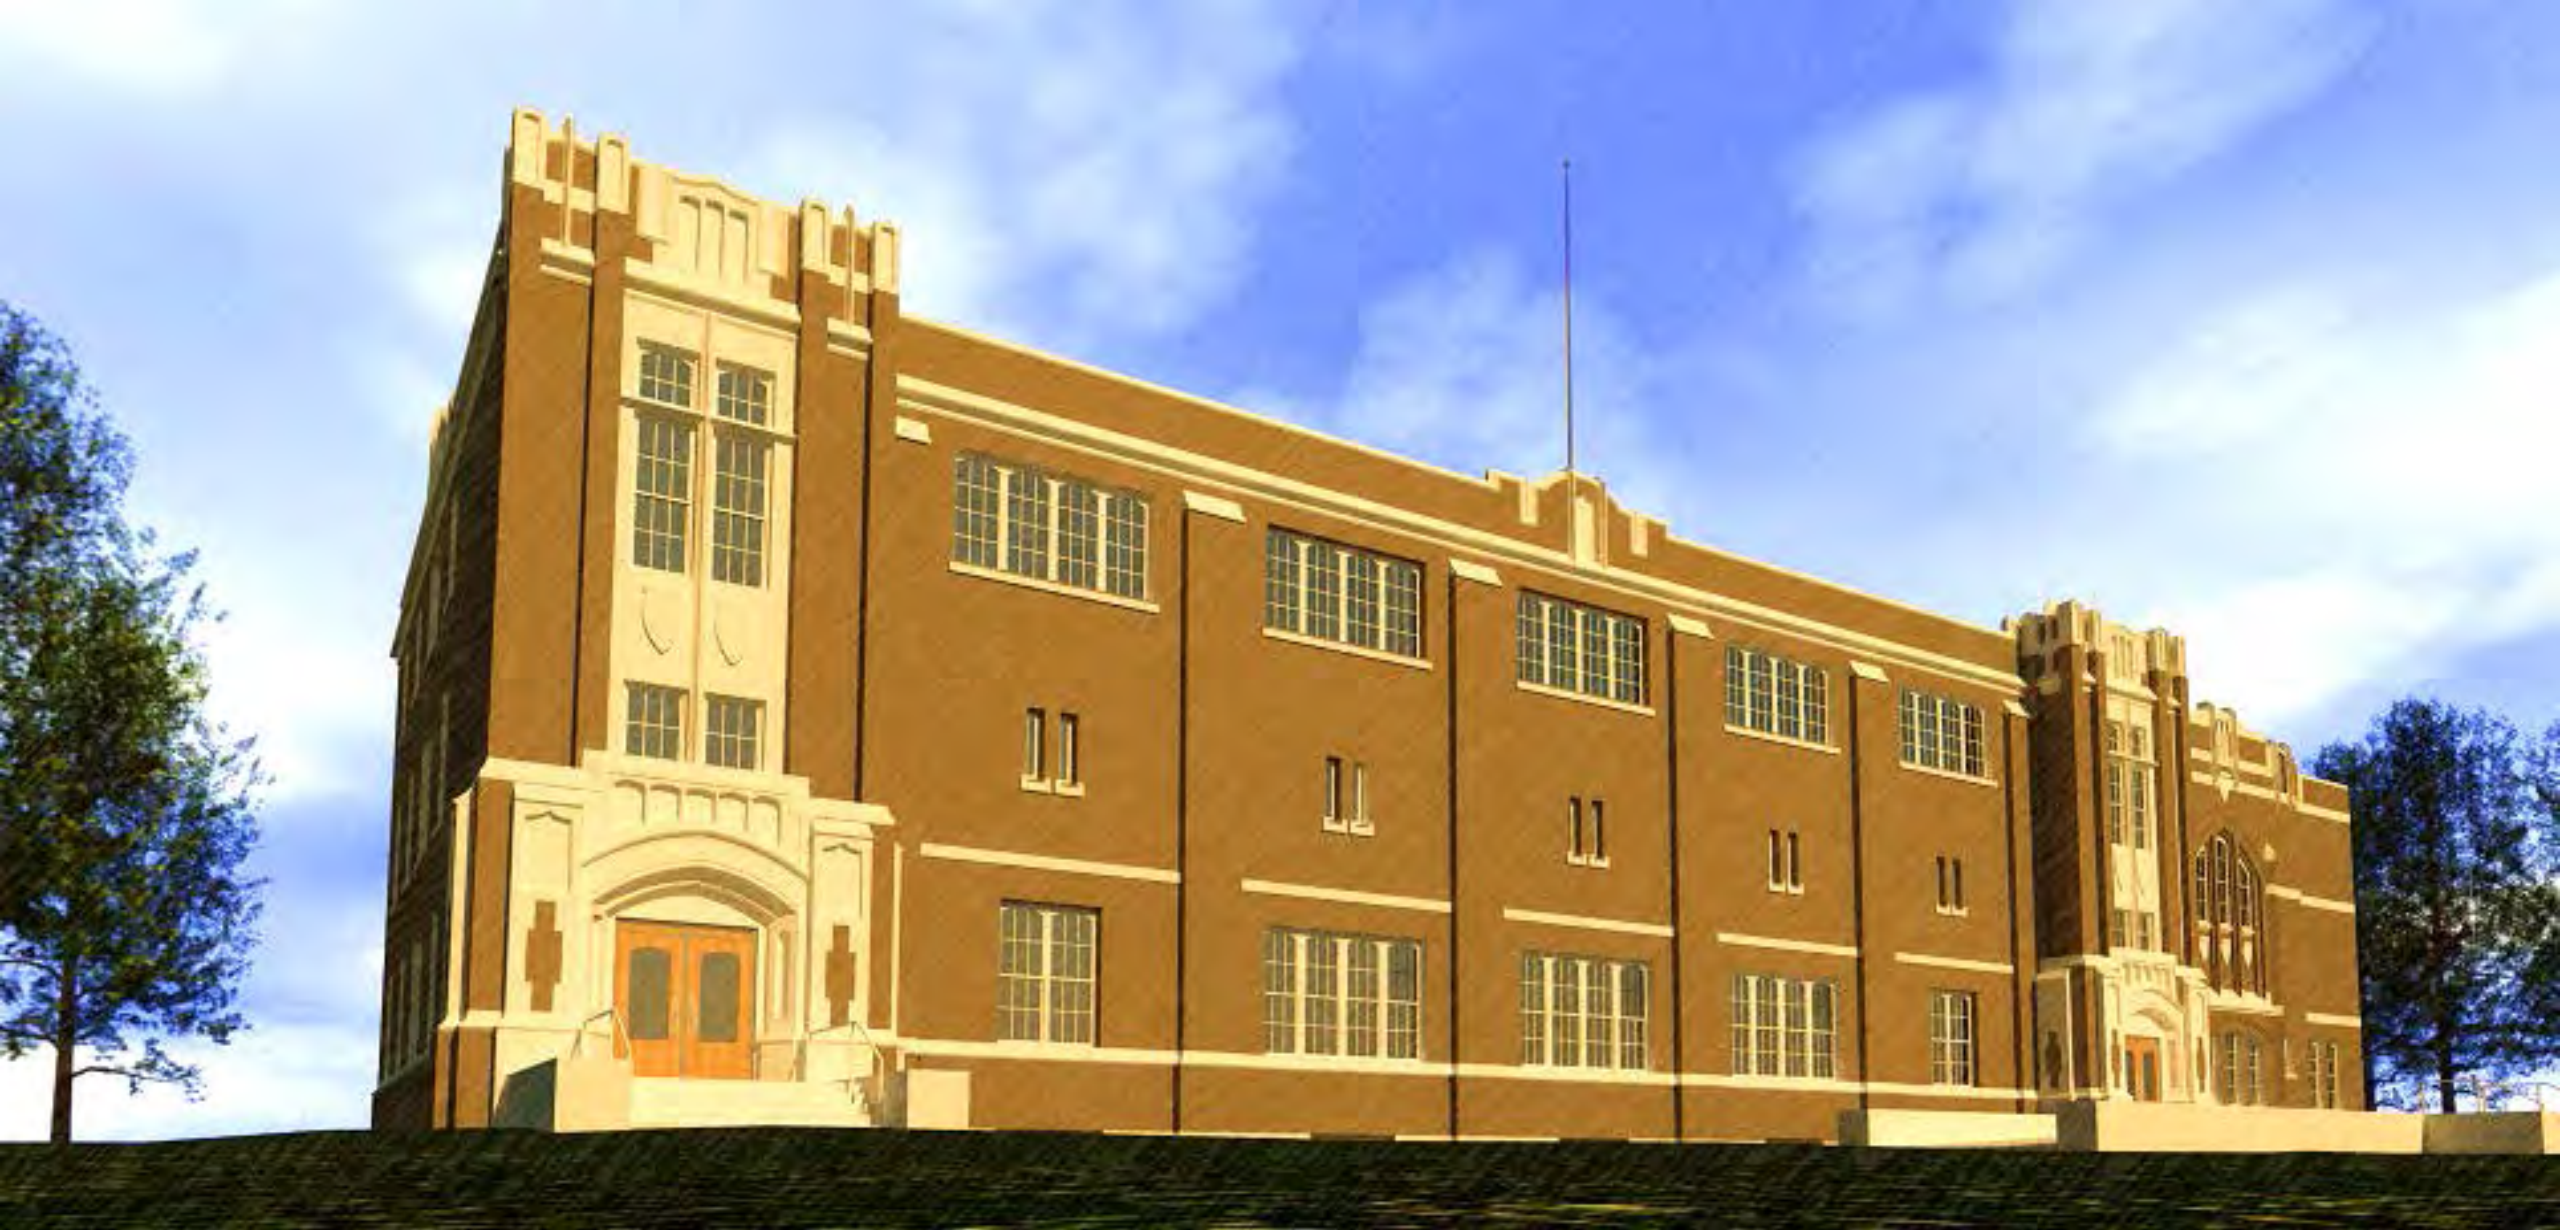
Historic Structure Report: Page 32  
Preservation Plan: Page 24-31  
Drawings: A502
