# Wittich Hall Renovation

Preservation Plan  
Appendix 2

University of Wisconsin – La Crosse  
November 1, 2016

DFD Project No. 14I20

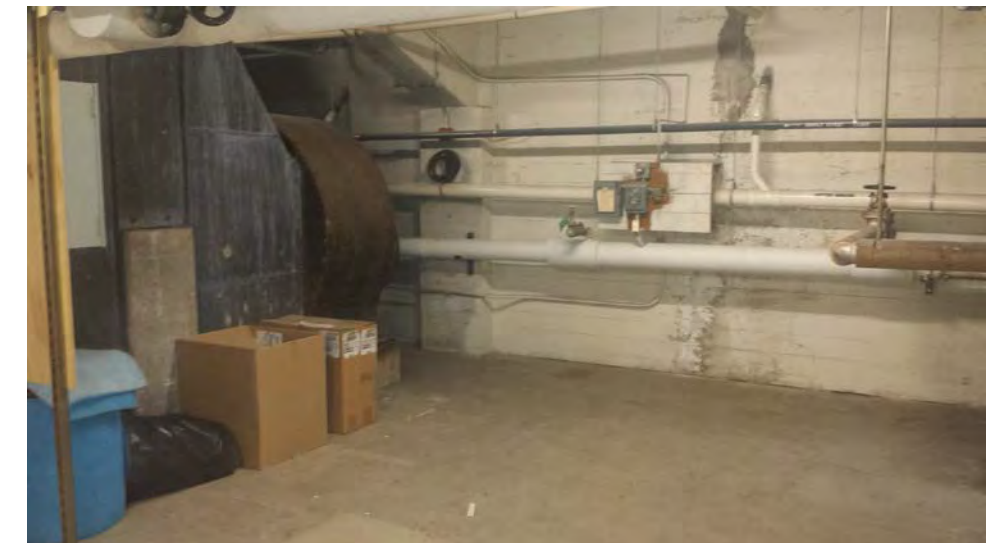
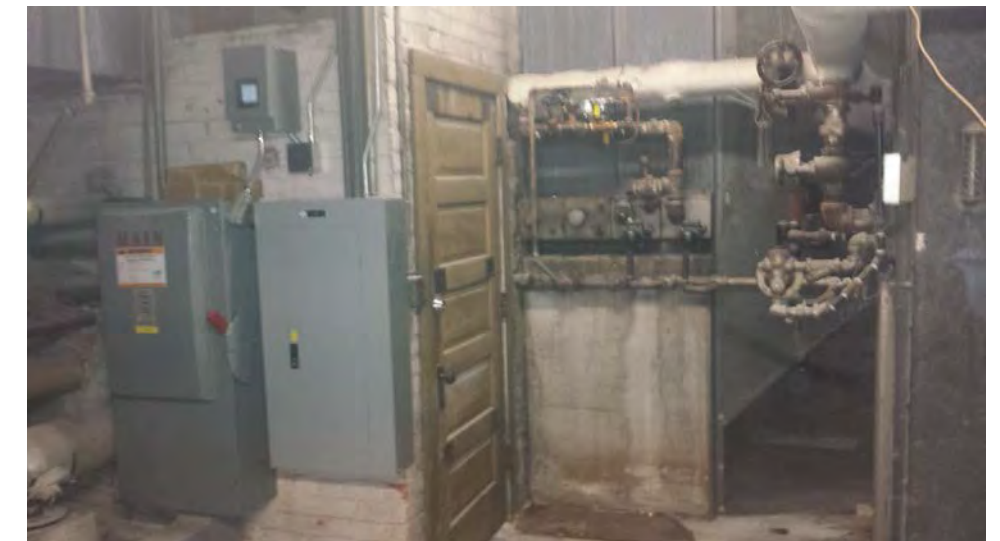
Figure 30: Basement Mechanical Room, Wittich Hall; River Architects (2016)

The majority of the plumbing system is original and is at the end of its useful life. It is recommended to remove all original and remodeled/replaced plumbing systems and possibly salvage any newer replaced items of the plumbing system. Any renovation to the Wittich Hall Building will require newly designed plumbing systems.

The service entrance equipment is in a state of mixed conditions. Due to the significance of the proposed renovation, it is recommended it be replaced.

Branch panelboards located through the facility are also in a state of mixed conditions. Most of which have eclipsed their reliable operating life and replacement is recommended. Many of the panel locations are not compliant with the National Electric Code (NEC) equipment space and working clearances. Reuse of the panelboards installed within the last 10 years or so could be considered if the budget does not allow for all new equipment. Replacement of branch circuit panelboards recommended.

Provide all new telecom rooms, provide new fiber optic riser cable and provide new Category 6 station cable to all interior areas.

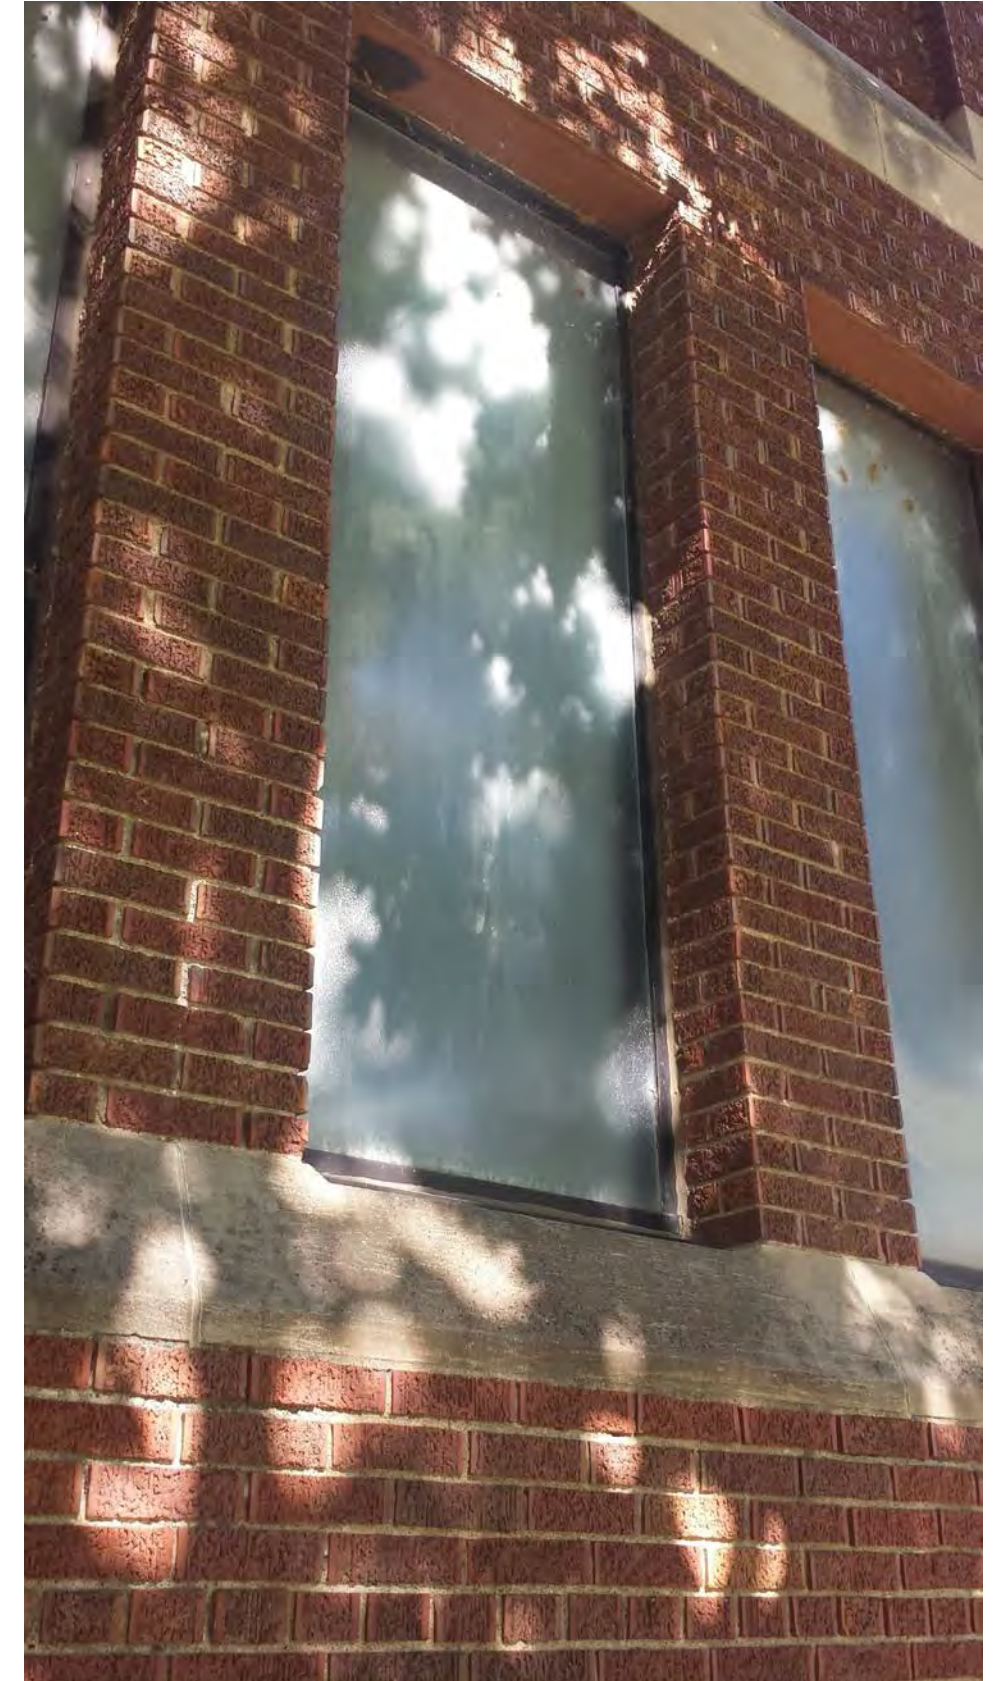
Figure 42: 1930 Pool Window, Wittich Hall; River Architects (2016)

Windows in the 1930 pool area have been replaced with aluminum units and will be removed and replaced with units to match the historic double-hung configuration. It is recommended that these units be painted as originally specified.

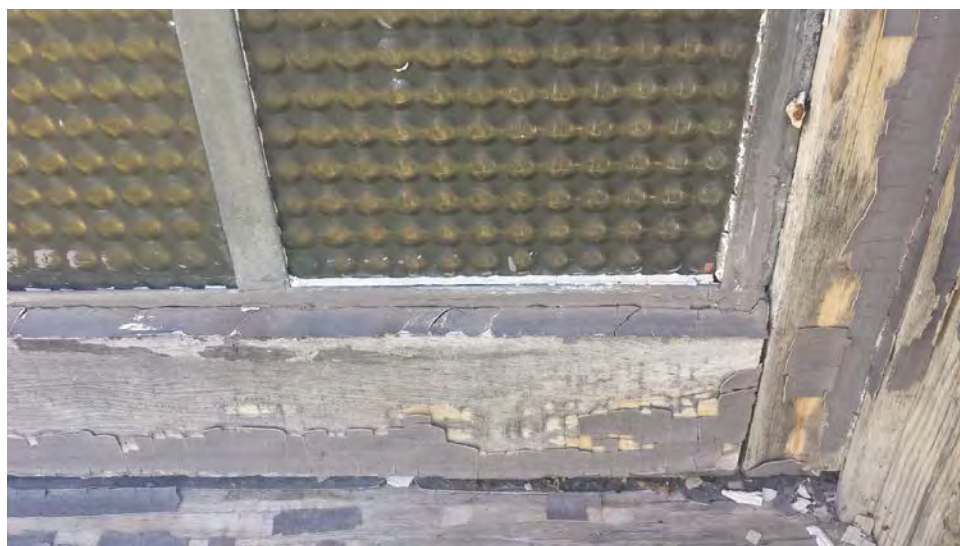
Figure 40: Window Condition, Wittich Hall; River Architects (2016)

On a specific point, approximately 52% of the total window area in Wittich has been compromised, either through replacement with glass block, insertion of venting systems, concrete infill, or sash or glass replacement. The recommended treatment of all the windows is replacement with replica units that would mimic precisely the original profile and configuration of the originals. The replacements would have metal-clad exteriors painted with the historic colors, and wooden interiors likewise matched to original treatment colors or stains. To restore some window units while replacing others would create an uneven appearance not in keeping with the historic design intent. Also, the application of exterior storm units would obliterate the arched top sash and obscure the historic window frame depth.

- Replace all wood window units with replicas. The windows should consist of an exterior material that is weather resistant and the interior should retain a wood character. Windows to have clear glass in lieu of the historic transfused glass. Muntin bars, sashes, brickmold, etc. to match historic profiles.

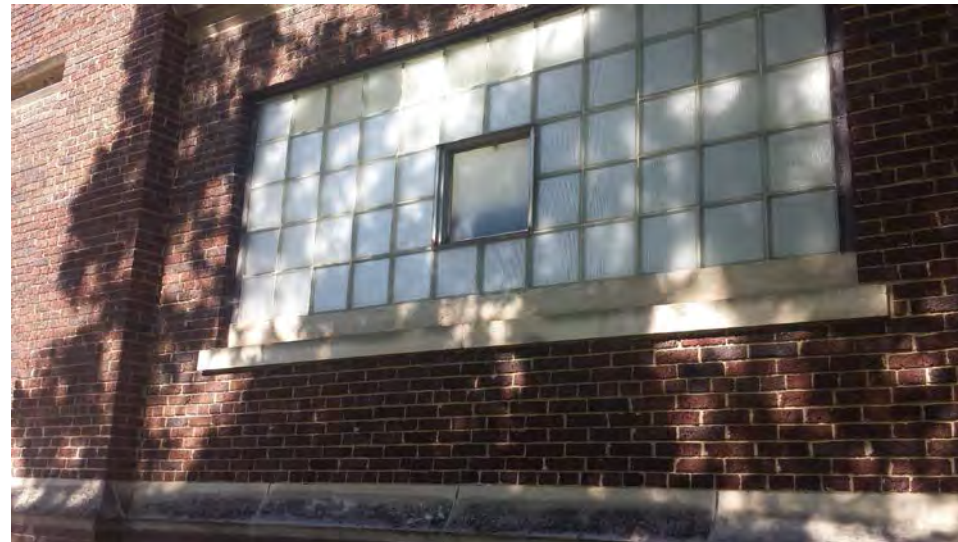
Figure 41: Glass Block Window, Wittich Hall; River Architects (2016)

Upper level windows in the 1916 gymnasium that have been replaced with glass block were originally trimmed in wood and stained. It is recommended that the new units match the historic color as closely as possible.

5. Replace entire wood window unit and frame with new metal-clad wood window unit with profiles that match the original.
6. Remove existing glass block window and replace with new metal-clad wood window unit with profiles that match the original.
7. Remove existing aluminum storefront entrance and replace with new metal-clad wood door unit with profiles to match the original.
8. Remove skylight infill and replace with new skylight/roof monitor.
9. Recreate flagpole to match original drawings.
10. Remove existing roof-mounted mechanical equipment.
11. Remove existing limestone copings in order to install flashing below coping stone. Backer rod and joint sealant to be used for new joint material.
12. Remove existing ramp and construct new, discrete and accessible entrance.
13. Remove non-original mechanical and electrical equipment.
14. Replace light fixture with historic replica fixture.

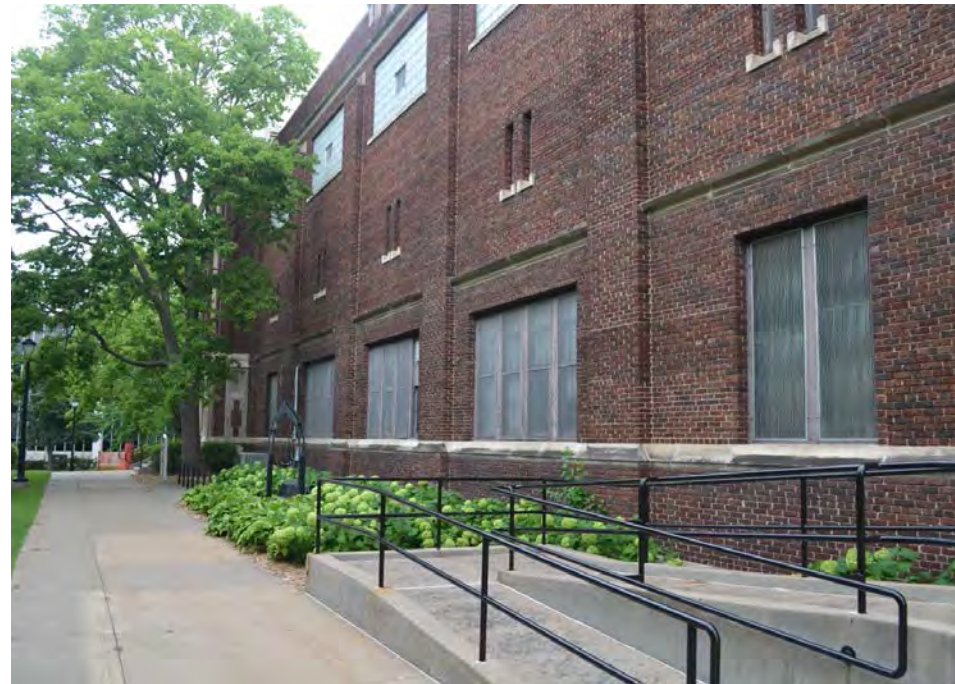
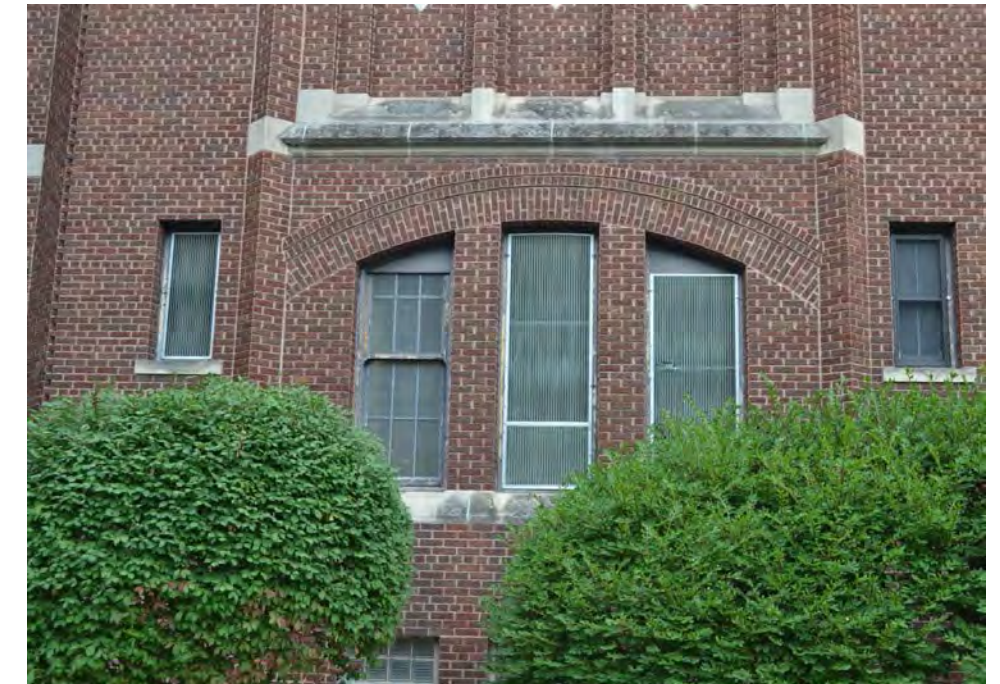
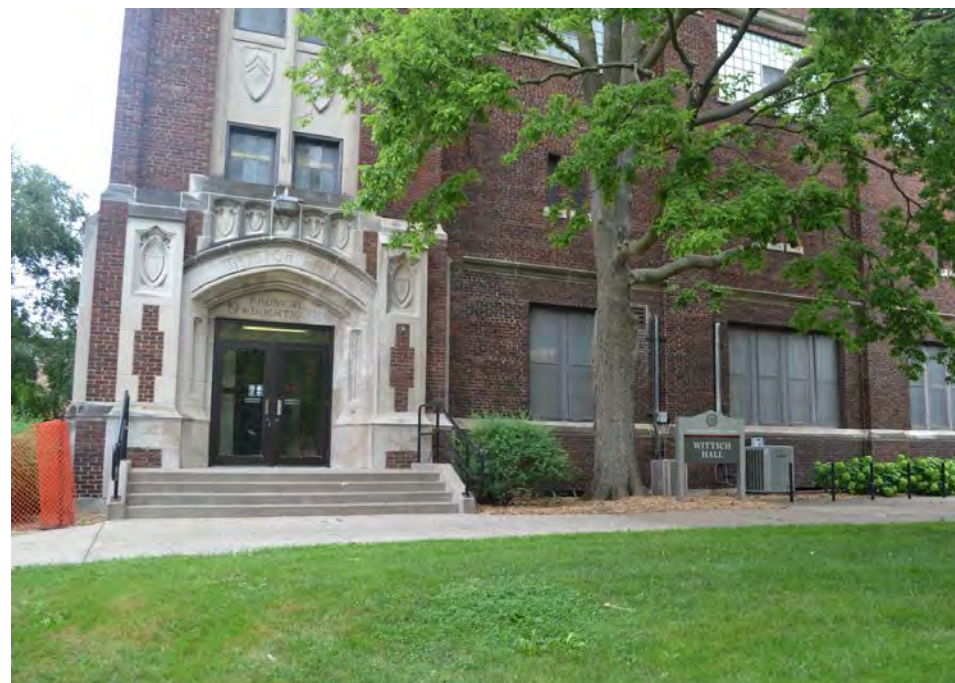
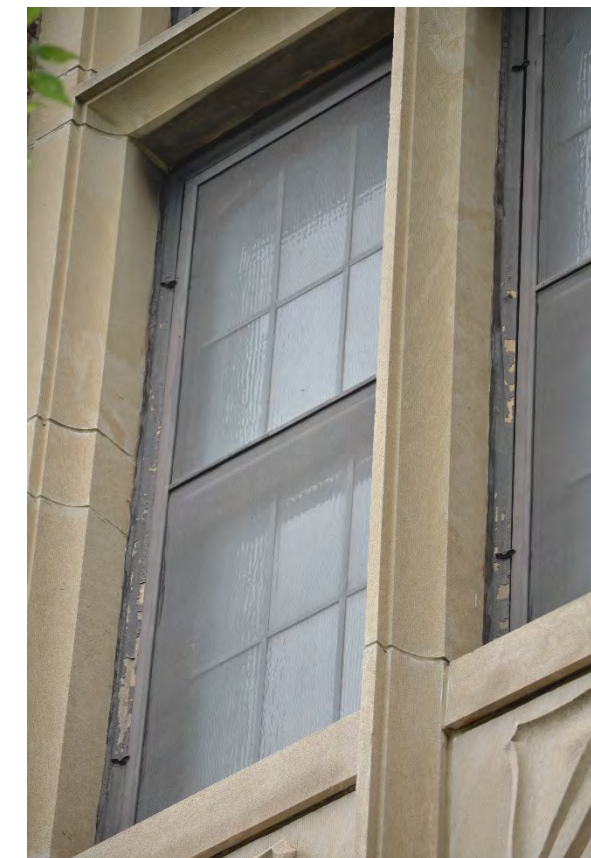
Figure 44: West Elevation, Wittich Hall; River Architects (2016)

Figure 45: West Elevation, Wittich Hall; River Architects (2016)

Figure 46: West Elevation, Wittich Hall; River Architects (2016)

Figure 47: West Elevation, Wittich Hall; River Architects (2016)

- Replace the aluminum storefront entrances at the northwest and southwest entrances with doors that replicate what were once there. Each door should consist of an exterior material that is weather resistant and the interior should retain a wood character.

- Replace the broken/deteriorated limestone panel located at grade near the northwest entrance.
- Clean all brick and limestone masonry.
- Point all joints within limestone trim and accent panels. Consider use of joint sealant.

- Remove all wood screen units.
- Consider removal of exterior concrete stairs and ramp with something more historically accurate.
- Recreate flagpole that was originally located on the roof.

- Remove non-original mechanical and electrical devices.
- Replace existing light fixture with historic replica fixture.

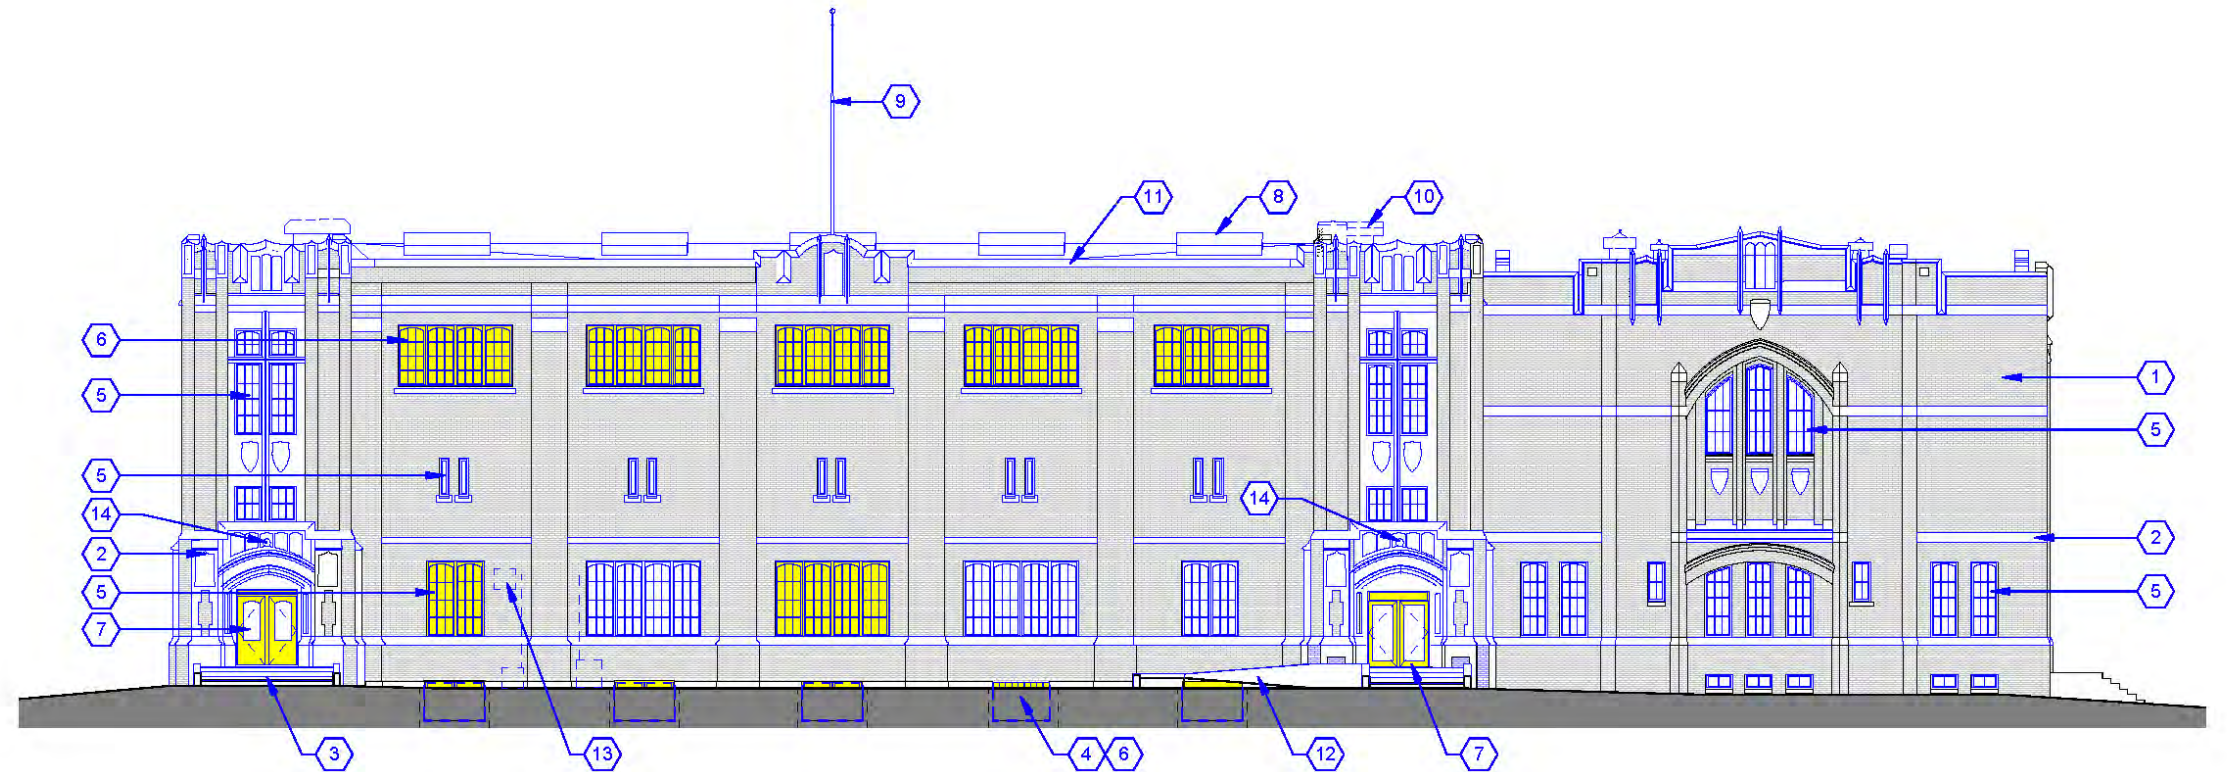
3. Consider removal of existing stairs and reconstruction of historic entrance stair seat walls.
4. Clean, repair, and restore metal window well grating.

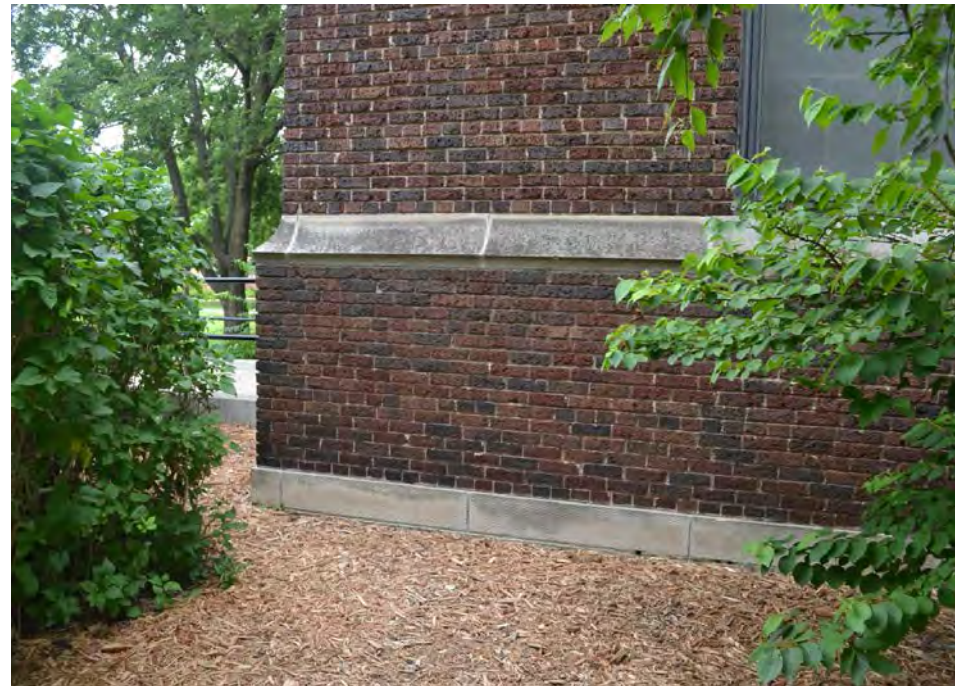
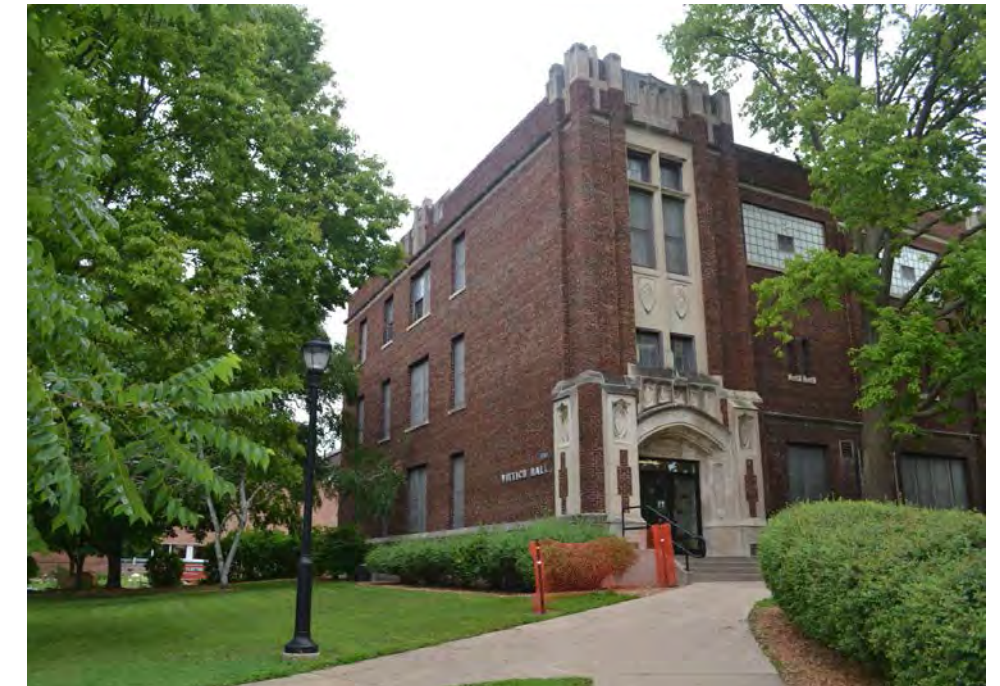
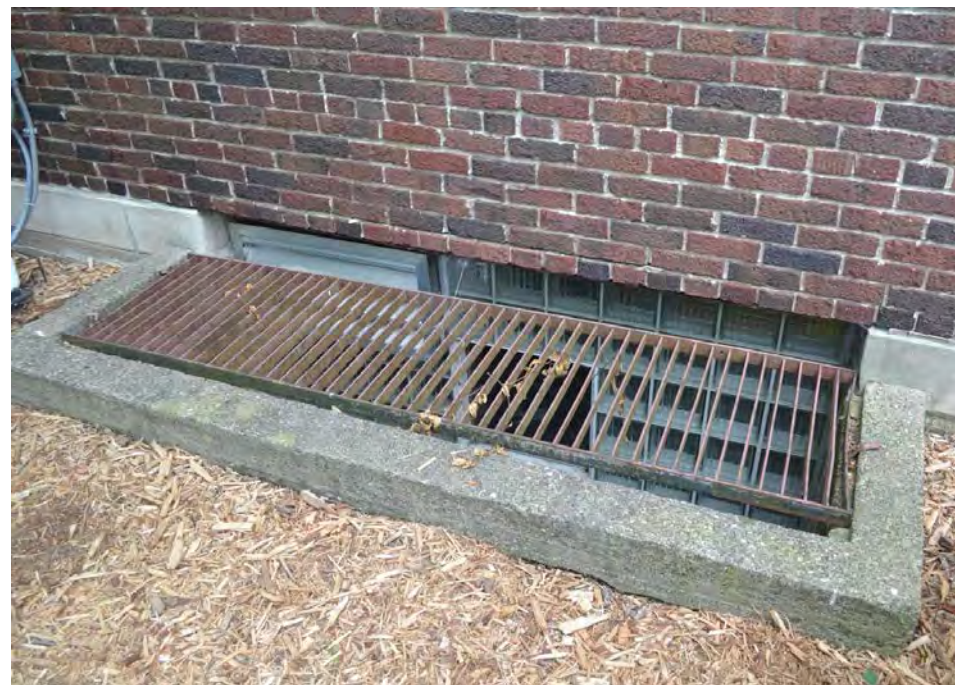
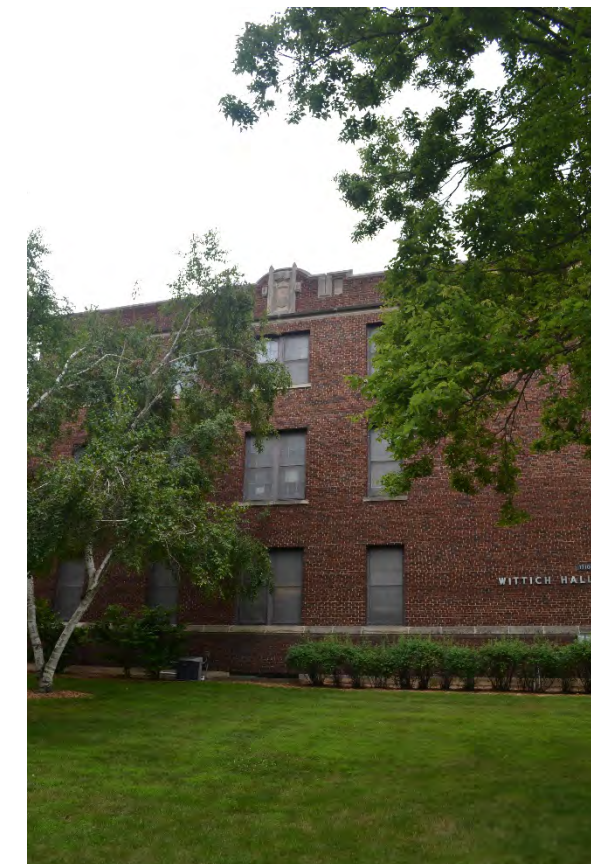
Figure 48: North Elevation, Wittich Hall; River Architects (2016)

Figure 49: North Elevation, Wittich Hall; River Architects (2016)

Figure 50: Basement Window, North Elevation, Wittich Hall; River Architects (2016)

Figure 51: North Elevation, Wittich Hall; River Architects (2016)

- Clean all brick and limestone masonry.
- Point all joints within limestone trim and accent panels. Consider use of joint sealant.
- Replace all wood window units with replicas. The windows should consist of an exterior material that is weather resistant and the interior should retain a wood character. Windows to have clear glass in lieu of the historic transfused glass. Muntin bars, sashes, brickmold, etc. to match historic profiles.
- Remove all wood screen units.
- Remove non-original mechanical and electrical devices.

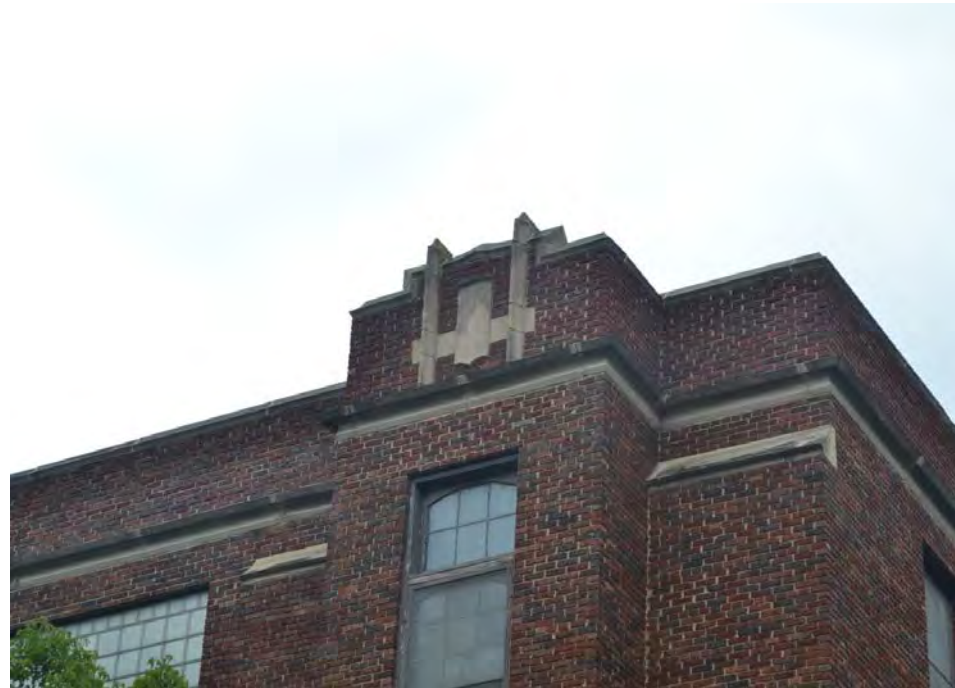
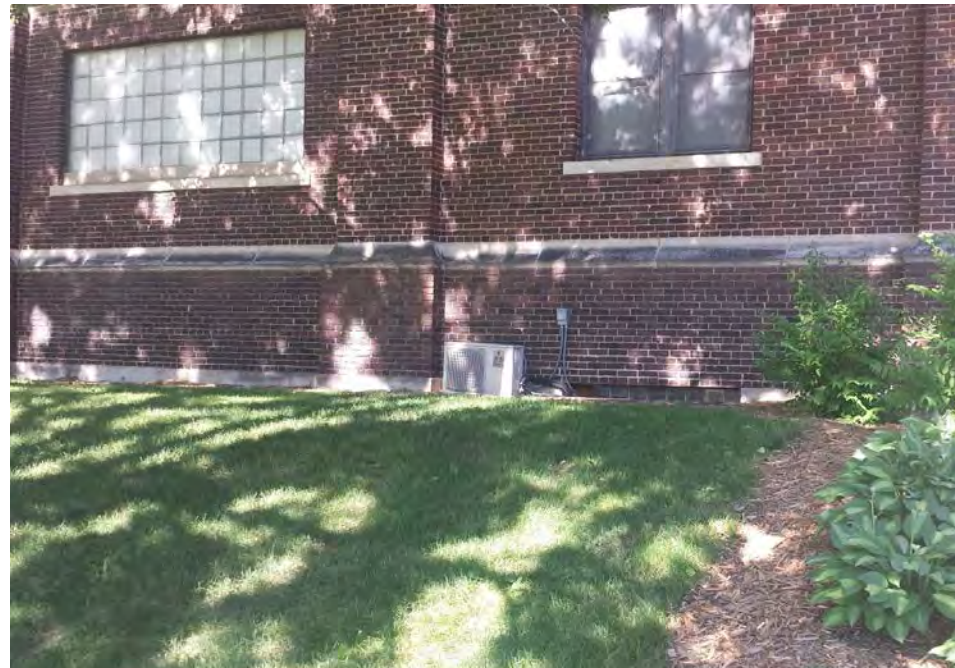
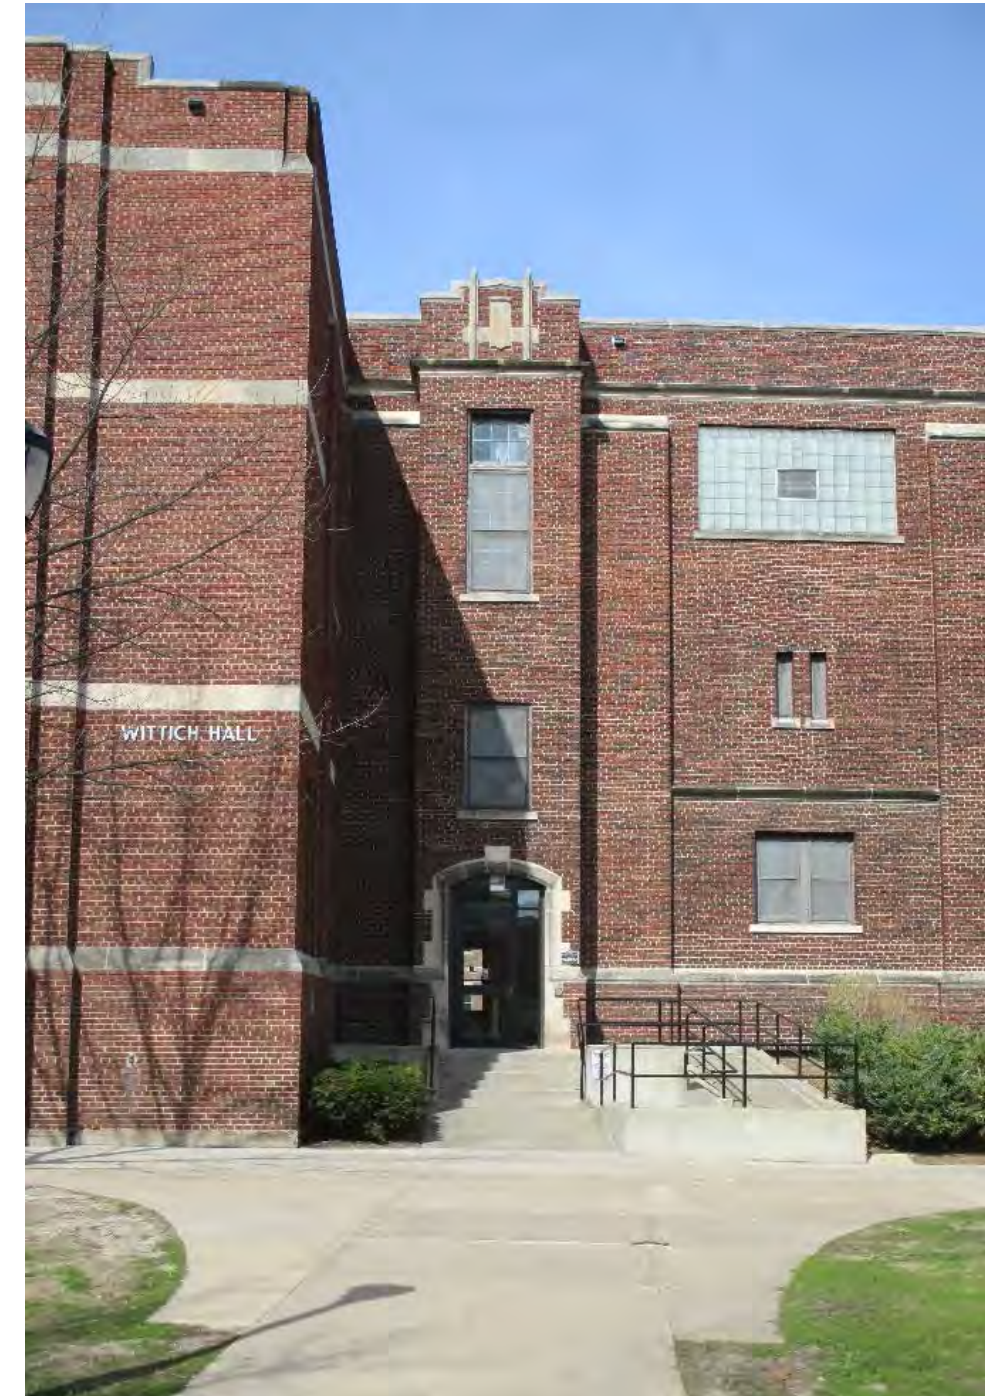
The east elevation of Wittich Hall is currently very much intact historically. It maintains the appearance of the original drawings with a few minor changes in the main level and upper level windows and two main entrances.

Figure 52: East Elevation, Wittich Hall; River Architects (2016)

Figure 53: East Elevation, Wittich Hall; River Architects (2016)

Figure 54: East Elevation, Wittich Hall; River Architects (2016)

- Remove all wood screen units.
- Consider removal of exterior concrete stairs and ramp with something more historically accurate.
- Remove non-original mechanical and electrical devices.

- Replace existing light fixture with historic replica fixture.

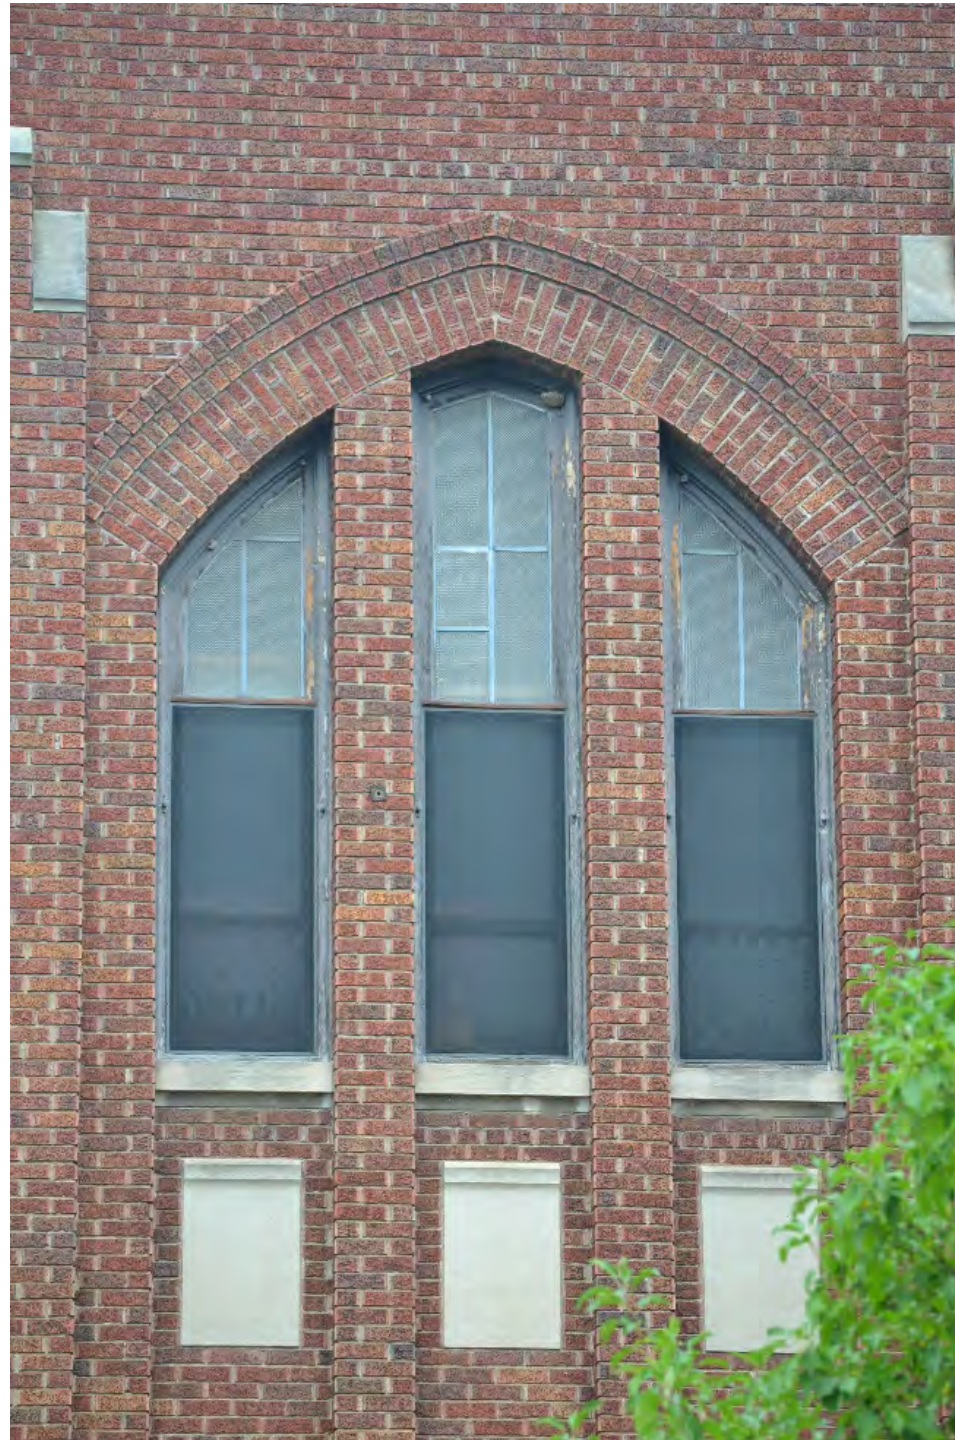
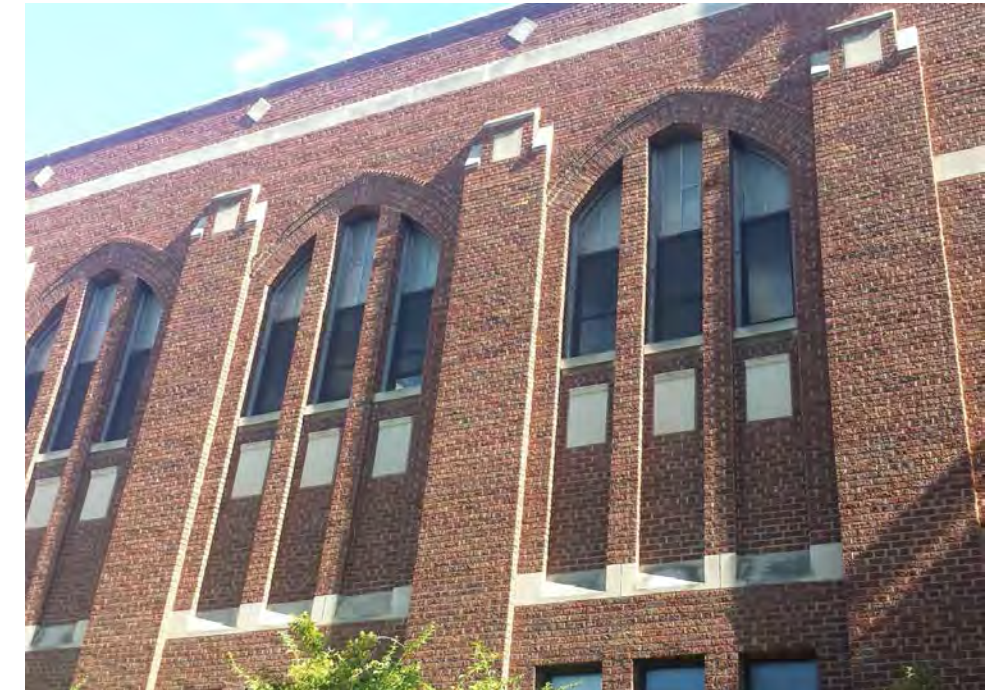
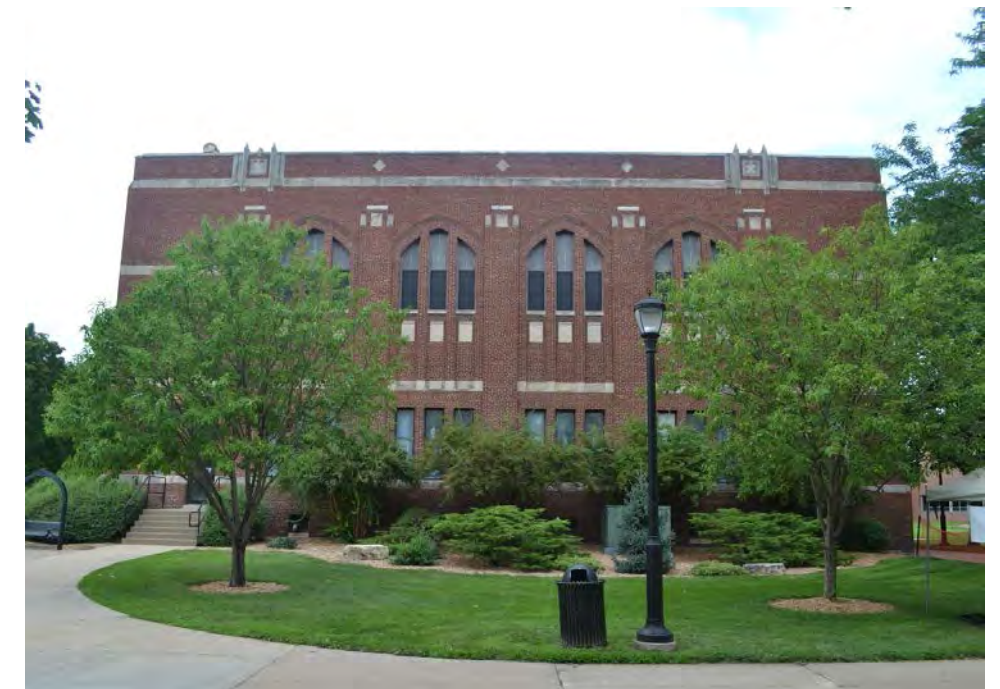
The south elevation of Wittich Hall is currently very much intact historically. It maintains the appearance of the original drawings with a few minor changes in the main level windows and entrance.

Figure 55: South Elevation, Wittich Hall; River Architects (2016)

Figure 56: South Elevation, Wittich Hall; River Architects (2016)

Figure 57: South Elevation, Wittich Hall; River Architects (2016)

- Replace the aluminum storefront entrances at the northwest and southwest entrances with doors that replicate what were once there. Each door should consist of an exterior material that is weather resistant and the interior should retain a wood character.
- Clean all brick and limestone masonry.
- Point all joints within limestone trim and accent panels. Consider use of joint sealant.
- Replace all wood window units with replicas. The windows should consist of an exterior material that is weather resistant and the interior should retain a wood character. Windows to have clear glass in lieu of the historic transfused glass. Muntin bars, sashes, brickmold, etc. to match historic profiles.
- Remove all wood screen units.
- Consider removal of exterior concrete stairs and ramp with something more historically accurate.
- Remove non-original mechanical and electrical devices.

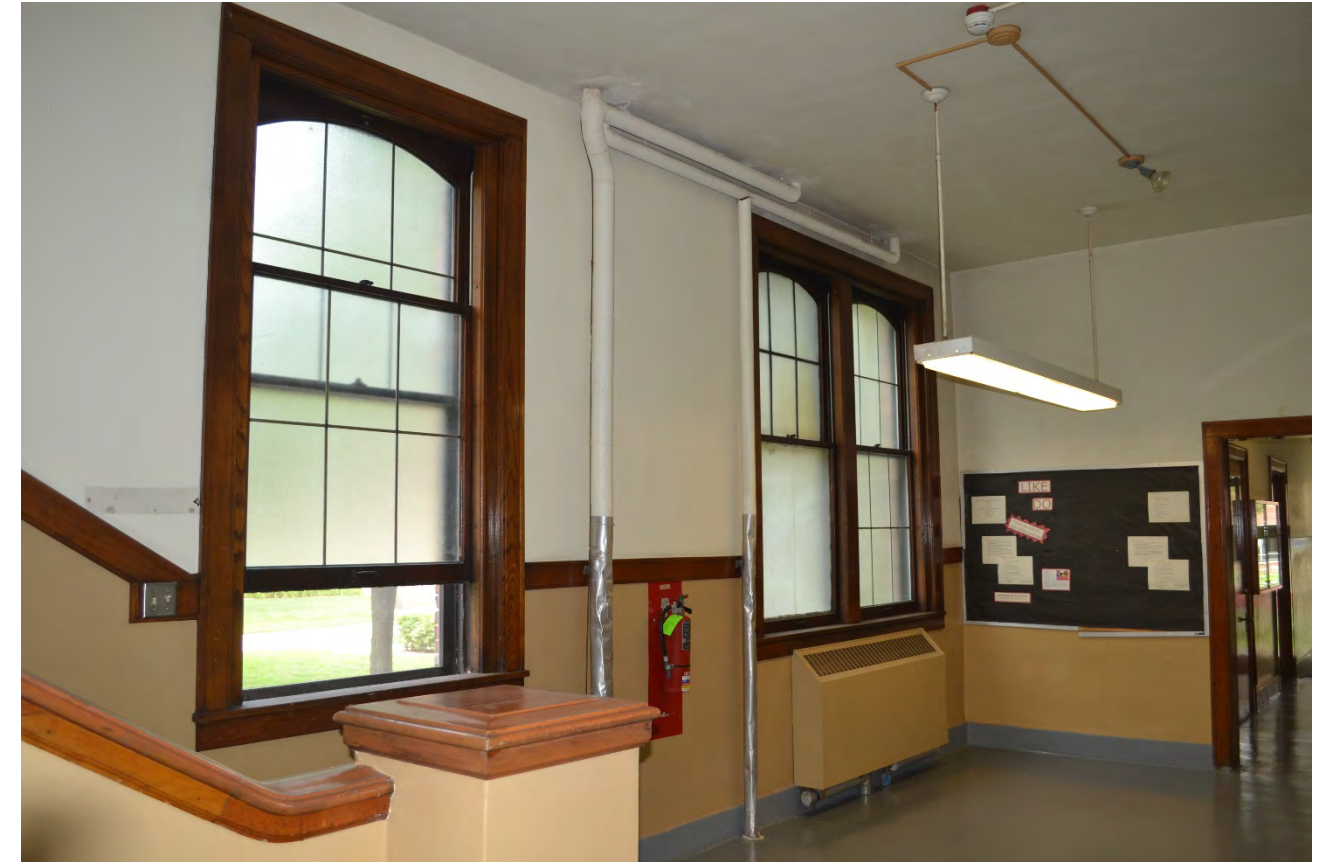
Figure 61: North Entrance Lobby, Wittich Hall; River Architects (2016)

The aluminum entrance doors at the exterior will be replaced with metal-clad wood doors that replicate the original wood doors. Plaster walls are in fair condition. The scope of the wall treatment has yet to be determined. Plaster restoration will be considered as will options of providing metal furring channels and gypsum board.

Due to the amount of renovation work anticipated in this area, preservation of all the terrazzo floor may not be feasible. Consideration should be given to providing new flooring as needed that replicates the original. Analysis of the original finish is required.

1. Original stairs should be treated with new slip resistant nosings and code compliant handrails. Plaster guardrail and wood cap should be repaired, cleaned, and restored.

2. Repair plaster wall finish. (Typical)
3. Remove painted coating from existing floors and base trim and restore concrete/terrazzo substrate. (Typical)
4. Repair plaster ceiling finish. (Typical)

5. Remove and replace existing wood double-hung window with fixed metal-clad wood window. Provide new interior wood trim to match original profile.
6. Remove and replace all mechanical systems. (Typical)
7. Remove and replace all electrical systems. (Typical)
8. Remove and replace all fire alarm systems. (Typical)
9. Remove and replace aluminum entrance door and frame with metal-clad wood door and frame.
10. Consider complete removal of east stair due to insufficient width.

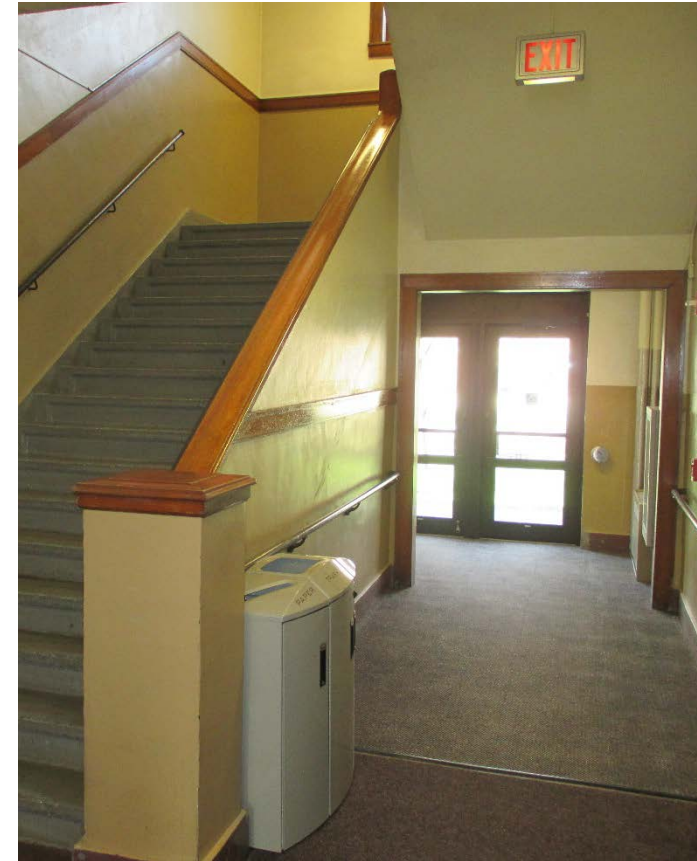
Figure 65: South Entrance Lobby, Wittich Hall; River Architects (2016)

The aluminum entrance doors at the exterior will be replaced with metal-clad wood doors that replicate the original wood doors. The plaster walls are in fair condition. The scope of the wall treatment has yet to be determined. Plaster restoration will be considered as will options of providing metal furring channels and gypsum board.

Due to the amount of renovation work anticipated in this area, preservation of all the terrazzo floor may not be feasible. Consideration should be given to providing new flooring as needed that replicates the original. Analysis of the original finish is required.

1. Original stairs should be treated with new slip resistant nosings and code compliant handrails. Plaster guardrail and wood cap should be repaired, cleaned, and restored.

2. Repair plaster wall finish. (Typical)
3. Remove painted coating from existing floors and base trim and restore concrete/terrazzo substrate. (Typical)
4. Repair plaster ceiling finish. (Typical)

5. Remove and replace all mechanical systems. (Typical)
6. Remove and replace all electrical systems. (Typical)
7. Remove and replace all fire alarm systems. (Typical)
8. Remove and replace aluminum entrance door and frame with metal-clad wood door and frame.
9. Remove and replace existing wood double-hung window with fixed metal-clad wood window. Provide new interior wood trim to match original profile.
10. Consider complete removal of east stair due to insufficient width.
11. Elevator replacement recommended and shall service all floors.

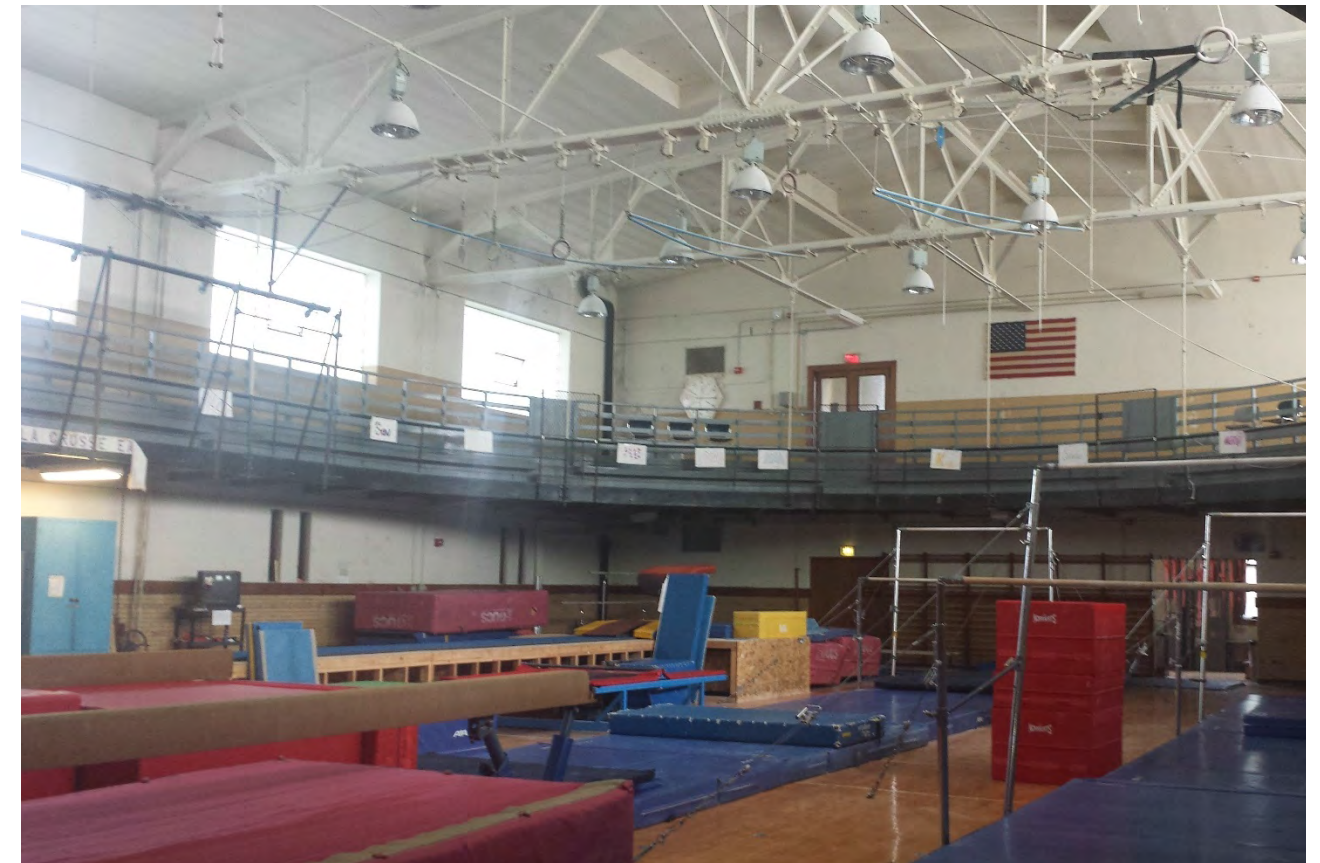
Figure 70: 1916 Gymnasium, Wittich Hall; River Architects (2016)

The plaster walls are in need of repair. The scope of the wall treatment has yet to be determined. Plaster restoration will be considered as will options of providing metal furring channels and gypsum board. The existing brick wainscoting will remain in place and either be expressed to the interior or covered and preserved in place.

2. Repair plaster wall finish. Recommendation is to express the brick wainscot.
3. Repair plaster ceiling finish.

4. Remove and replace existing wood casement window with fixed metal-clad wood window. Provide new interior wood trim to match original profile.
5. Remove and replace existing glass block window with fixed metal-clad wood window. Provide new interior wood trim to match original profile.
6. Salvage wood gymnasium flooring for possible reuse.
7. Remove skylight infill and replace with new skylight/roof monitor.
8. Remove suspended running track. Salvage suspension hardware for possible reuse.
9. Replace damaged roof conductor piping and plaster finishes.
10. Remove and replace all mechanical systems. (Typical)
11. Remove and replace all electrical systems. (Typical)
12. Remove and replace all fire alarm systems. (Typical)
