# Wittich Hall Renovation

Preservation Plan  
Appendix 2

University of Wisconsin – La Crosse  
November 1, 2016

DFD Project No. 14I20

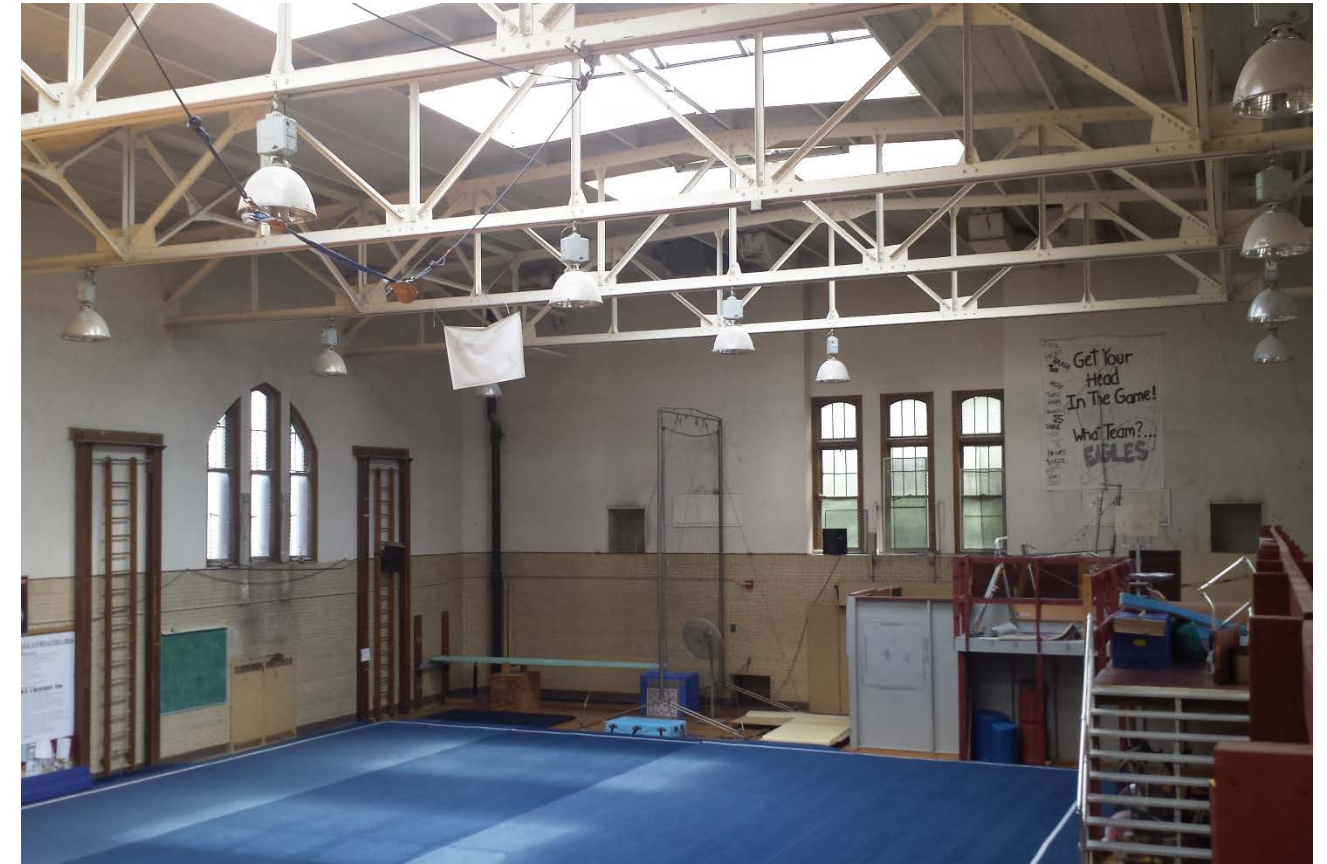
Figure 74: 1930 Gymnasium, Wittich Hall: River Architects (2016)

The plaster walls are in need of repair. The scope of the wall treatment has yet to be determined. Plaster restoration will be considered as will options of providing metal furring channels and gypsum board. The existing brick wainscoting will remain in place and either be expressed to the interior or covered and preserved in place.

1. Preserve metal roof trusses and restore finish.

2. Repair plaster wall finish. Consideration of expressing the brick wainscot pending.
3. Remove acoustical ceiling treatment and consider expressing structural wood decking.

4. Remove and replace existing wood window with fixed metal-clad wood window. Provide new interior wood trim to match original profile.
5. Salvage wood gymnasium flooring for possible reuse.
6. Remove skylight and replace with new skylight/roof monitor.
7. Remove mezzanine structure along south wall.
8. Consider salvage of physical education equipment for display.
9. Remove and replace all mechanical systems. (Typical)
10. Remove and replace all electrical systems. (Typical)
11. Remove and replace all fire alarm systems. (Typical)

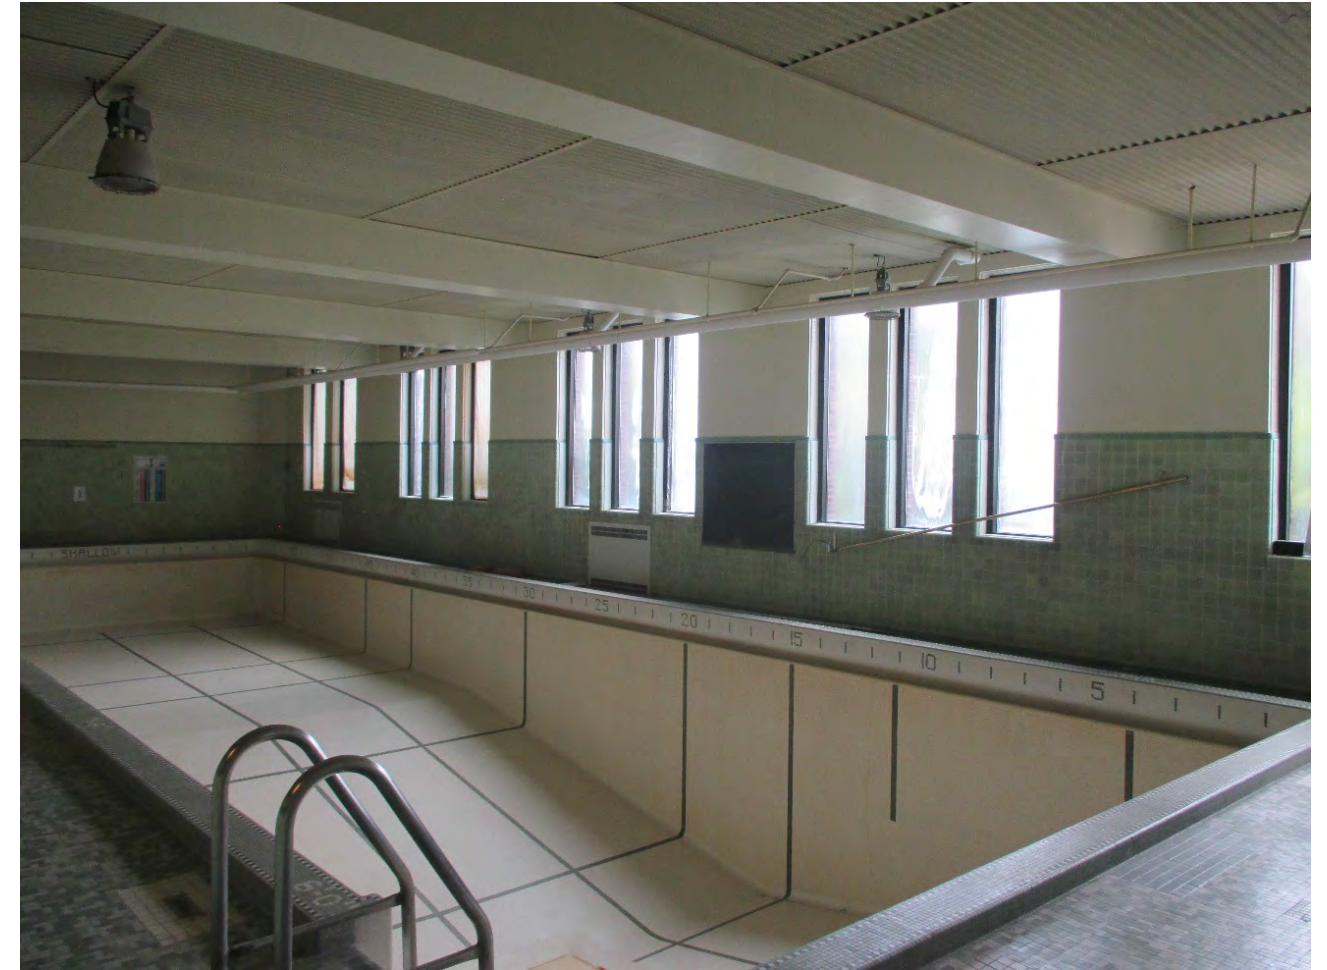
Figure 79: 1930 Pool, Wittich Hall: River Architects (2016)

The plaster walls are in need of repair. The scope of the wall treatment has yet to be determined. Plaster restoration will be considered as will options of providing metal furring channels and gypsum board. The existing tile wainscoting will be removed.

1. Repair plaster wall finish. (Typical)
2. Remove metal decking at ceiling and repair plaster ceiling finish. (Typical)

3. Remove and replace existing wood window with fixed metal-clad wood window. Provide new interior wood trim to match original profile.
4. Remove and replace existing aluminum window with fixed metal-clad wood window. Provide new interior trim to match original profile.
5. Remove and replace existing aluminum entrance door and frame with metal-clad wood door and frame.
6. Remove all floor and wall tile.
7. Remove tiered seating.
8. Consider installation of wood picture rail to match existing.
9. Remove and replace all mechanical systems. (Typical)
10. Remove and replace all electrical systems. (Typical)
11. Remove and replace all fire alarm systems. (Typical)

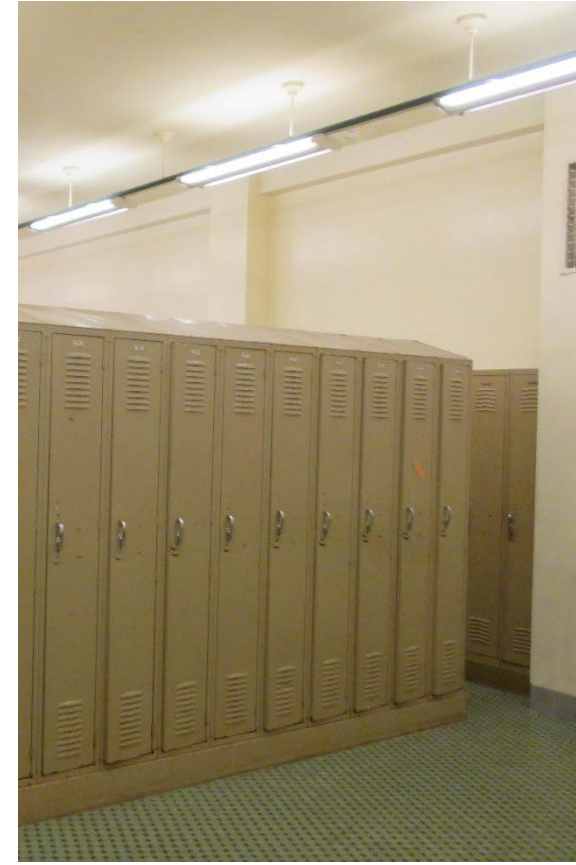
Figure 84: Women's Locker Room 118, Wittich Hall: River Architects (2016)

The main level locker room located in the 1930 addition provided adequate changing facilities for women in the physical education courses. Natural light is provided by north facing windows, making this space quite unique. The space is furnished with marble wall panels, plaster walls and ceilings, and is in overall fair condition.

The plaster walls are in need of repair. The scope of the wall treatment has yet to be determined. Plaster restoration will be considered as will options of providing metal furring channels and gypsum board. All existing wall tile will be removed.

1. Repair plaster wall finish. (Typical)
2. Remove metal decking at ceiling and repair plaster ceiling finish. (Typical)
3. Consider retaining wall niche at original towel pass-through.

4. Remove and replace existing wood window with fixed metal-clad wood window. Provide new interior wood trim to match original profile.
5. Remove all floor and wall tile.
6. Remove and replace all mechanical systems. (Typical)
7. Remove and replace all electrical systems. (Typical)
8. Remove and replace all fire alarm systems. (Typical)

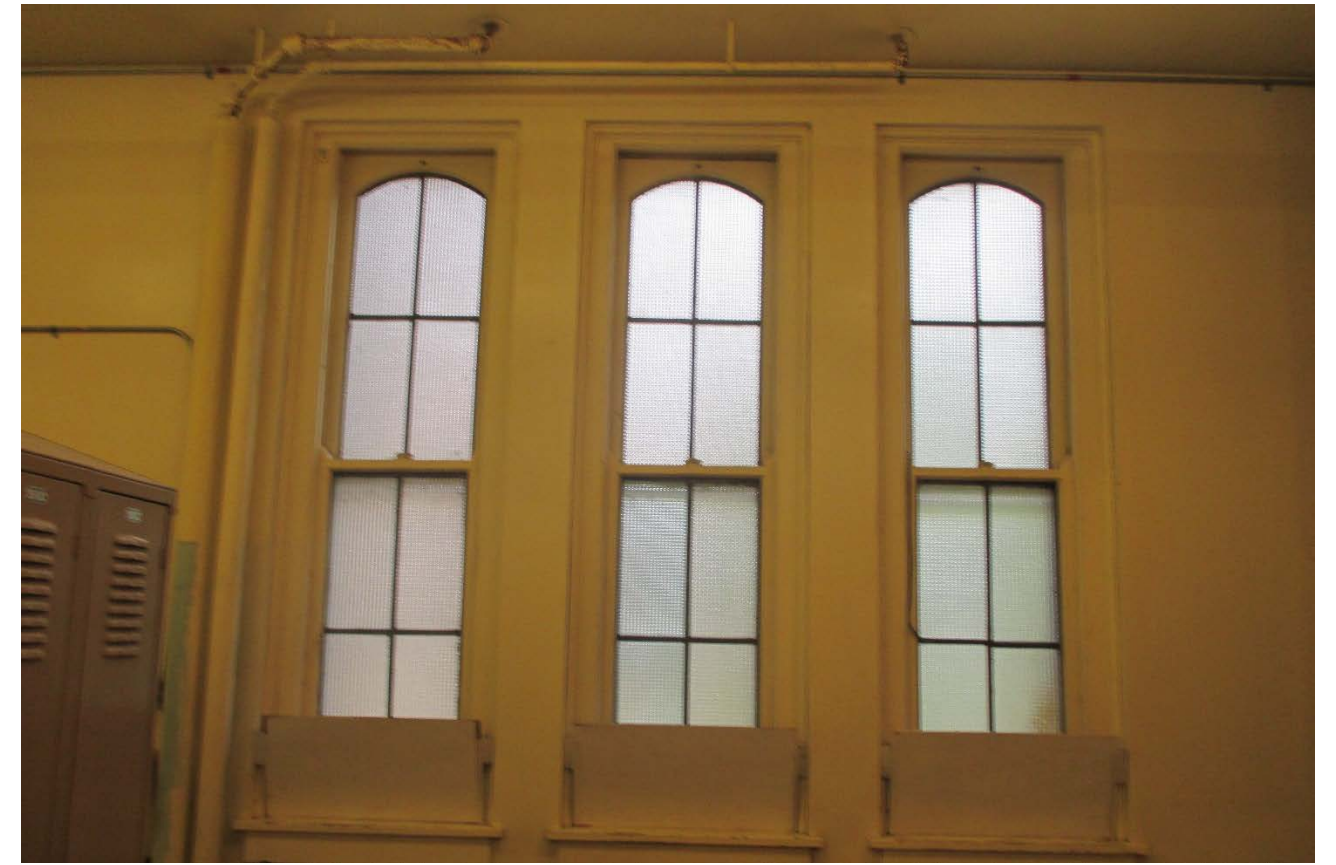
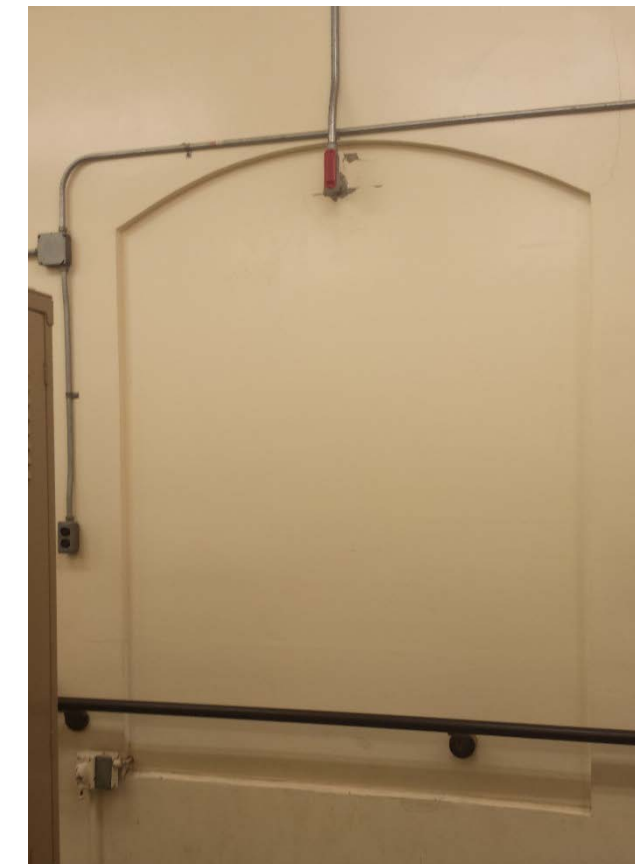
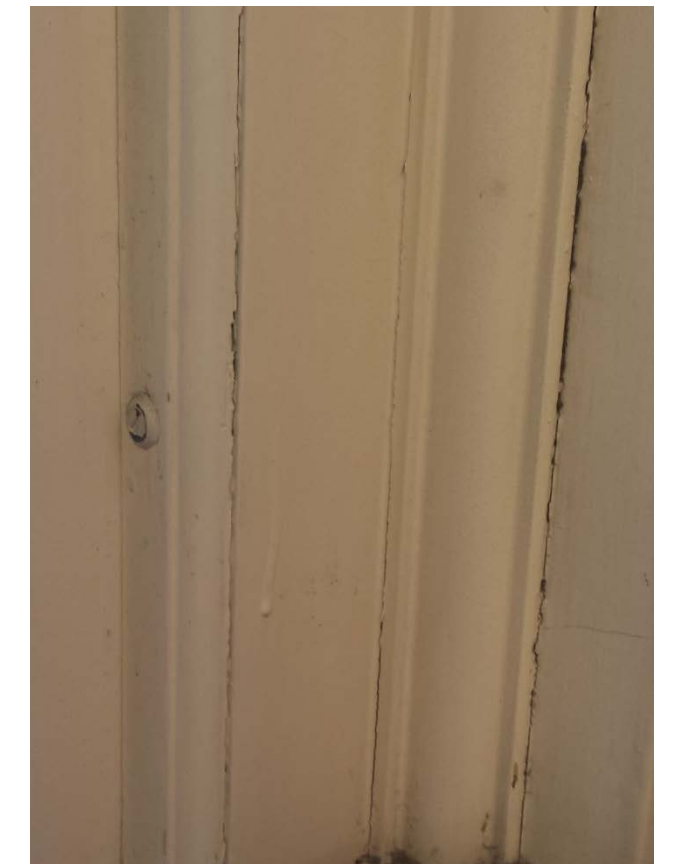
Figure 86: Women's Locker Room 118, Wittich Hall; River Architects (2016)

Figure 87: Women's Locker Room 118, Wittich Hall; River Architects (2016)

Figure 88: Women's Locker Room 118, Wittich Hall; River Architects (2016)

The wood windows will be removed and replaced with windows that replicate the original. It is recommended that the new windows located on the first floor of the 1930 addition have a painted interior finish. Paint analysis required to determine original color.
