WITTICH HALL RENOVATION

WITTICH HALL RENOVATION
FACILITY CONDITION ASSESSMENT
APPENDIX 3

DFD Project No. 14120

November 1, 2016

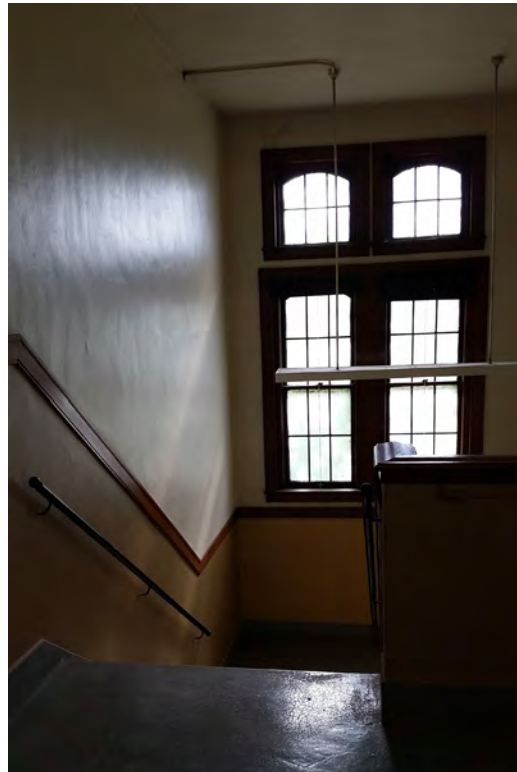
CORRIDOR-C309

D2060 - Process Support Plumbing Systems		
Fiberglass pipe insulation	assumed ACM	5 - Unsatisfactory
WIT - C309 - Corridor		
		4 - Poor
Description	Condition Comments	Rating
C - Exteriors		
C10 - Exterior Construction		
C1080 - Exterior openings		
Exterior Window Glazing		3 - Fair
C20 - Interior Finishes		
C2010 - Wall Finishes		
Plaster walls		3 - Fair
WIT - C310 - Corridor		
		4 - Poor
Description	Condition Comments	Rating
C - Exteriors		
C10 - Exterior Construction		
C1080 - Exterior openings		
Exterior window glazing		4 - Poor
C20 - Interior Finishes		
C2010 - Wall Finishes		
Plaster walls		4 - Poor
C2030 - Flooring		
Concrete flooring and concrete base	painted terrazo floor is chipped, cracked and worn	4 - Poor
WIT - C311 - Corridor		
		4 - Poor
Description	Condition Comments	Rating
C - Exteriors		
C10 - Exterior Construction		
C1080 - Exterior openings		
Exterior window glazing		3 - Fair
C20 - Interior Finishes

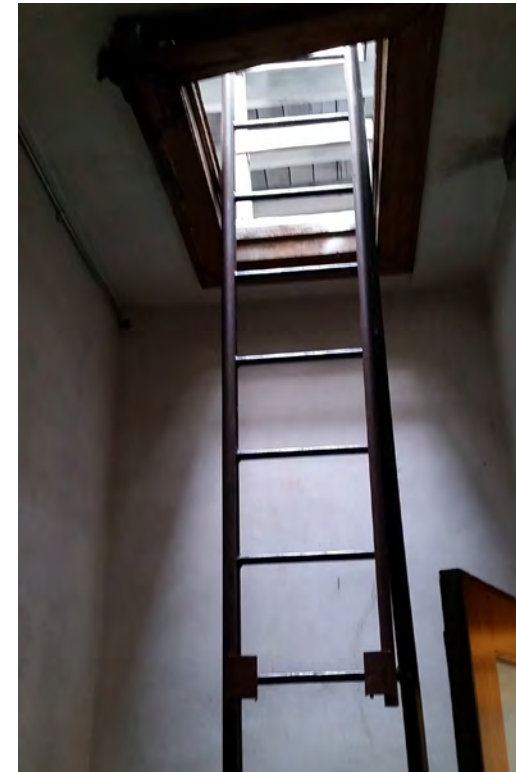
ROOF ACCESS-312

E1090 - Other Equipment		
Electrical insulation	assumed ACM	4 - Poor
WIT - 312 - Roof Access		
		5 - Unsatisfactory
Description	Condition Comments	Rating
C - Exteriors		
C10 - Exterior Construction		
C1080 - Exterior openings		
Roof hatch	Stair to the roof does not meet OSHA requirements	6 - Replace
C20 - Interior Finishes		
C2010 - Wall Finishes		
Plaster walls		5 - Unsatisfactory
C2030 - Flooring		
concrete with concrete wall base		4 - Poor
E - Equipment & Furnishings		
E10 - Equipment		
E1090 - Other Equipment		
steel ladder up to roof	Stair to the roof does not meet OSHA requirements	5 - Unsatisfactory
WIT - C308 - Corridor		
		4 - Poor
Description	Condition Comments	Rating
C - Exteriors		
C10 - Exterior Construction		
C1080 - Exterior openings		
Exterior window glazing		3 - Fair
C20 - Interior Finishes		
C2010 - Wall Finishes		
Plaster walls		4 - Poor
C2030 - Flooring		
Concrete with painted terrazzo finish and concrete base		4 - Poor

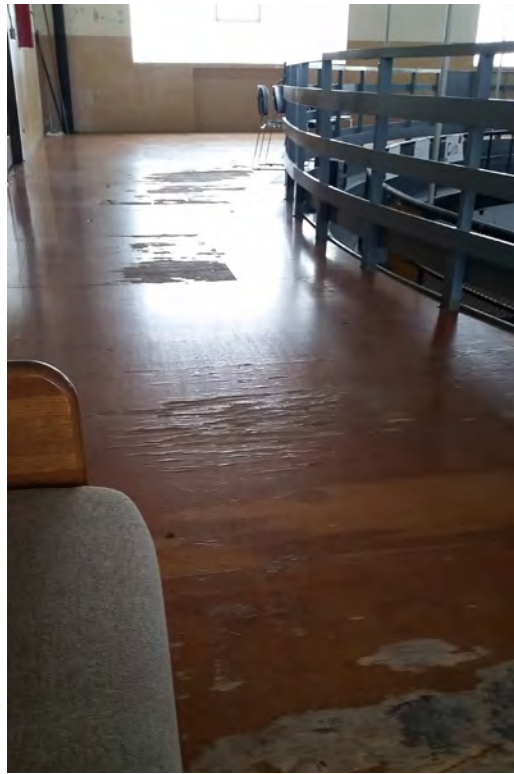
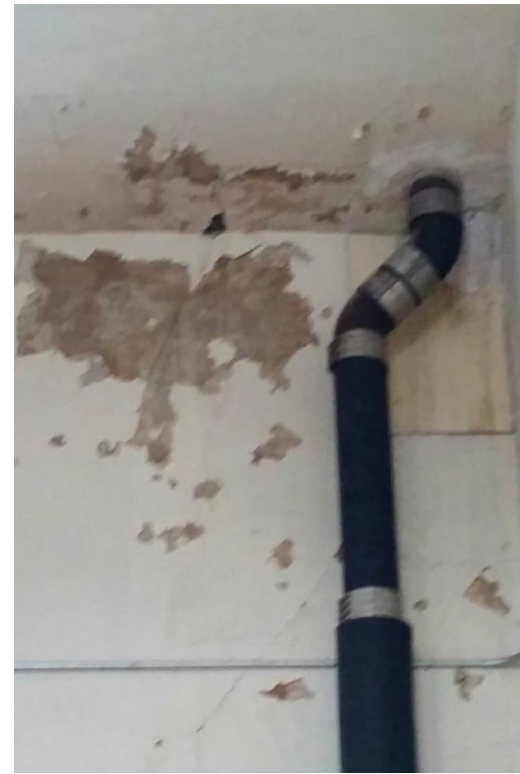
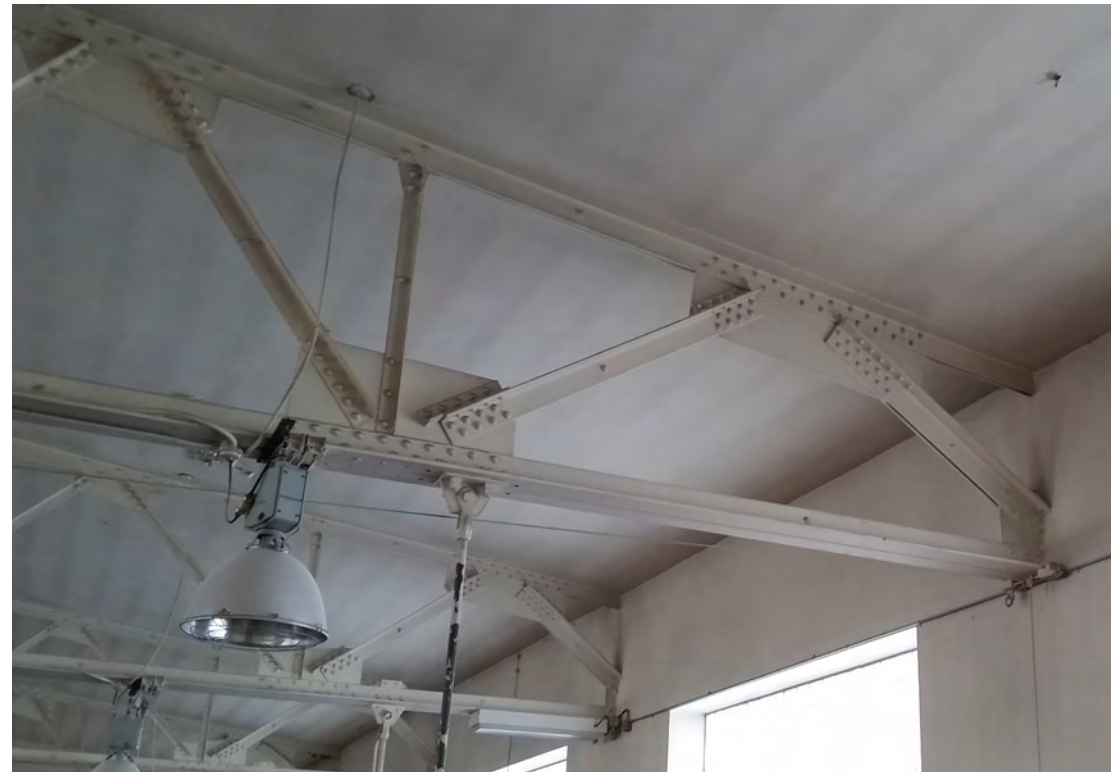
C2050 - Ceiling Finishes				
2x4 ACT ceiling	many water marks and bowed ceiling tiles	6 - Replace		
D - Services				
D50 - Electrical				
D5020 - Lighting				
1x4 surface mounted fixtures		4 - Poor		
WIT - 304 - Track				5 - Unsatisfactory
Description	Condition Comments	Rating		
C - Interiors				
C10 - Interior Construction				
C1030 - Interior Doors				
Wood double doors	Non-ADA hardware, doors do not latch properly, finish is worn and doors should be replaced	5 - Unsatisfactory		
C1080 - Exterior openings				
Concrete window sills	Sills are cracked in many locations, and paint is peeling, sealant at the windows is missing	5 - Unsatisfactory		
C20 - Interior Finishes				
C2010 - Wall Finishes				
Plaster walls	Cracking and peeling is extensive throughout the space	5 - Unsatisfactory		
C2030 - Flooring				
Plywood flooring with wood shoe moulding	Wood is peeling and worn out in many locations around the track	5 - Unsatisfactory

C2050 - Ceiling Finishes				
Plaster or paint on concrete roof/ceiling	Much peeling and staining from water leakage, some apparent patches	5 - Unsatisfactory		
D - Services				
D20 - Plumbing				
D2010.60 - Plumbing Fixtures				
Plumbing piping	Piping is exposed throughout the space	4 - Poor		
D2060 - Process Support Plumbing Systems				
Fittings on Fiberglass pipe insulation	This is assumed ACM, areas are peeling off and missing	5 - Unsatisfactory		
D50 - Electrical

D5010 - Electrical Service and Distribution				
Electrical conduit	All conduit is exposed and surface mounted	3 - Fair		
D5020 - Lighting				
High bay fixtures	Fixtures function but are not energy efficient	4 - Poor		
E - Equipment & Furnishings				
E10 - Equipment				
E1090 - Other Equipment				
Wood handrail/guardrail	Painted, in relatively good shape, does not meet code requirements of allowed opening sizes	5 - Unsatisfactory		
WIT - 305 - Office				5 - Unsatisfactory
Description	Condition Comments	Rating

Third Floor contains the running track and some ancillary storage spaces. The floor on this level changes almost 3" across the length of the building. The condition of the plywood flooring in the track is peeling up at the corners, in some areas, and the level changes could be due to that condition. In the storage areas, the existing carpet is shredded in many cases and laying on top of the floor. This could also be revealing more unlevelled flooring than actually exists. This floor is not a large concern as the running track will be removed as part of the new construction and replaced with a new flooring system.

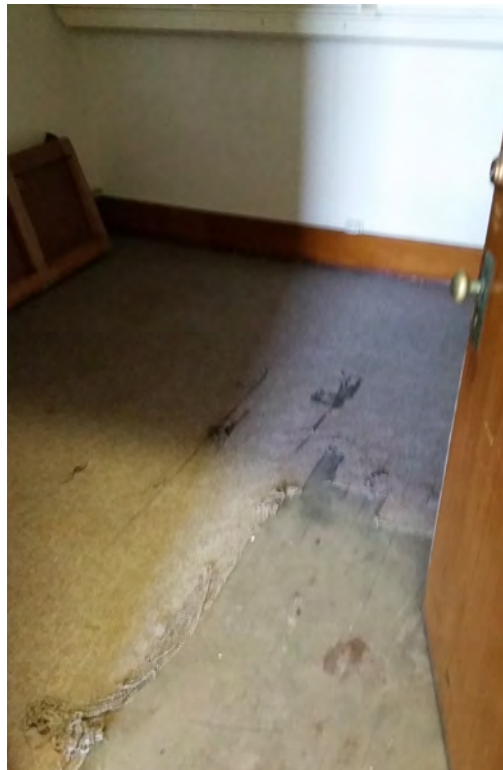
OFFICE-302

WIT - 302 - Office			5 - Unsatisfactory	
Description	Condition Comments	Rating		
- Interiors				
C20 - Interior Finishes				
C2060 - Architectural Woodwork				
Wood floor base 8"		3 - Fair		
C - Exteriors				
C10 - Exterior Construction				
C1080 - Exterior openings				
Exterior Window Glazing		4 - Poor		
C20 - Interior Finishes				
C2010 - Wall Finishes				
Plaster walls		4 - Poor		
C2030 - Flooring				
Carpet	Carpet is shredded and tearing apart	6 - Replace		
C2050 - Ceiling Finishes				
2x4 ACT	Sagging and dirty	6 - Replace		
D - Services				
D50 - Electrical				
D5020 - Lighting				
2x4 surface mounted light fixtures		4 - Poor		
WIT - 303 - Storage				5 - Unsatisfactory
Description	Condition Comments	Rating		
C - Interiors				
C10 - Interior Construction				
C1030 - Interior Doors				
wood door and frame with half light	glazing is textured	5 - Unsatisfactory		
C20 - Interior Finishes				
C2030 - Flooring				
Carpeting, with concrete painted base	Carpet is shredded and backing can be seen attached to floor in several places	6 - Replace
