WITTICH HALL  
FACILITY STUDY

*river* ARCHITECTS

DRAFT SUBMITTAL  
November 10, 2014

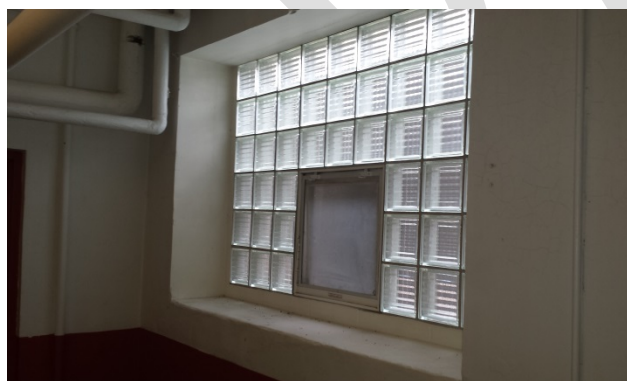
Level 0 Window – 1916 Wing (2014)

Based on field observations, it would appear that the majority of the windows in Wittich Hall are original. The exception being the glass block units in the upper floor of the 1916 gymnasium. The exterior finishes are deteriorating and as such the window frames and sashes are in need of repair or replacement.

Window replacement could be handled in two ways. First, a sash only replacement would provide modern-day, energy efficient glazing and could be done in a clad exterior – wood interior in order to provide a maintenance free exterior and historic interior. The existing wood brick molding would need to be covered or removed and replaced with metal of a similar profile. A second option would be to replace the entire window assembly. Since the interior woodwork is in good shape, this approach may not be the preferred option.

Masonry openings should be cleaned thoroughly and new sealant be provided as required for a proper window installation.

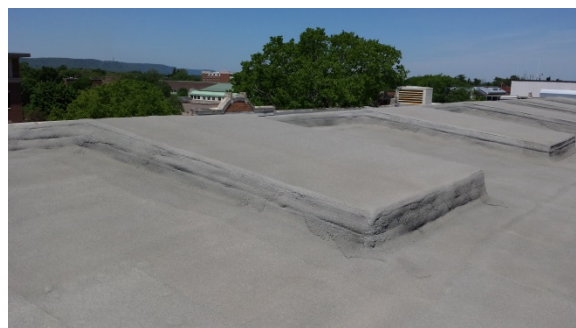
According to the 1985 roof replacement drawings, the existing roof consists of two layers of insulation for a total insulation thickness of 2 ¾" plus a ½" recovery board. The adhered sheet membrane roofing with hypalon coating was placed up the inside face of the parapet walls and terminated by a metal flashing. The roofing system also extends over the skylights of the 1916 wing.

Our recommendation is to remove all roofing materials down to the original wood decking, install an appropriate vapor barrier, roof deck insulation, and a fully adhered ethylene-propylene-diene-monomer (EPDM) membrane.

It is recommended to replace all metal flashing with stainless steel. Recommended flashing installation at the parapet would be to provide a through-wall flashing under the parapet coping rather than relying on sealant in a reglet joint. The original stone coping should be salvaged and reinstalled once the new flashing is in place.

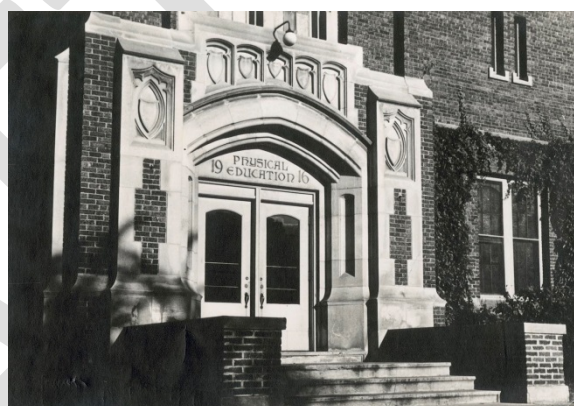
Northwest Entrance Stairs (c. XXXX)

Currently, there is no slip resistant treatment present at the four entrance stairs. The university has indicated that the concrete stairs can be hazardous in the winter season.

Slip resistive nosings are recommended at all four entrance stairs. An abrasive nosing should be applied to the leading edge of each tread to provide slip resistance and visual distinction.

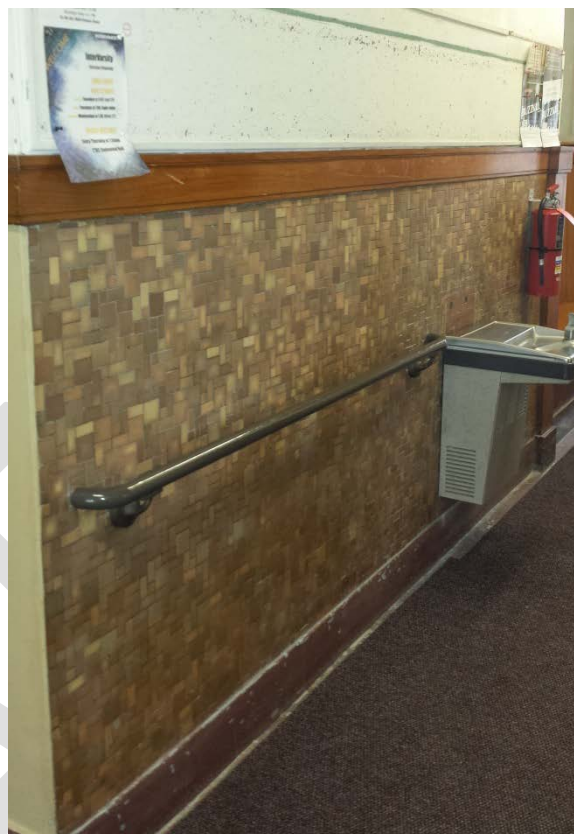
Level 1 Interior Partition (2014)

All the original walls in the building were finished with plaster and overall, the plaster appears to be in good condition. There are areas where cracking is present in the walls beneath the large span roof trusses over the 1916 gymnasium. At this time it is not known if these cracks are structural related.

Removal of the plaster finish is recommended at areas of deterioration. All interior walls should be carefully analyzed to determine if they are load bearing or not. The remodeling of this building will likely remove most of the existing interior walls.

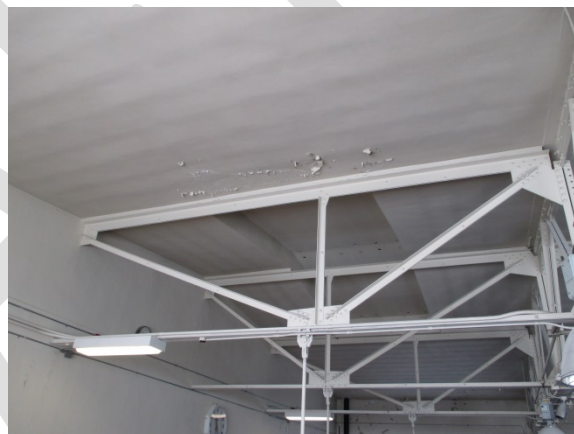
Gymnasium Roof Truss – 1916 Wing (2014)

Moisture damage can be seen in each corner of the 1916 gymnasium near the ceiling where water infiltrated the roof and walls through failed roof drain systems.

Plaster damage located in the gymnasium should be repaired.
