CAMPUS PHYSICAL DEVELOPMENT PLAN

2017 – 19 Capital Budget

UNIVERSITY of WISCONSIN LACROSSE

University of Wisconsin – La Crosse July, 2016

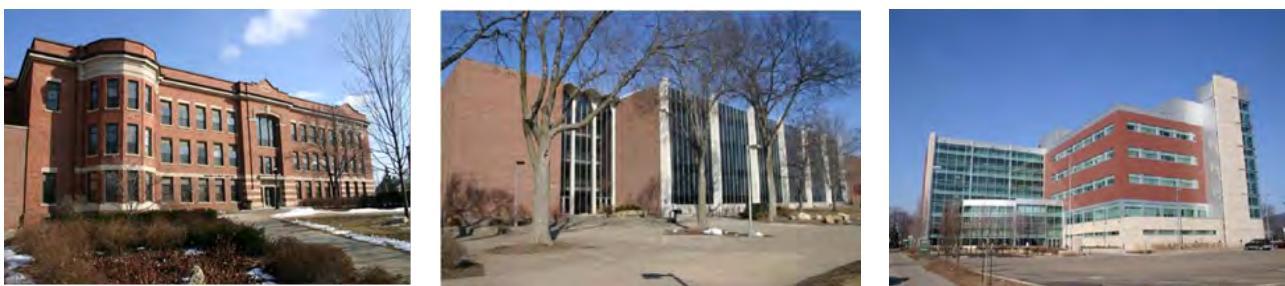
Existing divergent architectural styles

The physical character of the campus has evolved over the last century, with a variety of buildings that reflect the architectural influence of their time. The general architectural expression has been set by three major periods with distinctive character traits. The early period of the original La Crosse Normal School and the later La Crosse State Teachers College reflect a style that harkens back to a Collegiate Gothic, or Neo-Classicism. The second influential period was a twenty-three-year segment of time from 1951 to 1974 during which twenty new buildings with a very Modernist influence were built. Finally, the period of construction, from 1995 to 2005, is characterized by buildings that combine the historical and modernist styles in a Post-Modern approach.

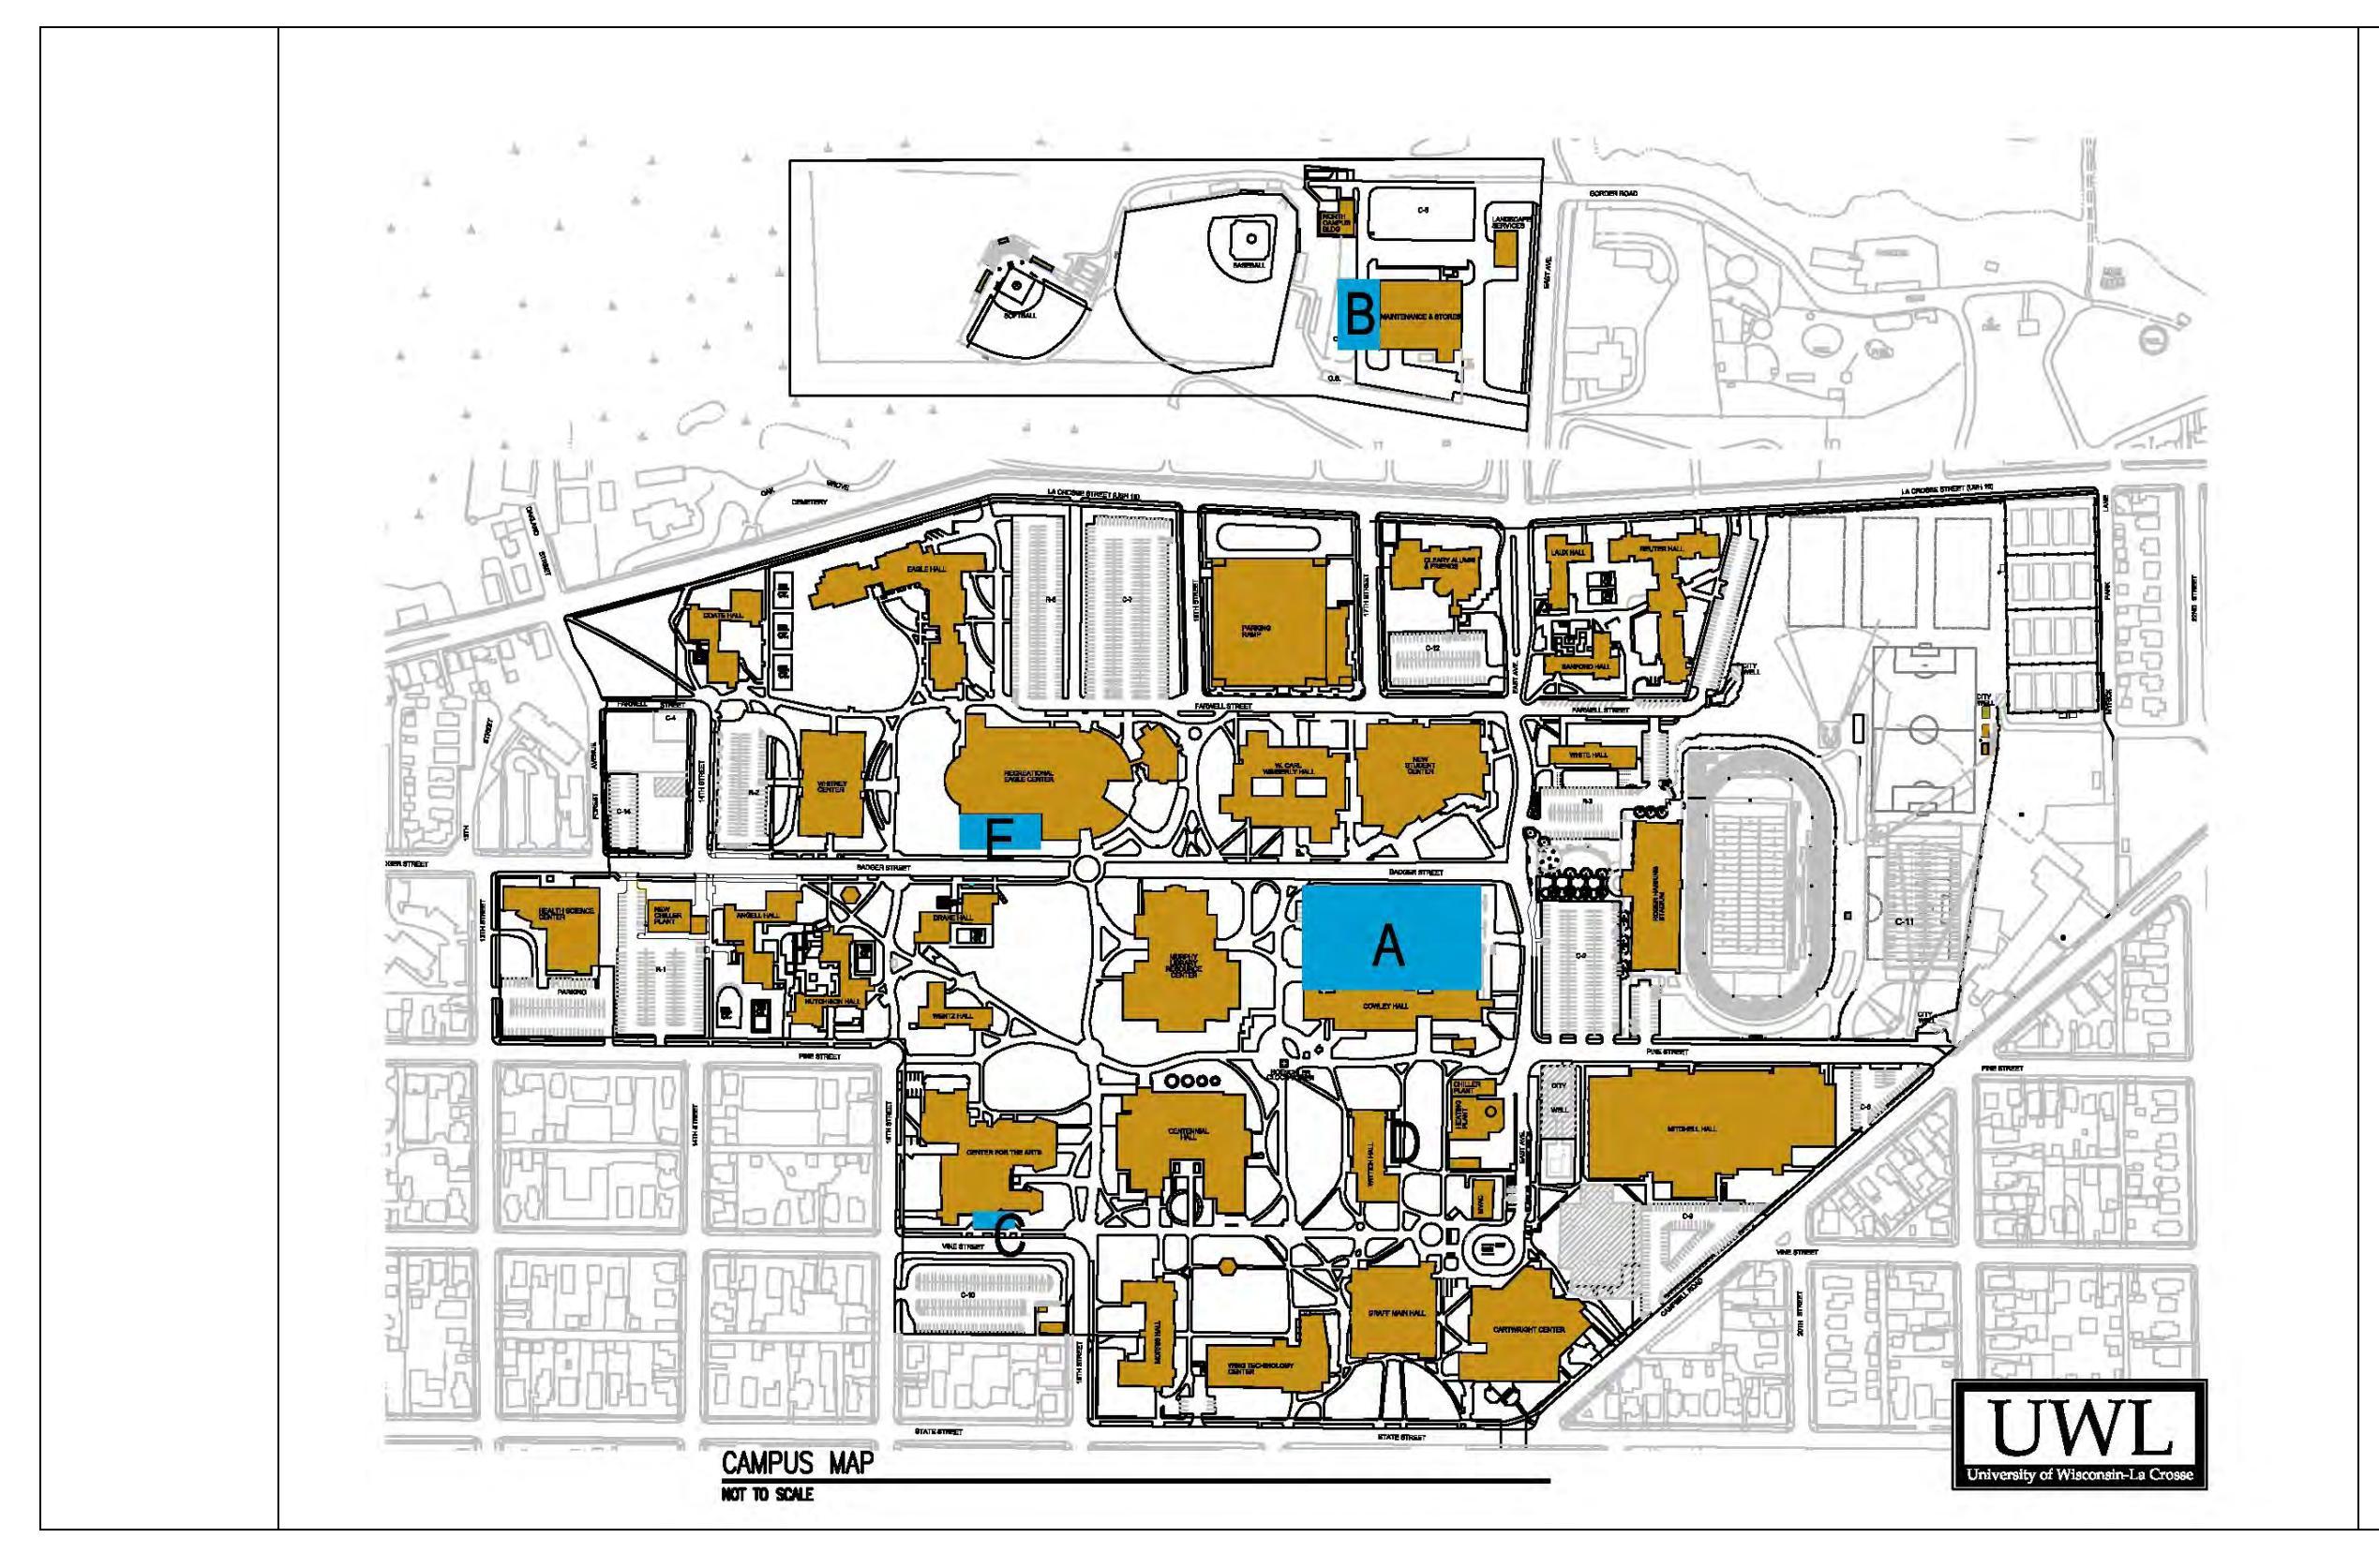
B. EXISTING CONDITIONS MAP

A Phase 1 of the New Science Building will start construction in Fall 2016 and be completed in Summer 2018.

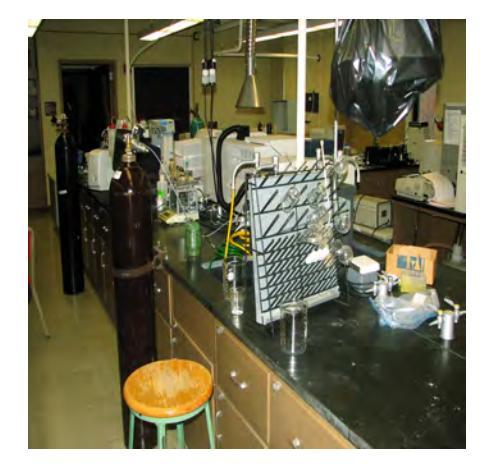
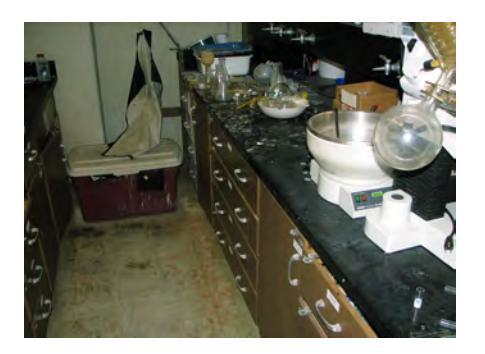
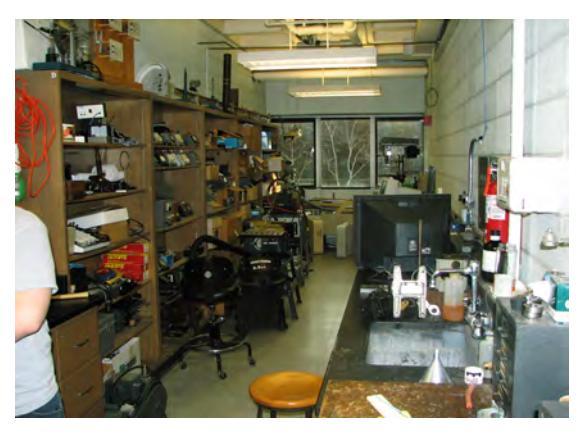
Photos on this page show various existing lab spaces in Cowley Hall

Cowley Hall was constructed in 1965 when there were far fewer science programs, and those programs demanded much less from the facility. The building has never had a major renovation, and it can no longer accommodate the quantity and intensity of the instruction and research that must occur in the building. All of the programs physical and life sciences the in are experiencing severe space shortages. In addition, the quantity and condition of the instructional labs are inadequate to serve the number of students that are demanding access to the programs. Along with the space deficiencies and the poor condition of individual labs, the overall infrastructure of the building itself is completely beyond its useful and expected life.

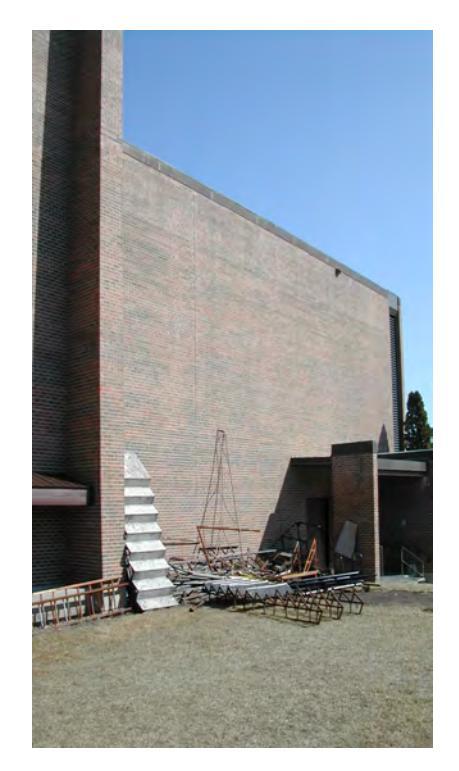
(At Right – Lack of storage for Theatre Arts results in items used for productions overflowing outside of the bldg)

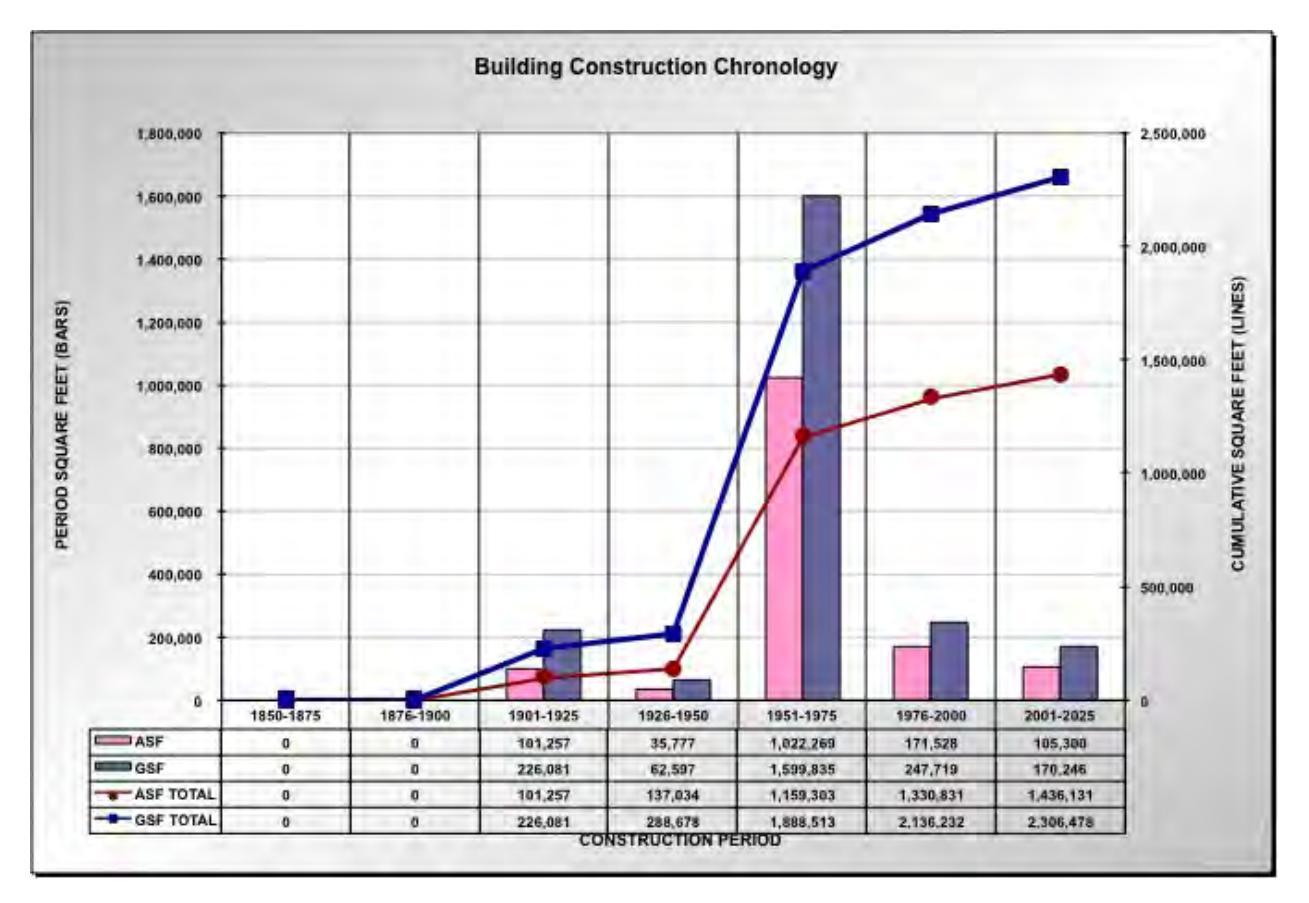
The Building Construction Chronology graph shown below illustrates the fact that the majority of the buildings on the UW-L campus are in excess of thirty five years old, with most of them actually being constructed prior to 1974. Of the buildings on campus that haven't been constructed within the last six years, only Graff Main Hall, Wing Technology Center, Murphy Library and Morris Hall have had significant renovations. And of those facilities, the most recent significant renovations occurred in Morris Hall in 1995, and in Graff Main Hall in 1980. Consequently, even the renovated areas in Graff Main Hall haven't been updated for over thirty years.

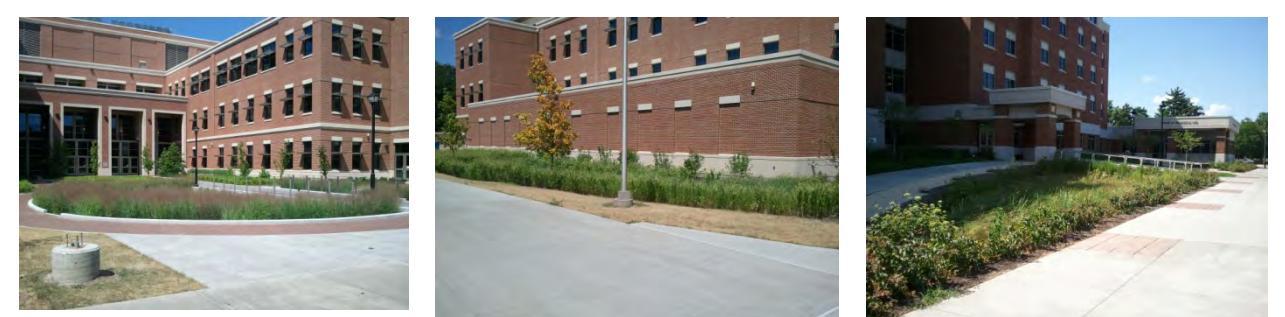
Various biofiltration basins at Centennial and Eagle Halls

While there are no known problems with the physical condition of the storm sewer piping on campus, there are some issues with capacity. The storm sewer system in the city of La Crosse cannot always adequately handle the loads it experiences during heavy rainfalls, and also during the spring thaw if it occurs under certain conditions. The main system is in roughly the same configuration as it was fifty years ago, prior to much of the development within the city. The amount of green space in the city of La Crosse has decreased and the amount of hard surfaces has increased, which has resulted in more runoff flowing directly into the storm sewer system. Consequently, the system cannot always accommodate the large flows caused by heavy rains, and areas within the city, including some portions of campus, experience back-up from the sewers under certain conditions. Because of this, and due to pursuit of LEED Certification for Centennial and Eagle Halls, biofiltration basins were designed and constructed as part of the site development for both of those buildings. The roof storm water and clear condensate water from the building systems are routed to these biolfiltration basins that are located around the perimeter of the new facilities. With the exception of very large rain events, the basins, which have been in place for little over a year, seem to be handling the storm water very well. The campus intends to develop additional such installations with future building projects as site constraints allow.

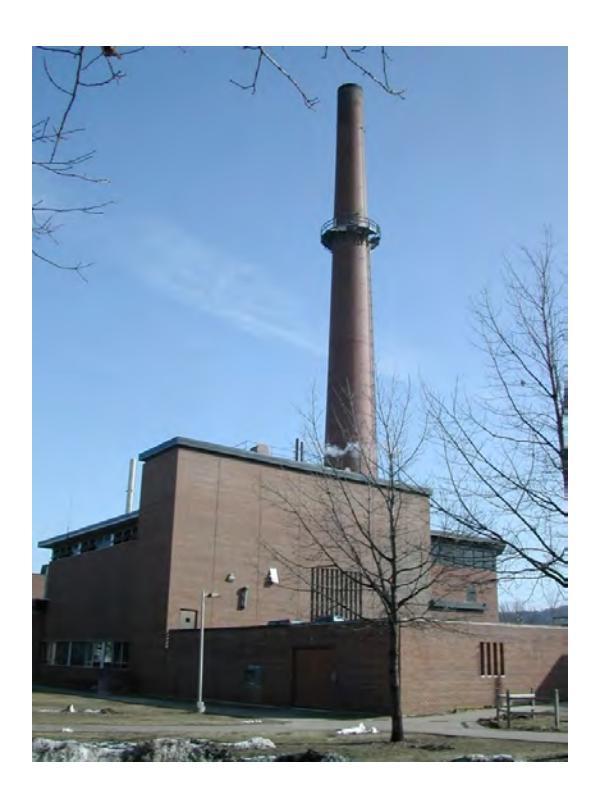
Campus steam is supplied by a central plant that produces steam with two 60,000 PPH coal fired boilers plus two 15,000 PPH natural gas fired boilers that have recently been installed. The high pressure steam is distributed throughout campus via underground pipes which are located in concrete ducts (Permaduct or Z-Crete). Approximately, 19,100 linear feet of steam and condensate lines serve twenty-seven buildings on the main campus. Within the buildings, the steam pressure is reduced from 100 to 15 PSIG. Steam is used for area heating, food processing, humidification, sterilization/autoclaves, domestic hot water, and, in limited applications, cooling.

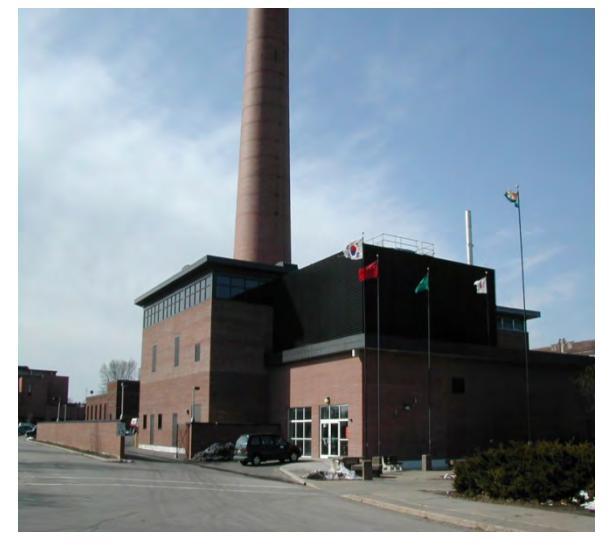
The campus chilled water plant, and distribution system, was constructed in 1997. The project included construction of 2,800 GSF building to house water chillers, pumps, cooling towers and auxiliary equipment needed to produce and distribute chilled water to seven buildings (Cowley Hall, Murphy Library, Center for the Arts, Recreation Eagle Center, Whitney Center, North Hall and Morris Hall). Approximately, 7,036 linear feet of 18" diameter chilled water supply and return line piping was direct buried without insulation. Subsequent to that, an additional seven buildings were connected to the system as well. Because of anticipated additional demand based on projections from building projects that were being planned at that time, a third chiller and cooling tower was added to the central plant in 2007. Since then, development of major projects as shown in the Campus Master Plan and Physical

Development Plans have resulted in chilled water demand projections that exceed the central plant's ability to satisfy those demands. Consequently, a satellite chiller plant was constructed to provide additional capacity to the central chilled water distribution system.

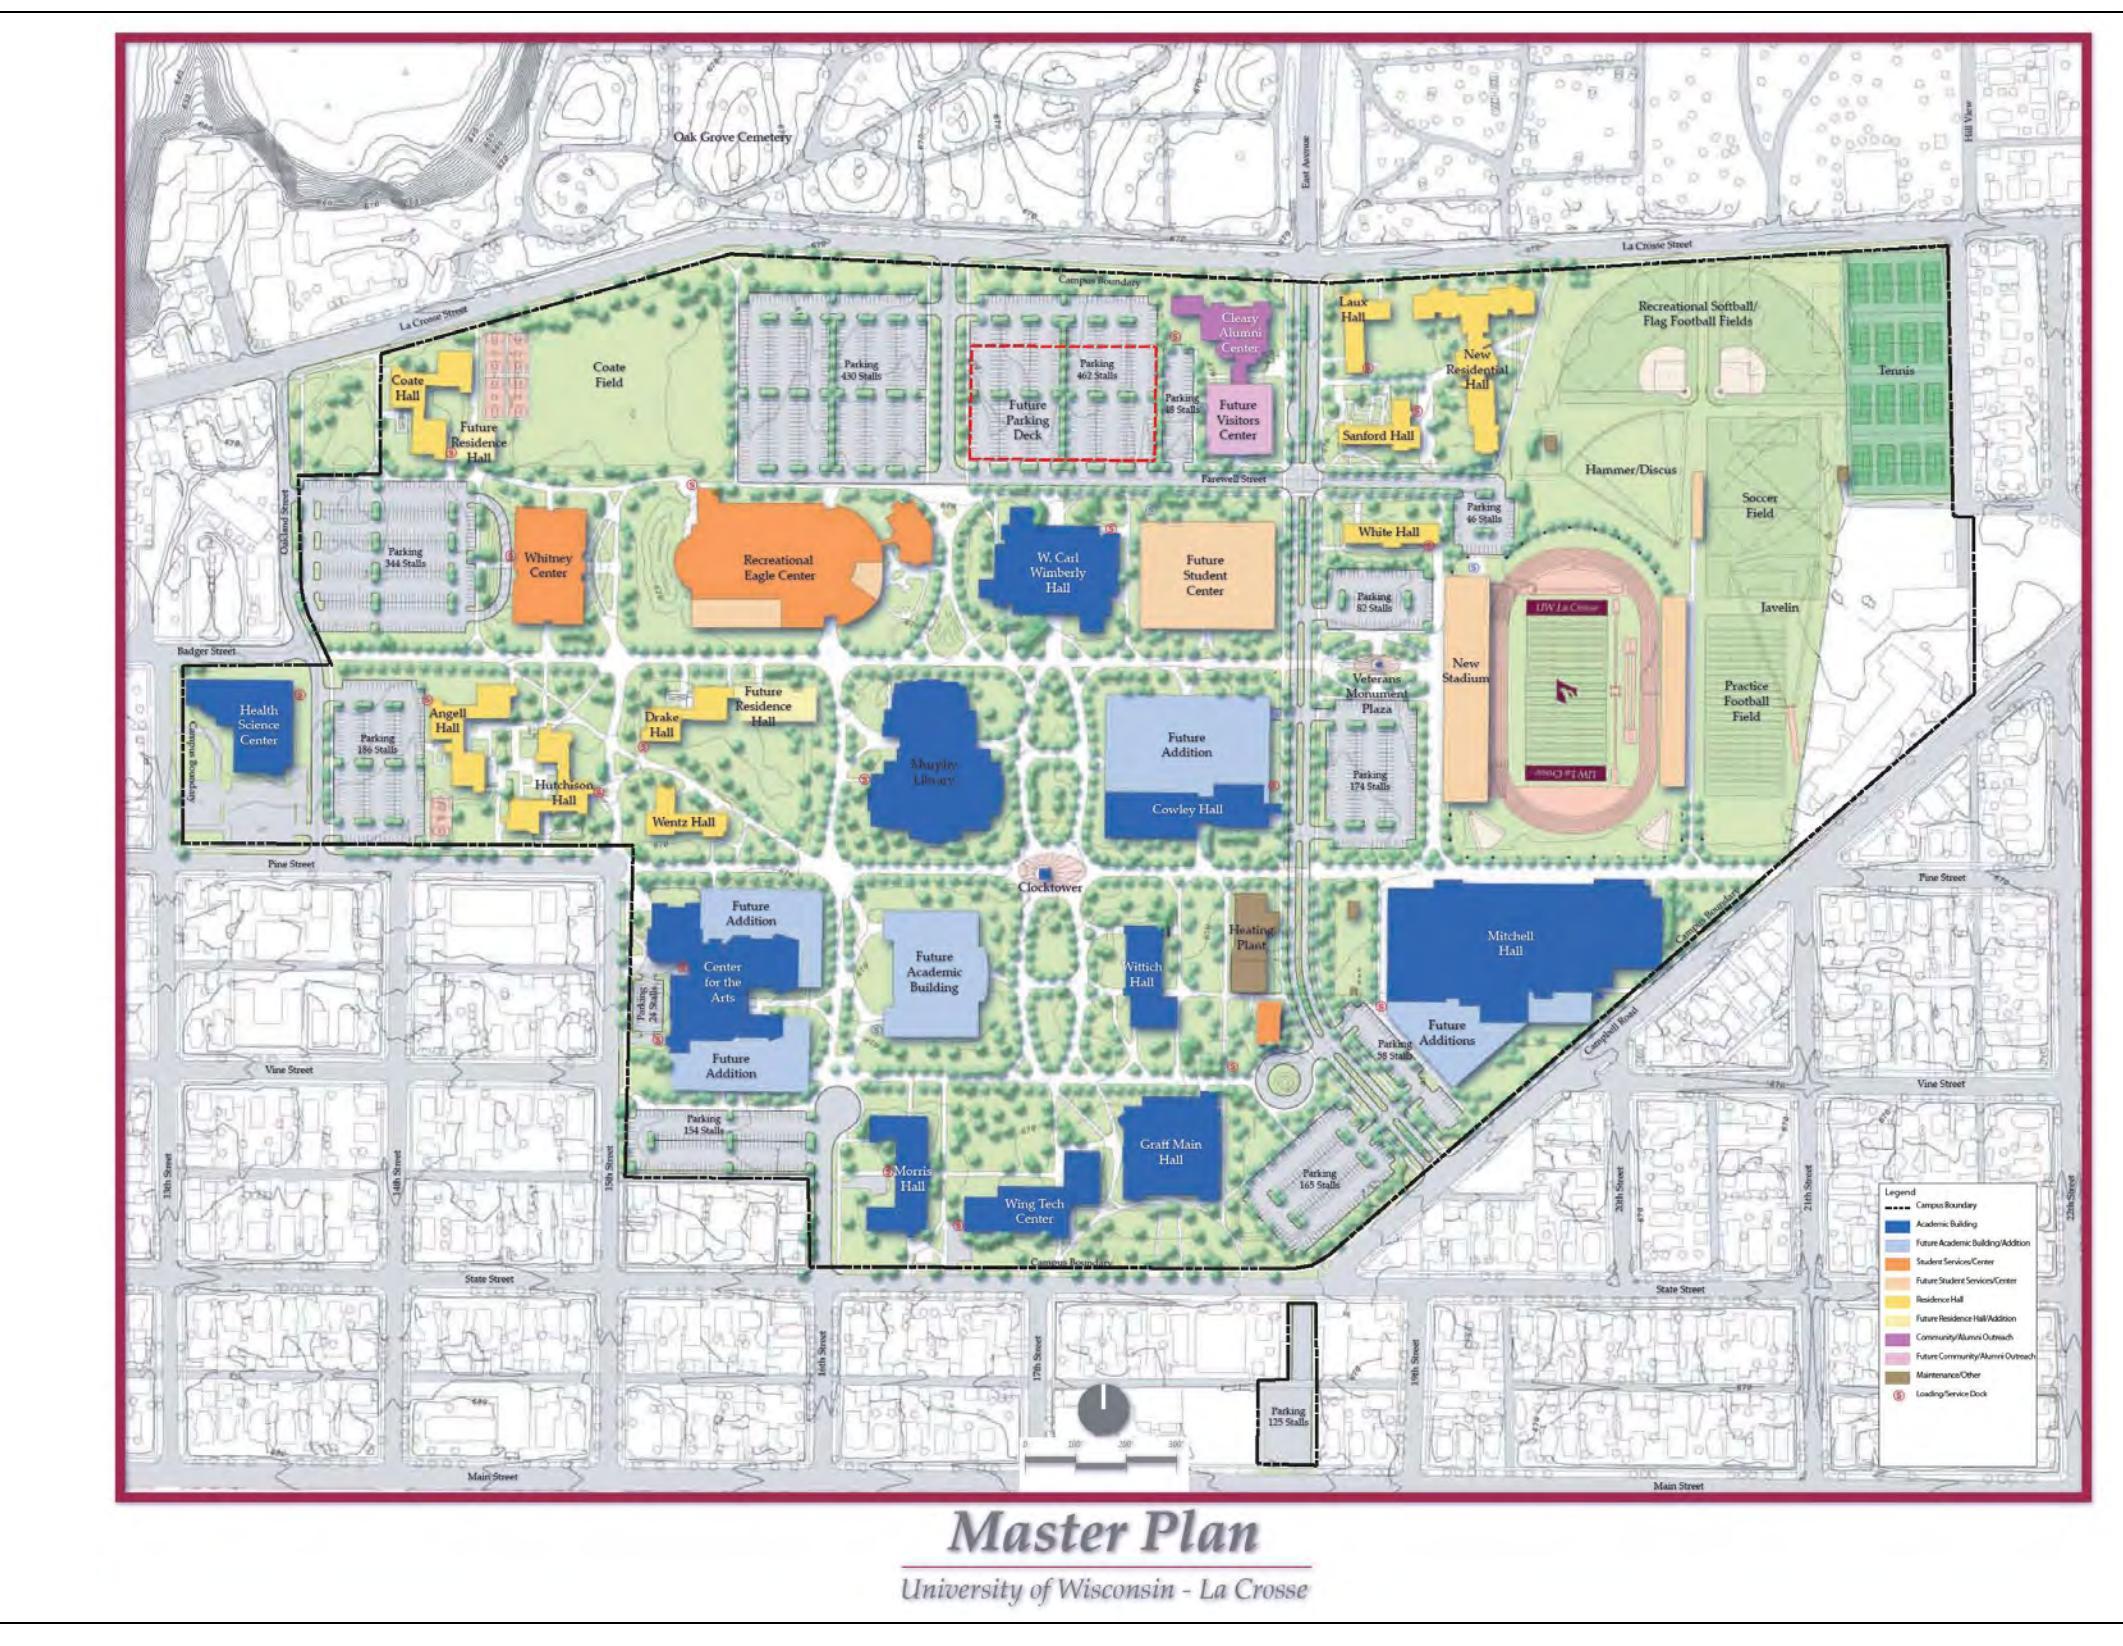
LONG-TERM DEVELOPMENT PLAN

The illustration shown at left is the UW-L Master Plan. It was developed through a public and collaborative process that spanned over a period of approximately 1 ½ years, and was finalized in 2005. It has served as a roadmap for development of major projects on campus that have occurred since its completion. These projects include Reuter Hall, Veterans Memorial Sports Fields Complex, Centennial Hall, the new Parking Ramp and Police Services Building, the new West Chiller Plant, and the New Student Center.
